Certificate of Appropriateness Application

Case Number: <u>CA-18-1</u>5

September 27, 2018

Re: Patane Garage 104 Hampshire Road Syracuse, NY 13203

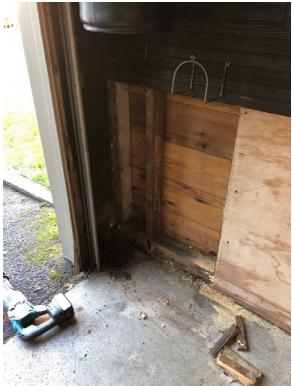
The sill plate on the north & east walls is actually below grade and as a result has extensive deterioration, despite the Owner's ongoing attempts at remediation.

PHOTO #1 – Northwest corner of garage.

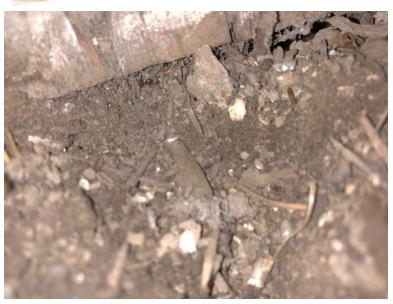
It is typical in garages constructed in the same era as the Patane's, that foundations only extended just below grade, well above the frost line and were undersized. As a result, differential settlement has occurred on all sides of the garage foundation, causing heaving, cracking in the garage floor and causing the garage doors to be inches out of plumb. The Patane foundation does not protect the wood sill plate or lower sections of the wall studding and sheathing around the entire north and east sides of the garage. As shown in photos #5 and #6, the chimney has separated from the wall framing because of a similarly inadequate foundation. The existing chimney could not be repaired or supported in place & would have to be demolished.

below sill plate.

PHOTO #4 - Lack of foundation

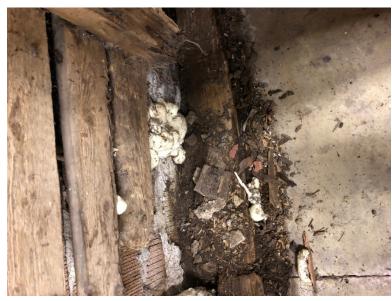
sheathing at east side chimney.

PHOTO #5 - Deteriorated sill plate &

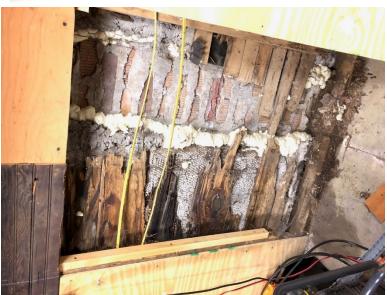
PHOTO #6 – Additional photos of deteriorated sheathing, sill plate & wall

intersection of chimney & exterior wall. Photo illustrates deteriorated sheathing, sill plate & wall studs.

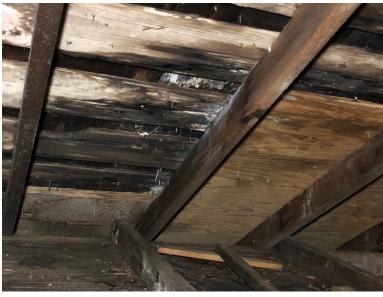
PHOTO #7 - Deteriorated roof board

slates, cedar shakes, & sagging rafters.

The Patane garage roof assembly consists of 2x4 rafters and ceiling joists at 24 inches on center, spaced wood boards, wood shakes, and asphalt shingles. The 2x4 framing are undersized for the snow loading that occurs in Onondaga County. As a result, the roof planes have bowed inward, which allows for water infiltration to deteriorate the rafters, the spaced boards, and wood shakes. Refer to photos #7 through #11. The cornice assembly has also been affected by this water infiltration requiring the replacement of rafter tails, fascia and cornice trim.

The garage roof (100%) would be required to be stripped to the rafters & re-structured to meet snow loading requirements. Upon completion, new sheathing, roofing & entire cornice assembly would be re-trimmed. These reconstruction requirements lend themselves to an unreasonable renovation cost. I hope the LBP see fit to allow for the demolition of the existing garage & construction of a new garage in compliance with City Zoning & LPB Design Guideline requirements.

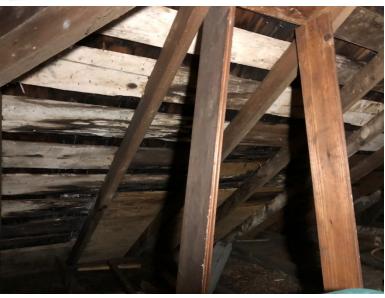
provide additional rafter support.

Photo #8 – Owner installed boards to

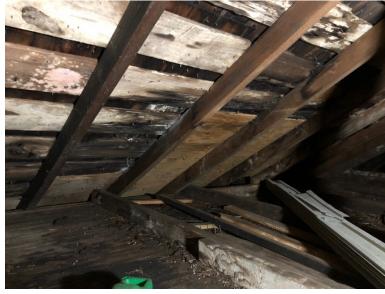
joists & rafters.

PHOTO #9 - Intersection of ceiling

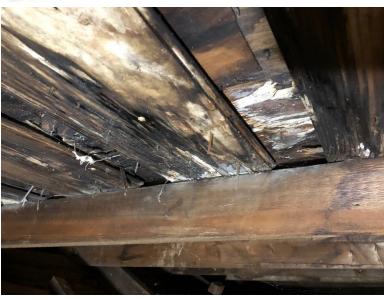
PHOTO #10 – Extensive deterioration

@ rafter bearing.

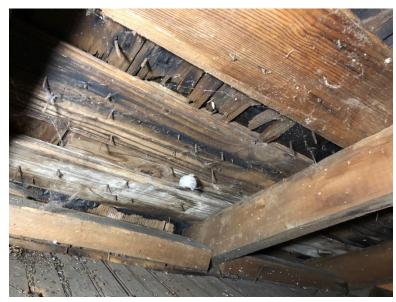
PHOTO #11 – Extensive deterioration

@ sheathing & rafter tails.

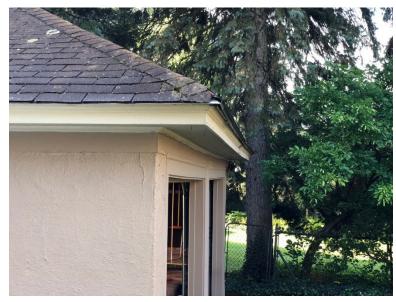
PHOTO #12 - Northwest exterior

corner, illustrating sagging @ garage doors. Due to an inadequate foundation, sill plate deterioration, & leaking at roof edge.

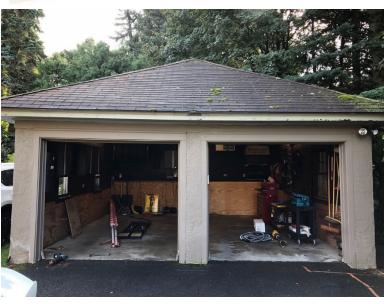
Patane Garage.

PHOTO #13 - West elevation of

It is my professional opinion, that the cost of the work that is required to renovate the existing garage is excessive and would far exceed the construction costs of a new garage. The existing garage is deteriorated beyond a point of a reasonable repair. To replace 100% of the foundation; the garage floor slab, entire perimeter, wall sheathing would need to be replaced in fractional segments. The garage would require to be temporarily jacked, shored and supported. The foundation and wall assembly would be replaced in no greater than 6 foot sections. The process of the foundation & wall framing remediation would also require the completed re-cladding of the exterior with a stucco finish.
