**SYRACUSE
LANDMARK
PRESERVATION
BOARD**

Certificate of Appropriateness Application

Case Number: CA-23-06

WINDOW SURVEY FORM

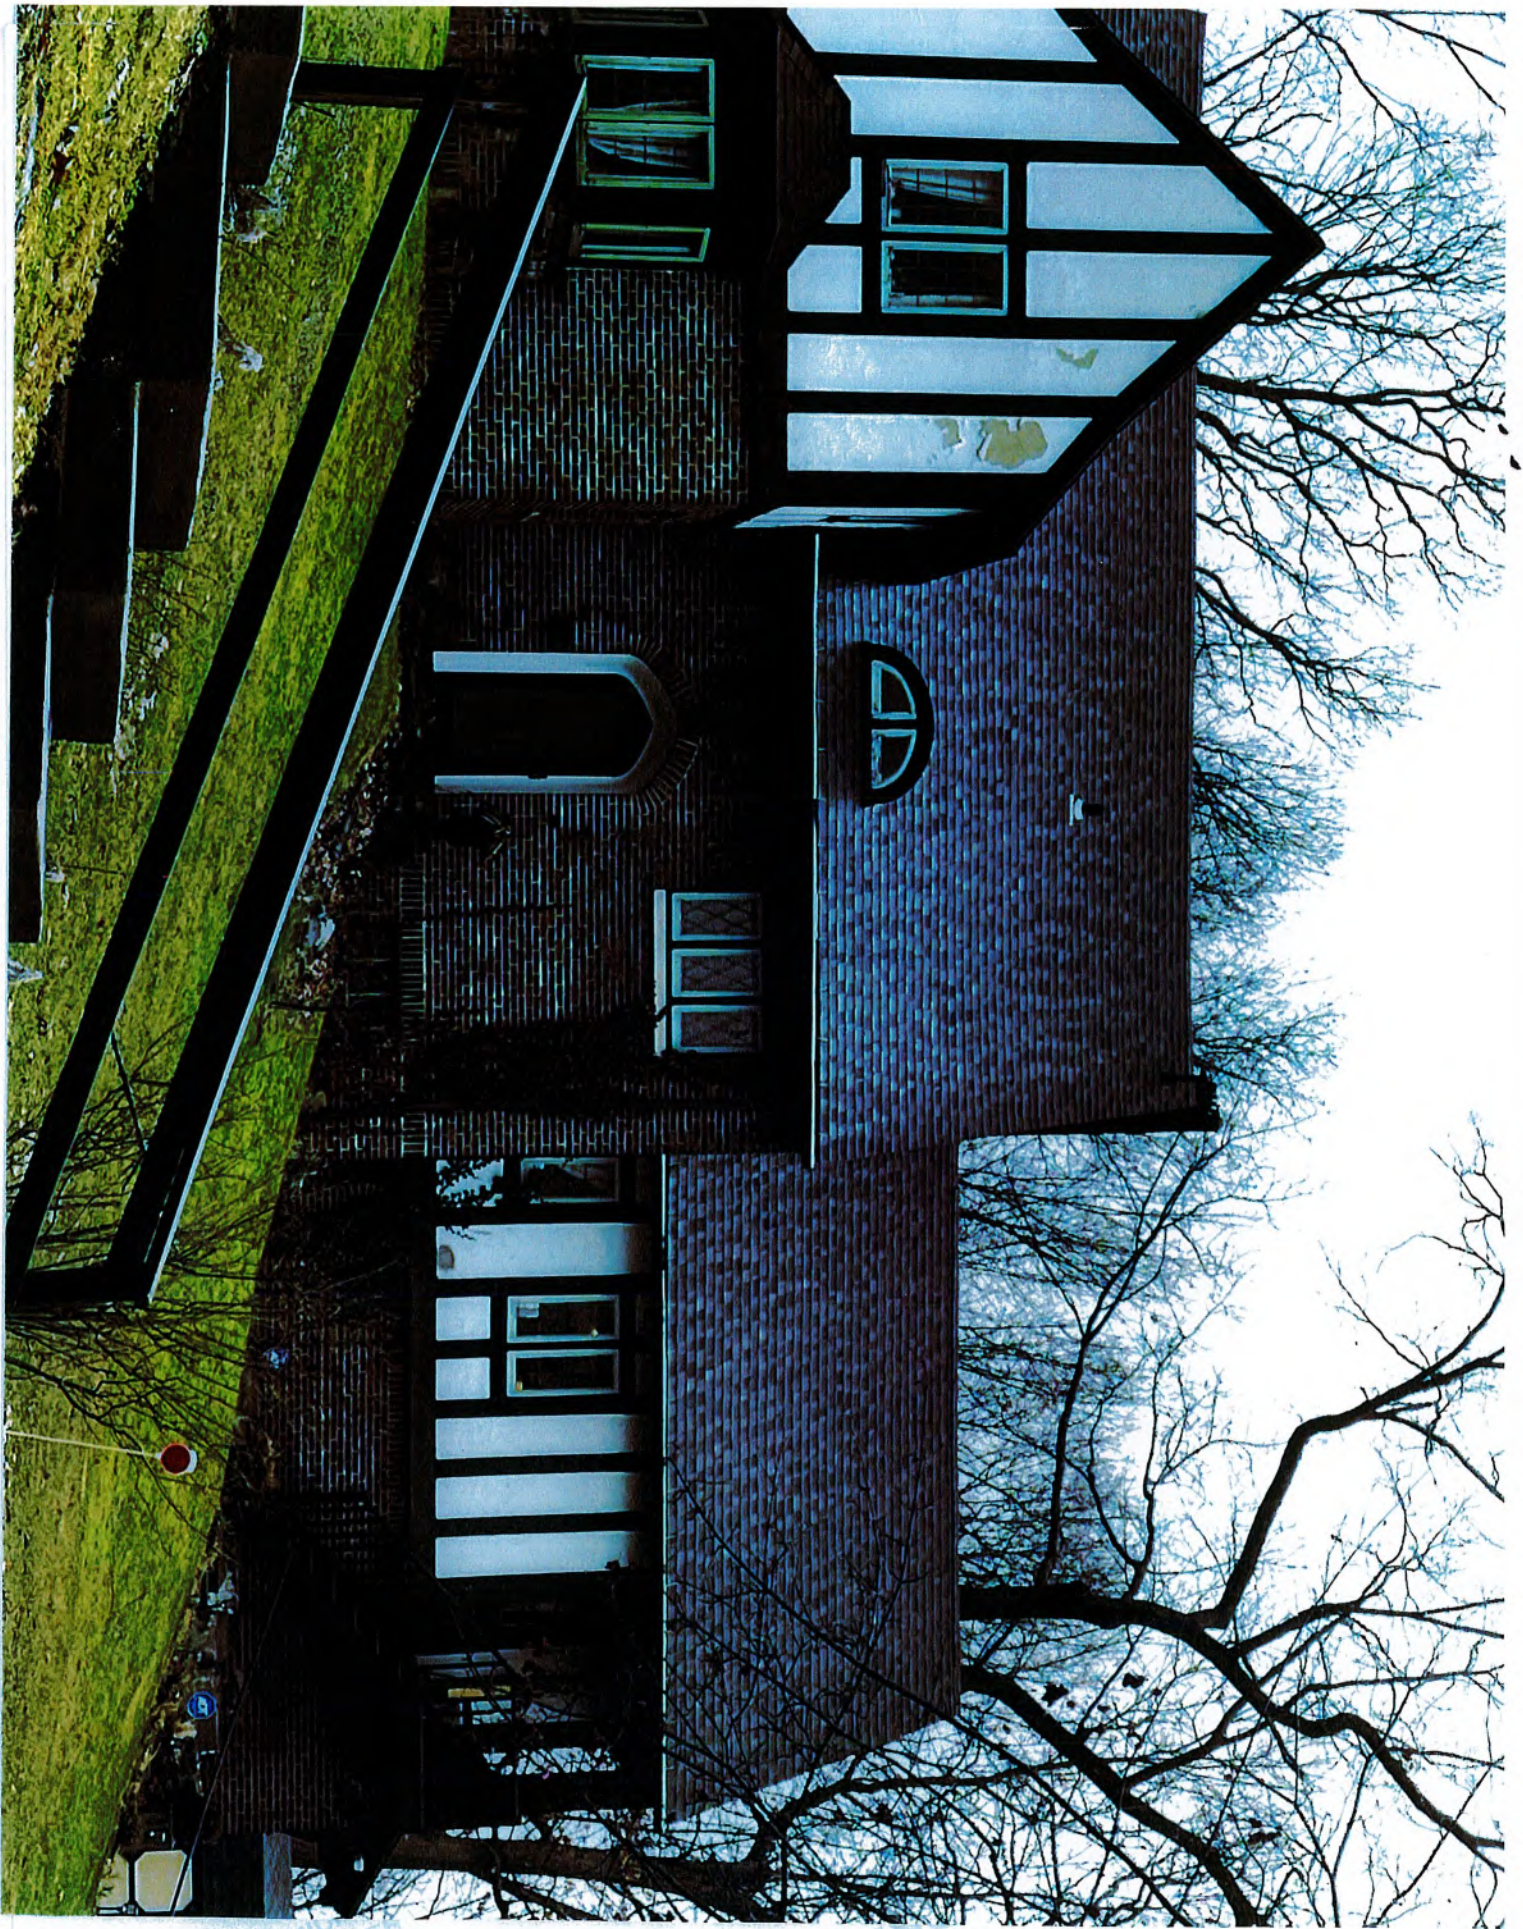
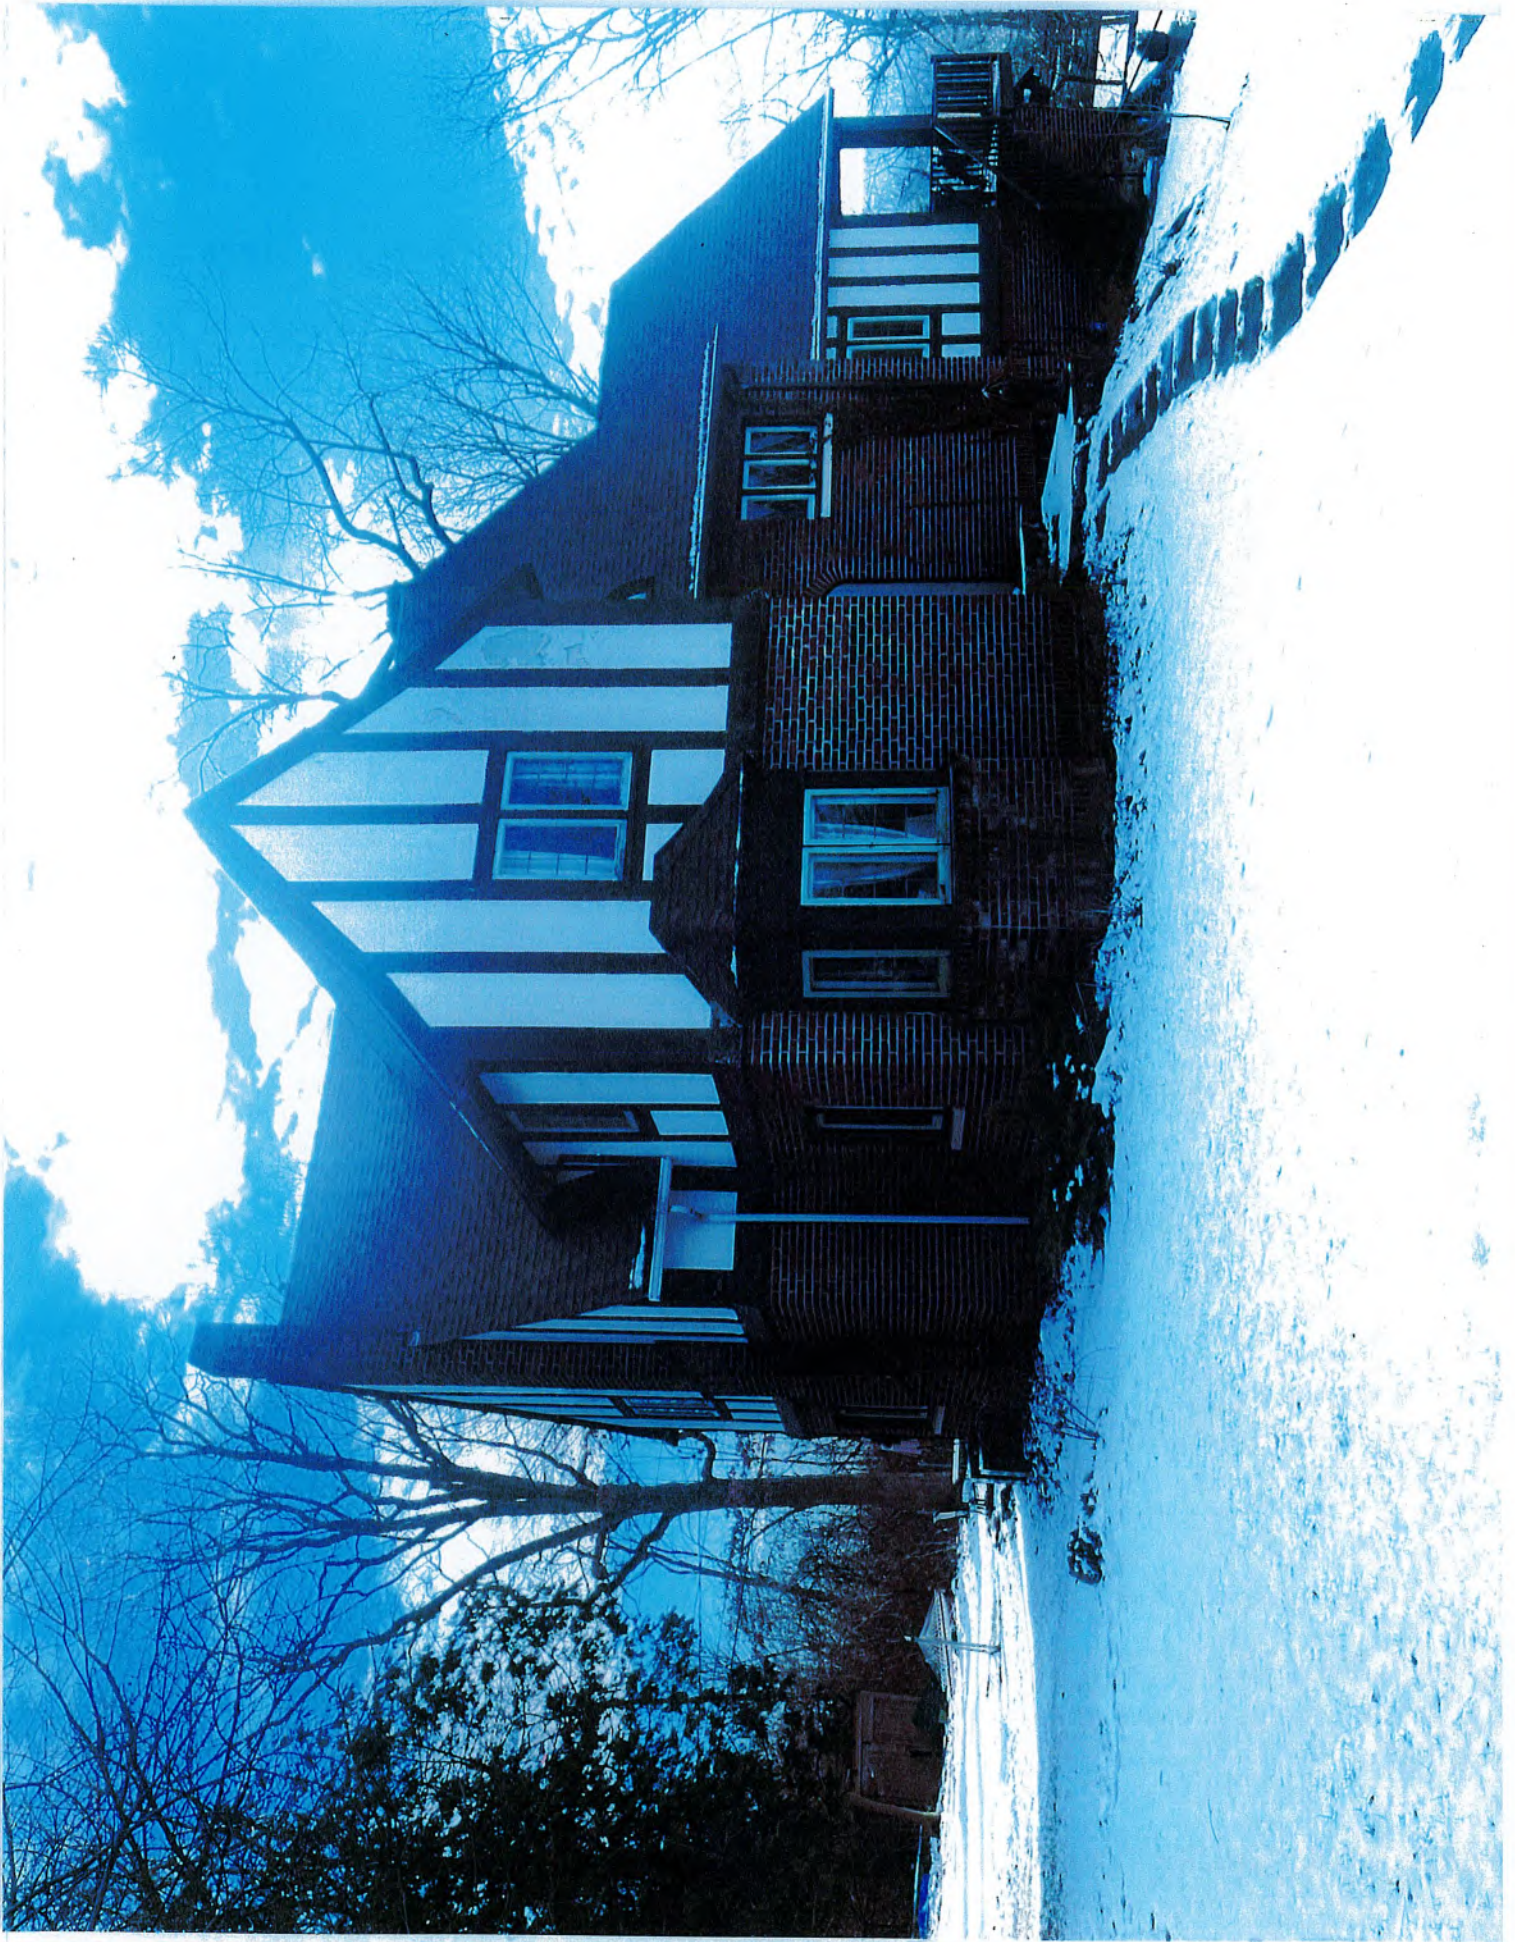
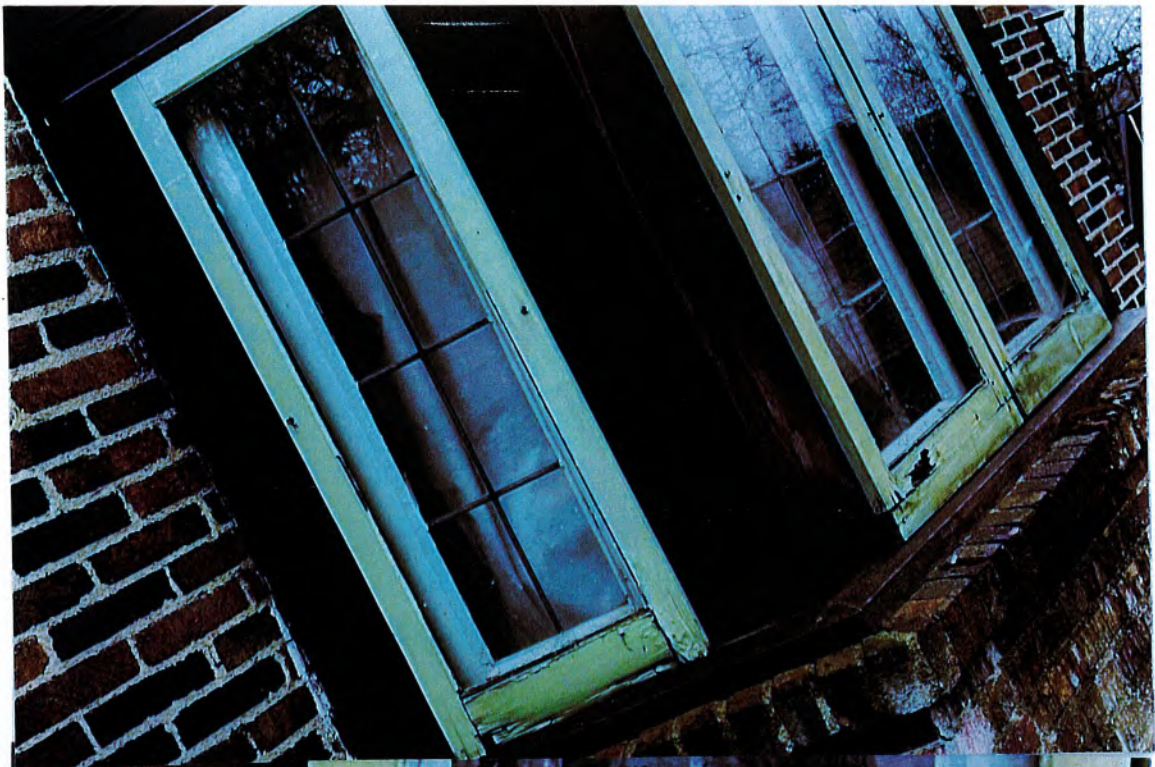
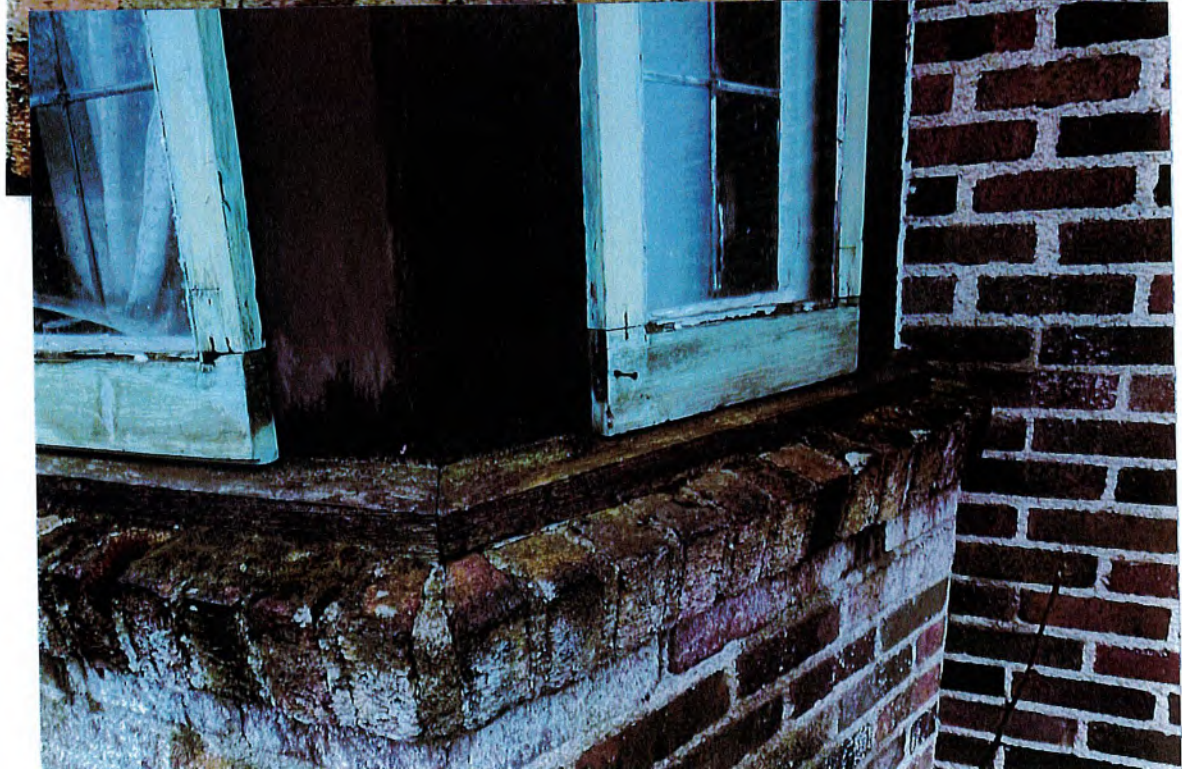
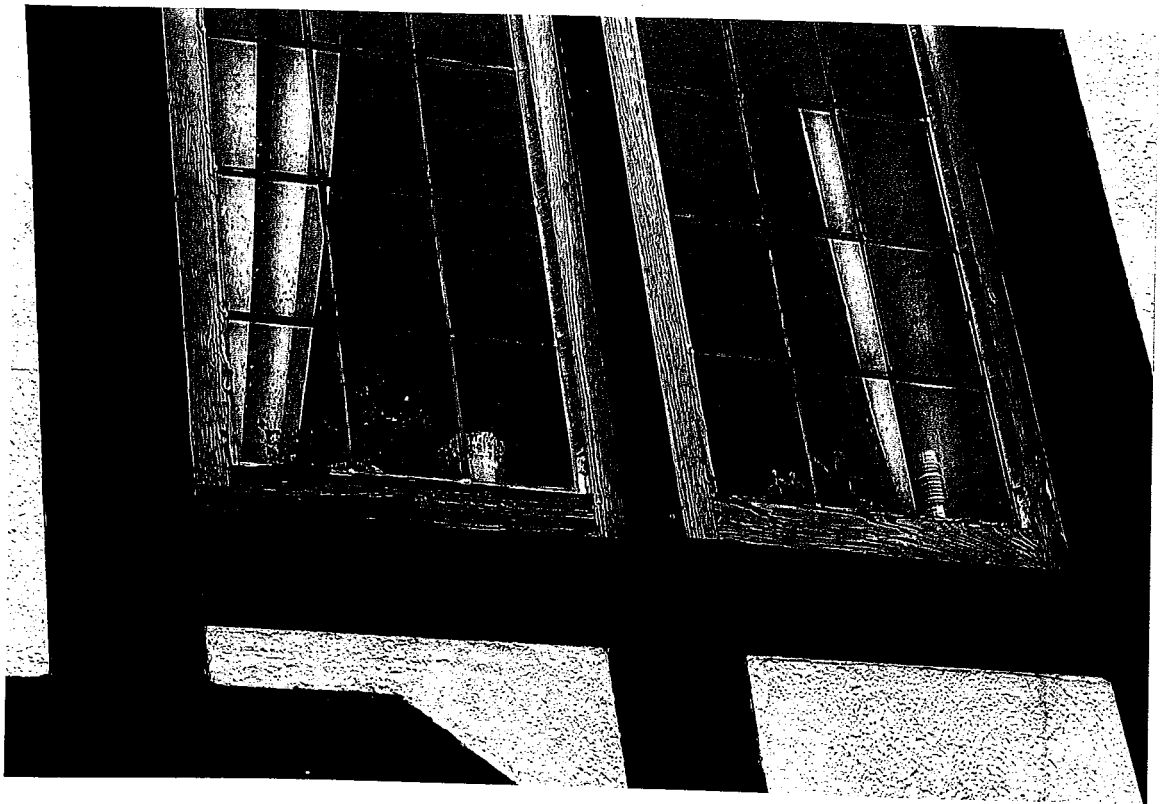
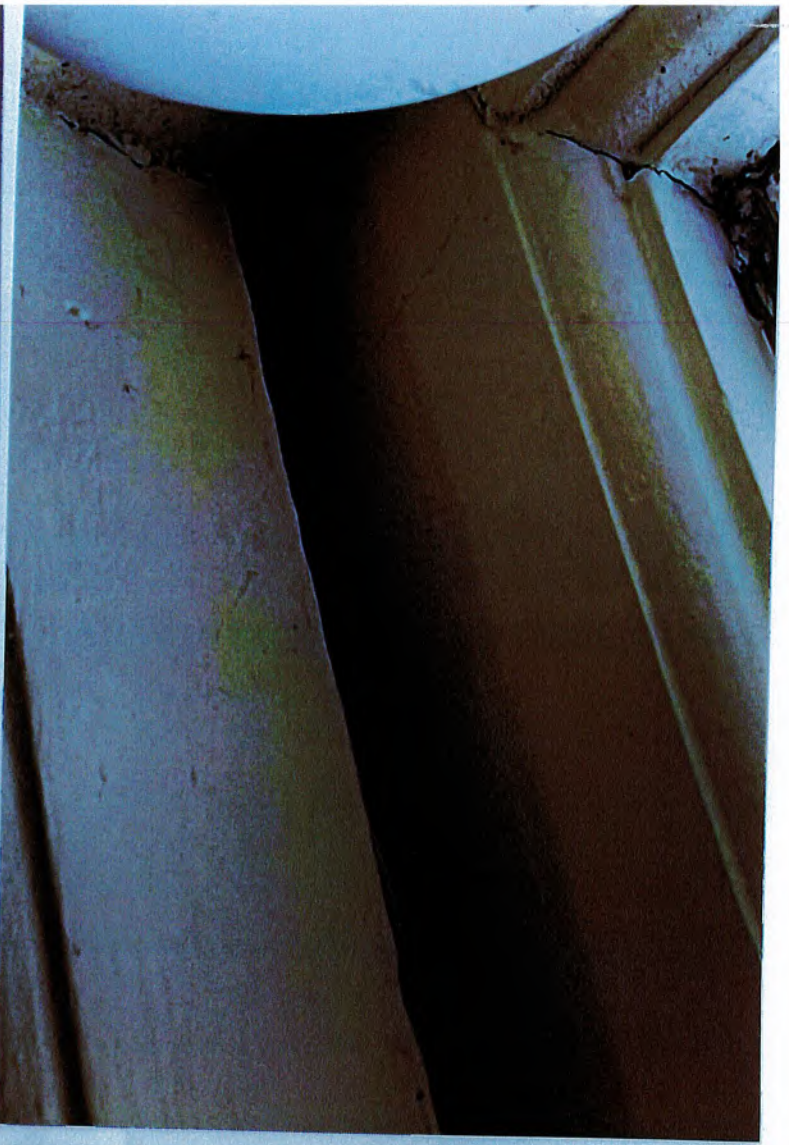
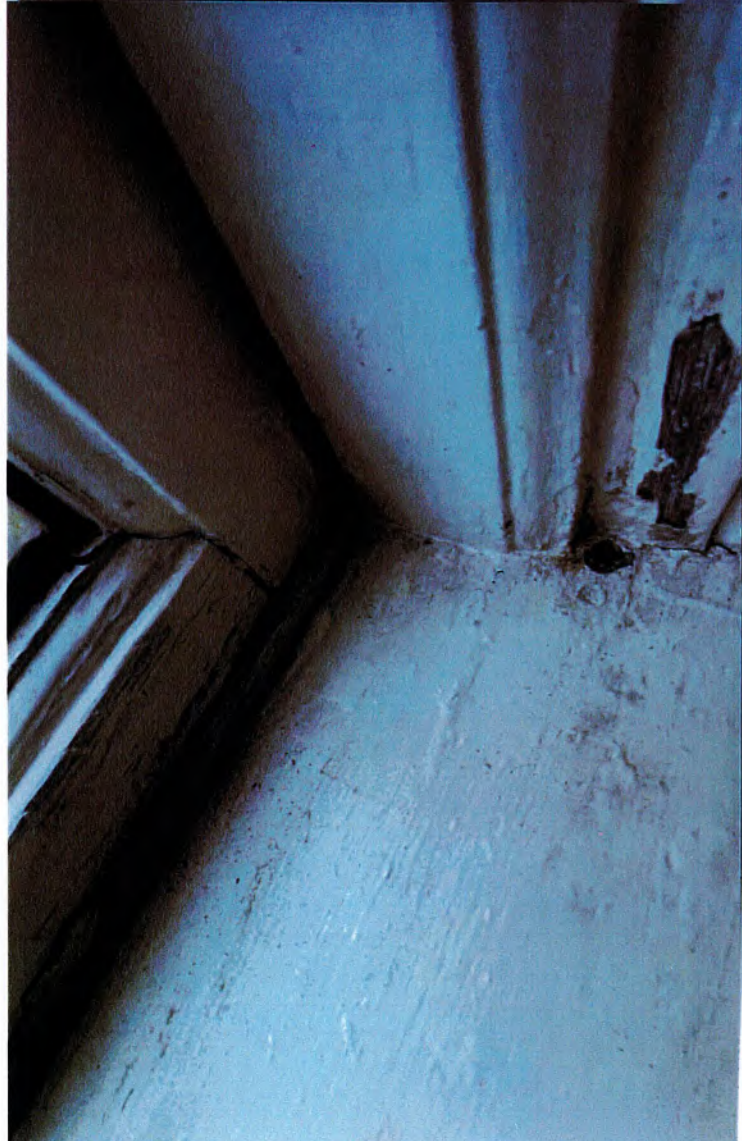
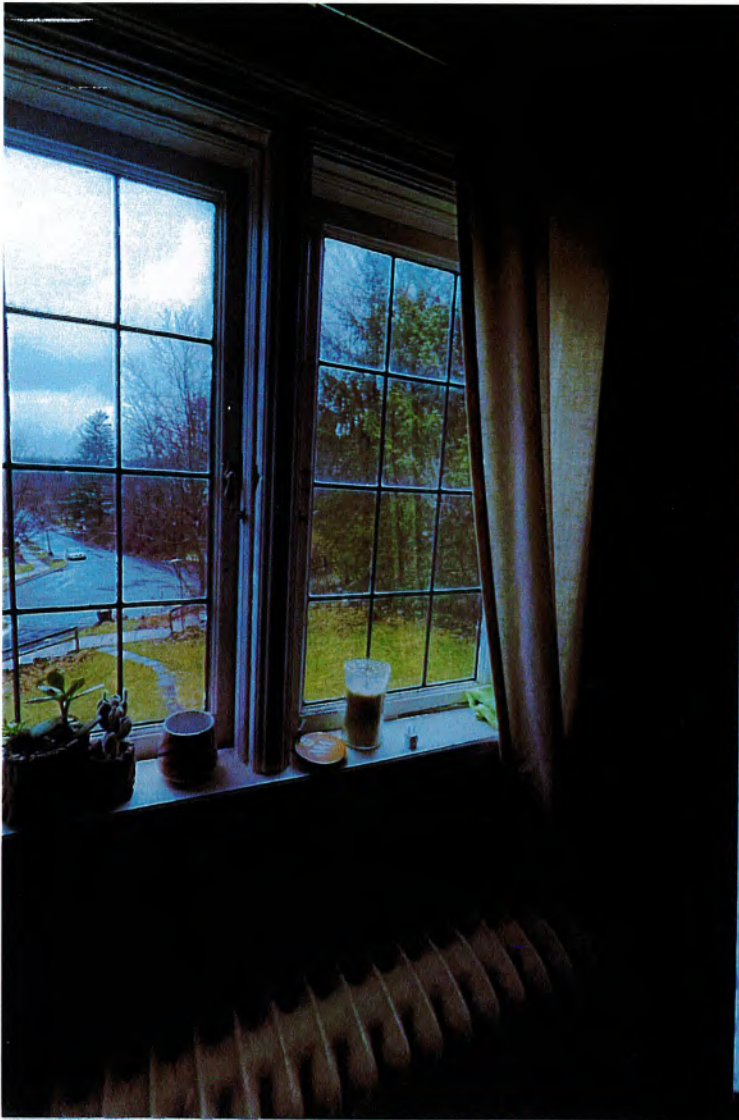
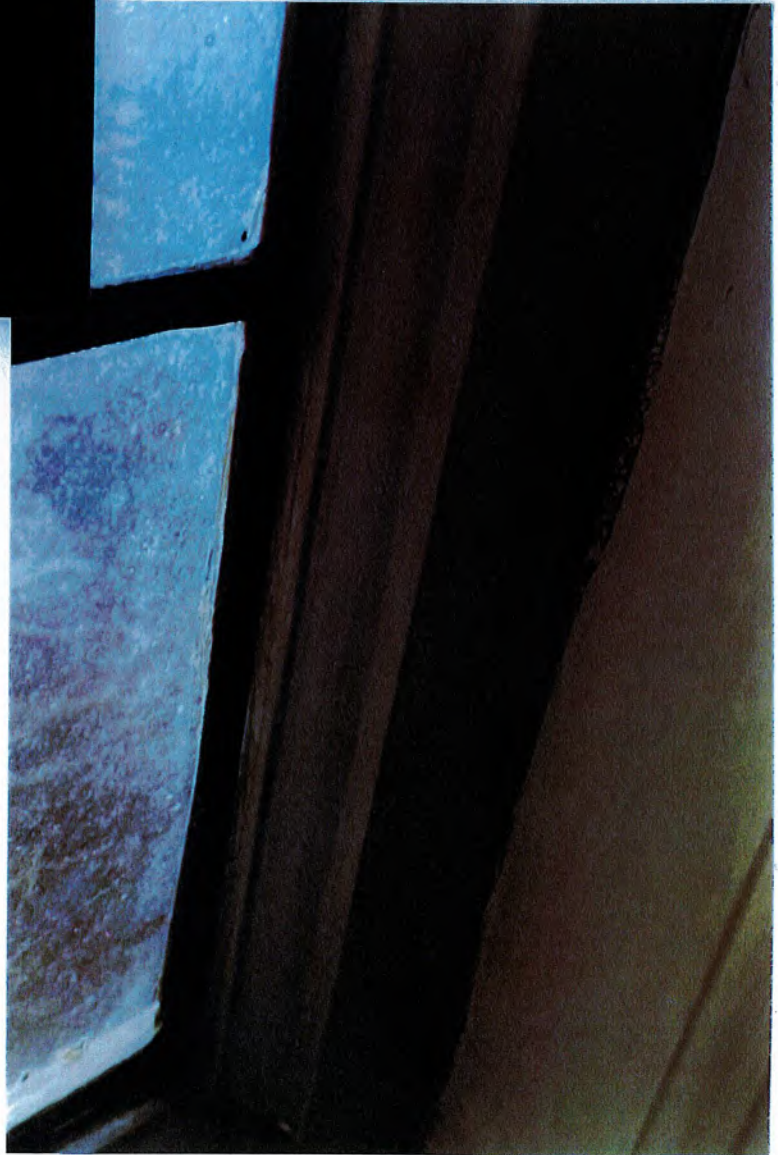
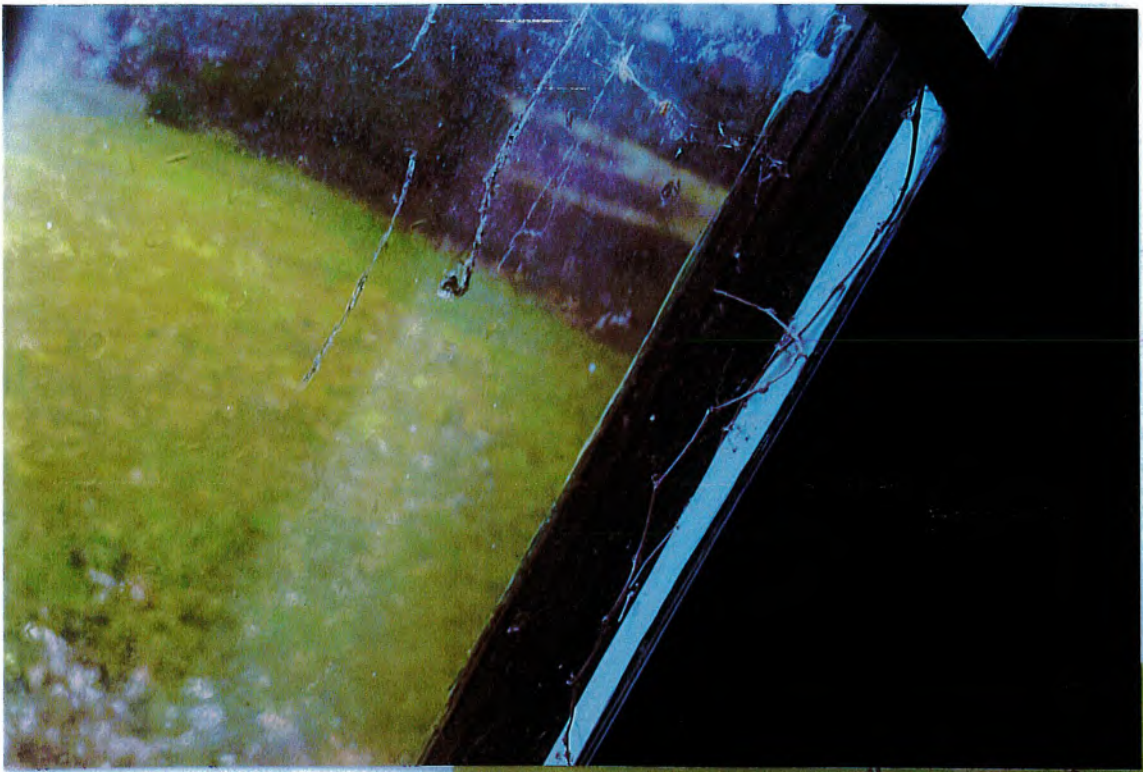
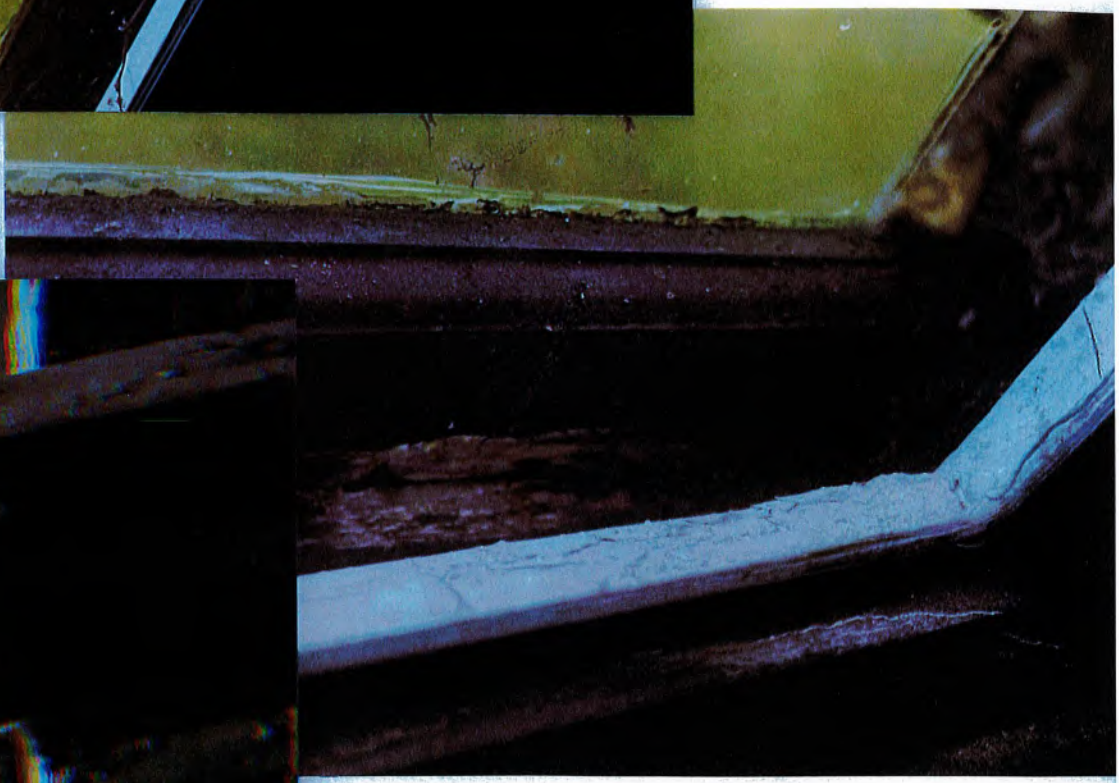
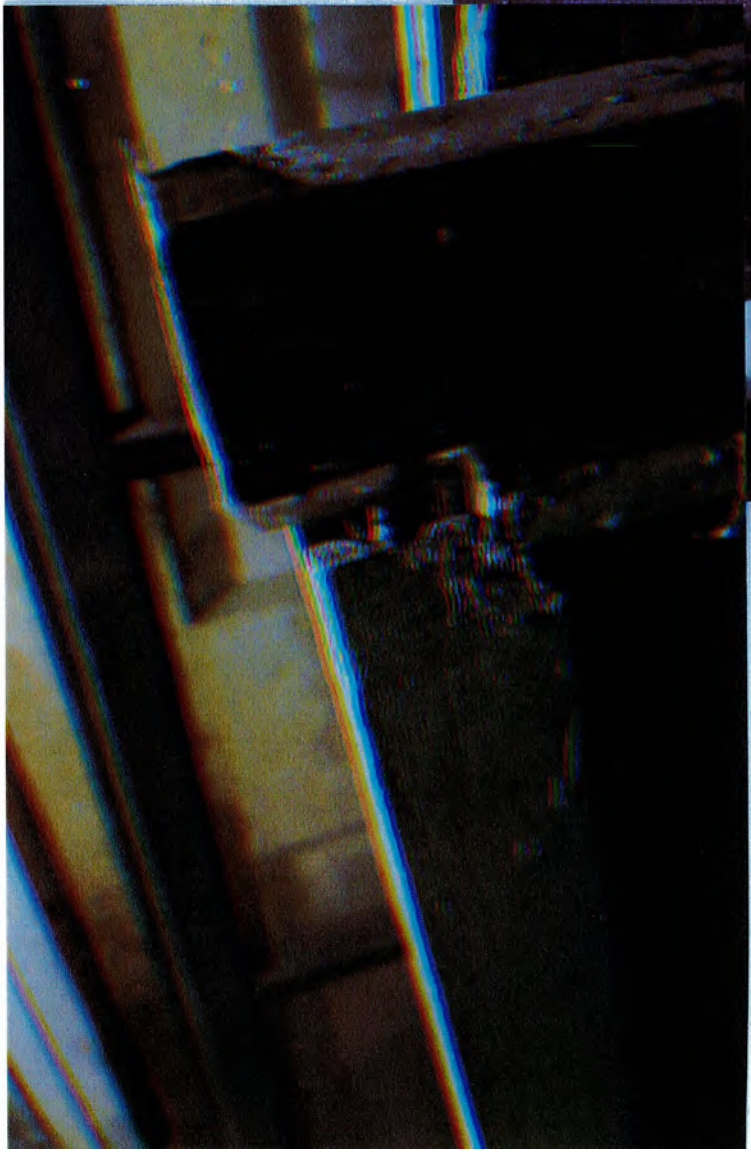
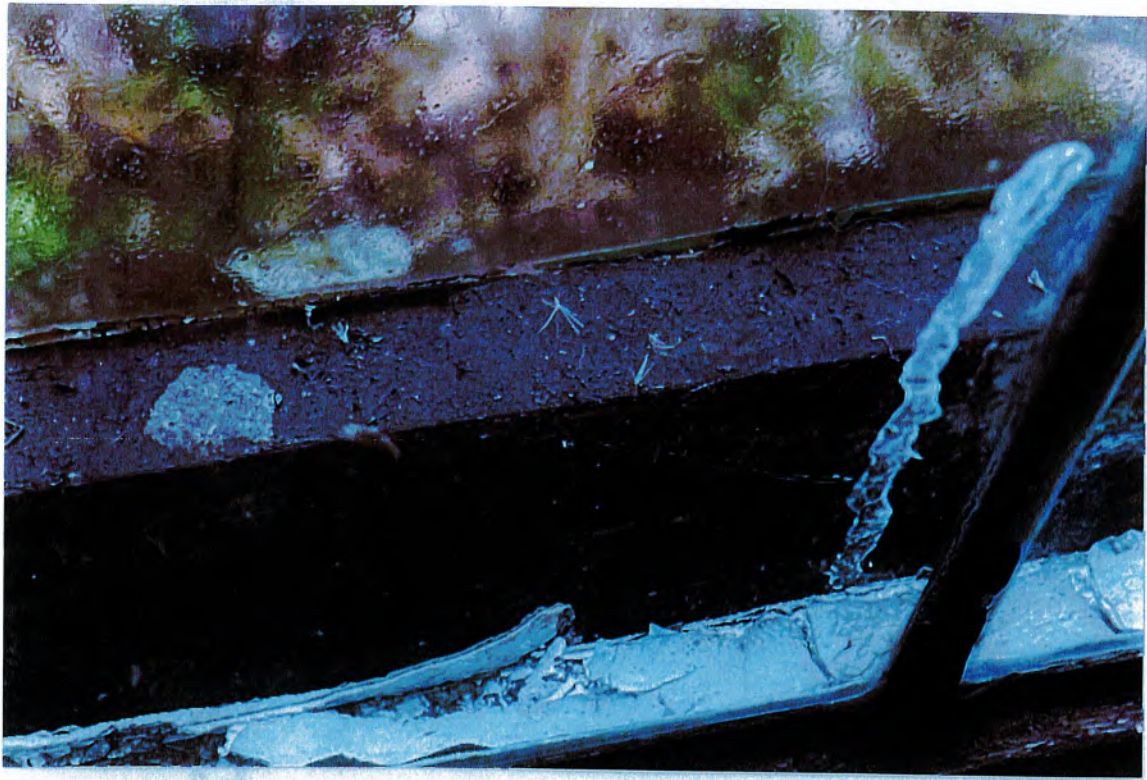
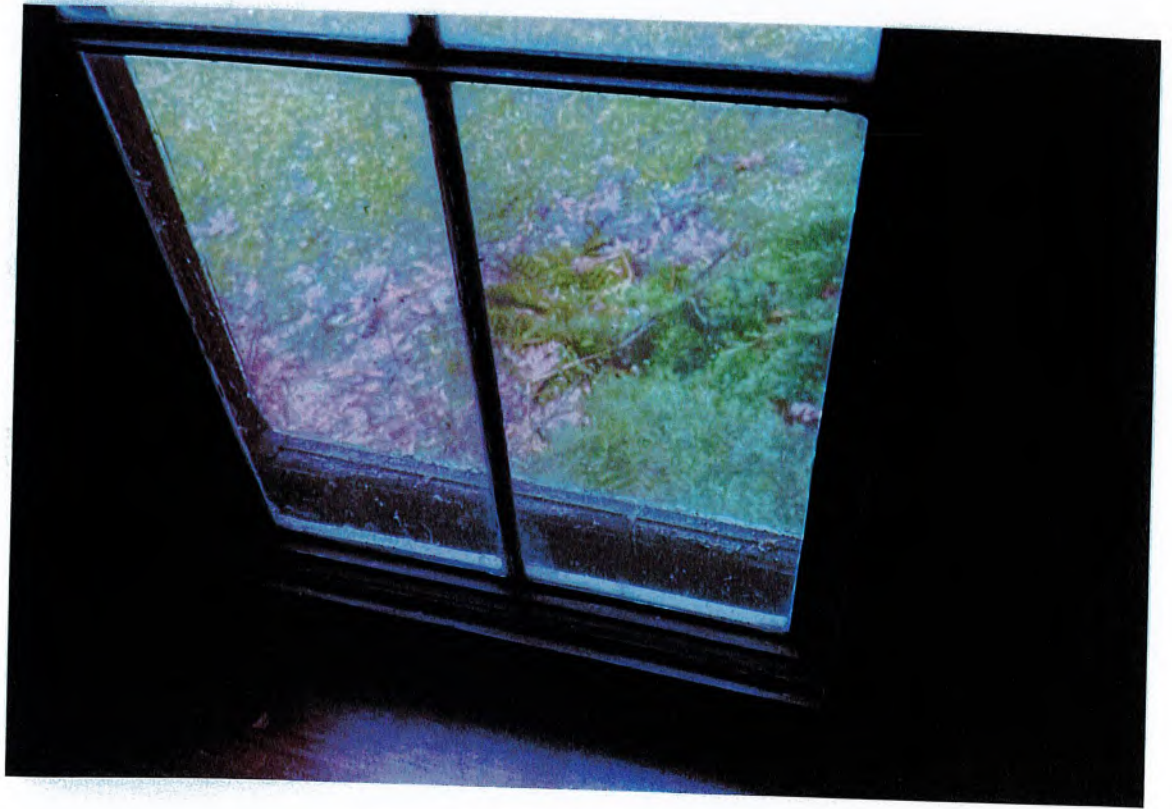
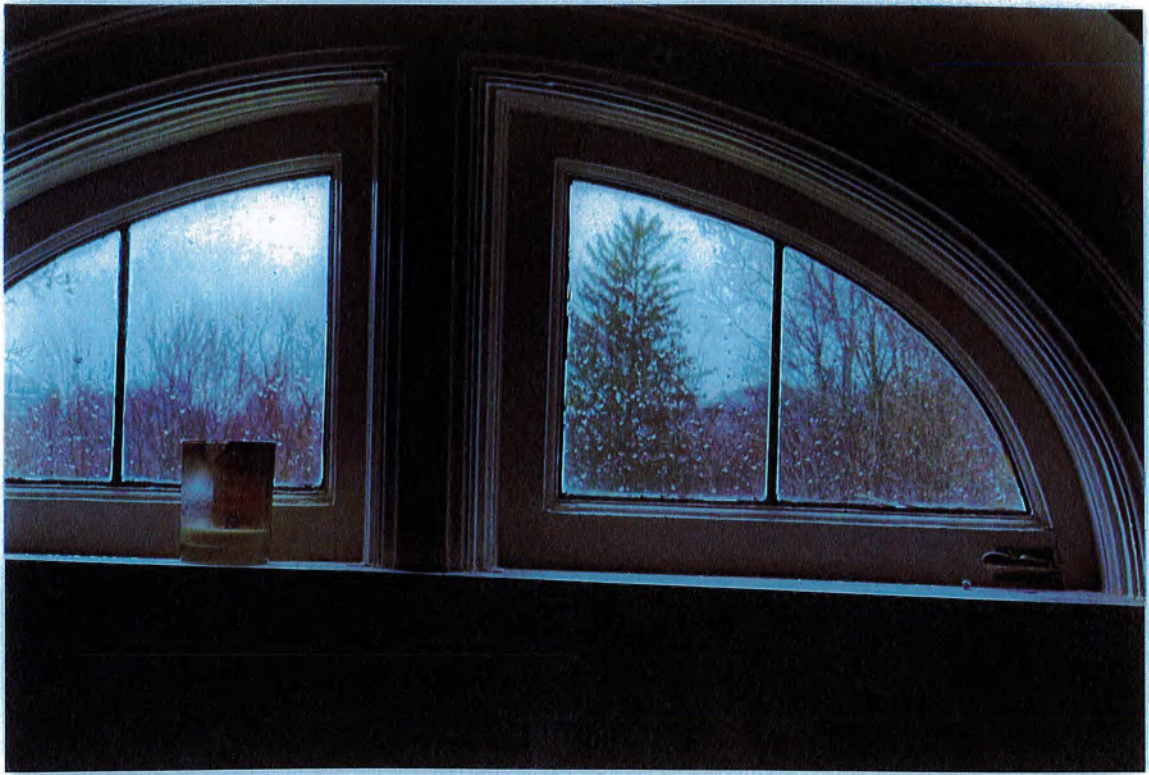
Front of House

At the front of the starting on the top left we have a double casement that is in the Master Bedroom. Inside and outside the unit is rotten. The storms leak at the top, the water used to sit on the sill, not runs into the wall as the sills have failed. When the window comes from the right direction rain comes in the top of the unit and runs down the interior sash. The unit doesn't close completely or correctly leading to large amounts of condensation in the master bedroom. The family is chasing mold and mildew in this room constantly even running a dehumidifier.

The eyebrow window is the character of the home. No supplier currently makes a venting unit like this. We will work to preserve this unit. Luckily out of all the units in the home this is one of the best currently.

The lower walk out bay has failed. The units are sinking into the rotten sills. The sills allow water in behind the brick. The units needed to be repaired and have maintenance done years ago. It hasn't happened. These units are almost unsalvageable. We will recreate the look and feel of this all while making the unit structurally sound again.

The triple unit of diamonds are interesting as they are fixed units and mostly protected. The storms and the sills show soft spots. The plan is to remove the storms, repair the sills and install the new fixed units from the outside. We are going to do all this while attempting to not touch the inner diamond sashes. This will help the house keep its character and elegance. IF the diamonds have to be removed to repair we have another plan to keep them intact and put them back in their rightful spot.

Lastly the three casements in the stucco by the porch. All three of these units are not closing due to water damaged sills. The leaks do not currently appear to be allowing water behind the stucco, but it is causing swelling of the sills and the sashes. The sashes are warping from not closing properly and are creating large drafts in addition to condensation concerns.

The plan that we have is the same for all the windows. We are going to remove the storms that remain. We will then remove the sashes of the old windows. The frames will be repaired and straightened. We will remove and replace any rotten or missing wood. We will moisture protect the entire opening. We will then be sliding new Pella Impervia windows back into the existing trim. The advantage for the Stazzone-McGee's with Impervia is it is a complete fiberglass unit. This is going to make it extremely strong to help hold the openings true and square going forward. The other advantages are that it can deal with the high moisture content that they have been experiencing since day. It is also designed to look like painted wood from the exterior, giving it more of that historic feel. For the neighborhood the advantages of Impervia are not only that textured painted look. The visible glass on the units will be on average ¼" narrower in width than the existing, but 3/8" taller visible glass on height, allowing the perspective to stay the same. Also the units are very slim which allows them to be installed in the place of the current sashes and not protrude further out of the house than the previous storm windows did. This is the closest match for historic applications as they could find after meeting with many different suppliers. All of this will be done with minimal disruption to the exterior of the home and also in a manner consistent with the EPA's lead safe practices to keep the family and the community safe.
