**SYRACUSE
LANDMARK
PRESERVATION
BOARD**

Certificate of Appropriateness Application

Case Number: CA-23-06

WINDOW SURVEY FORM

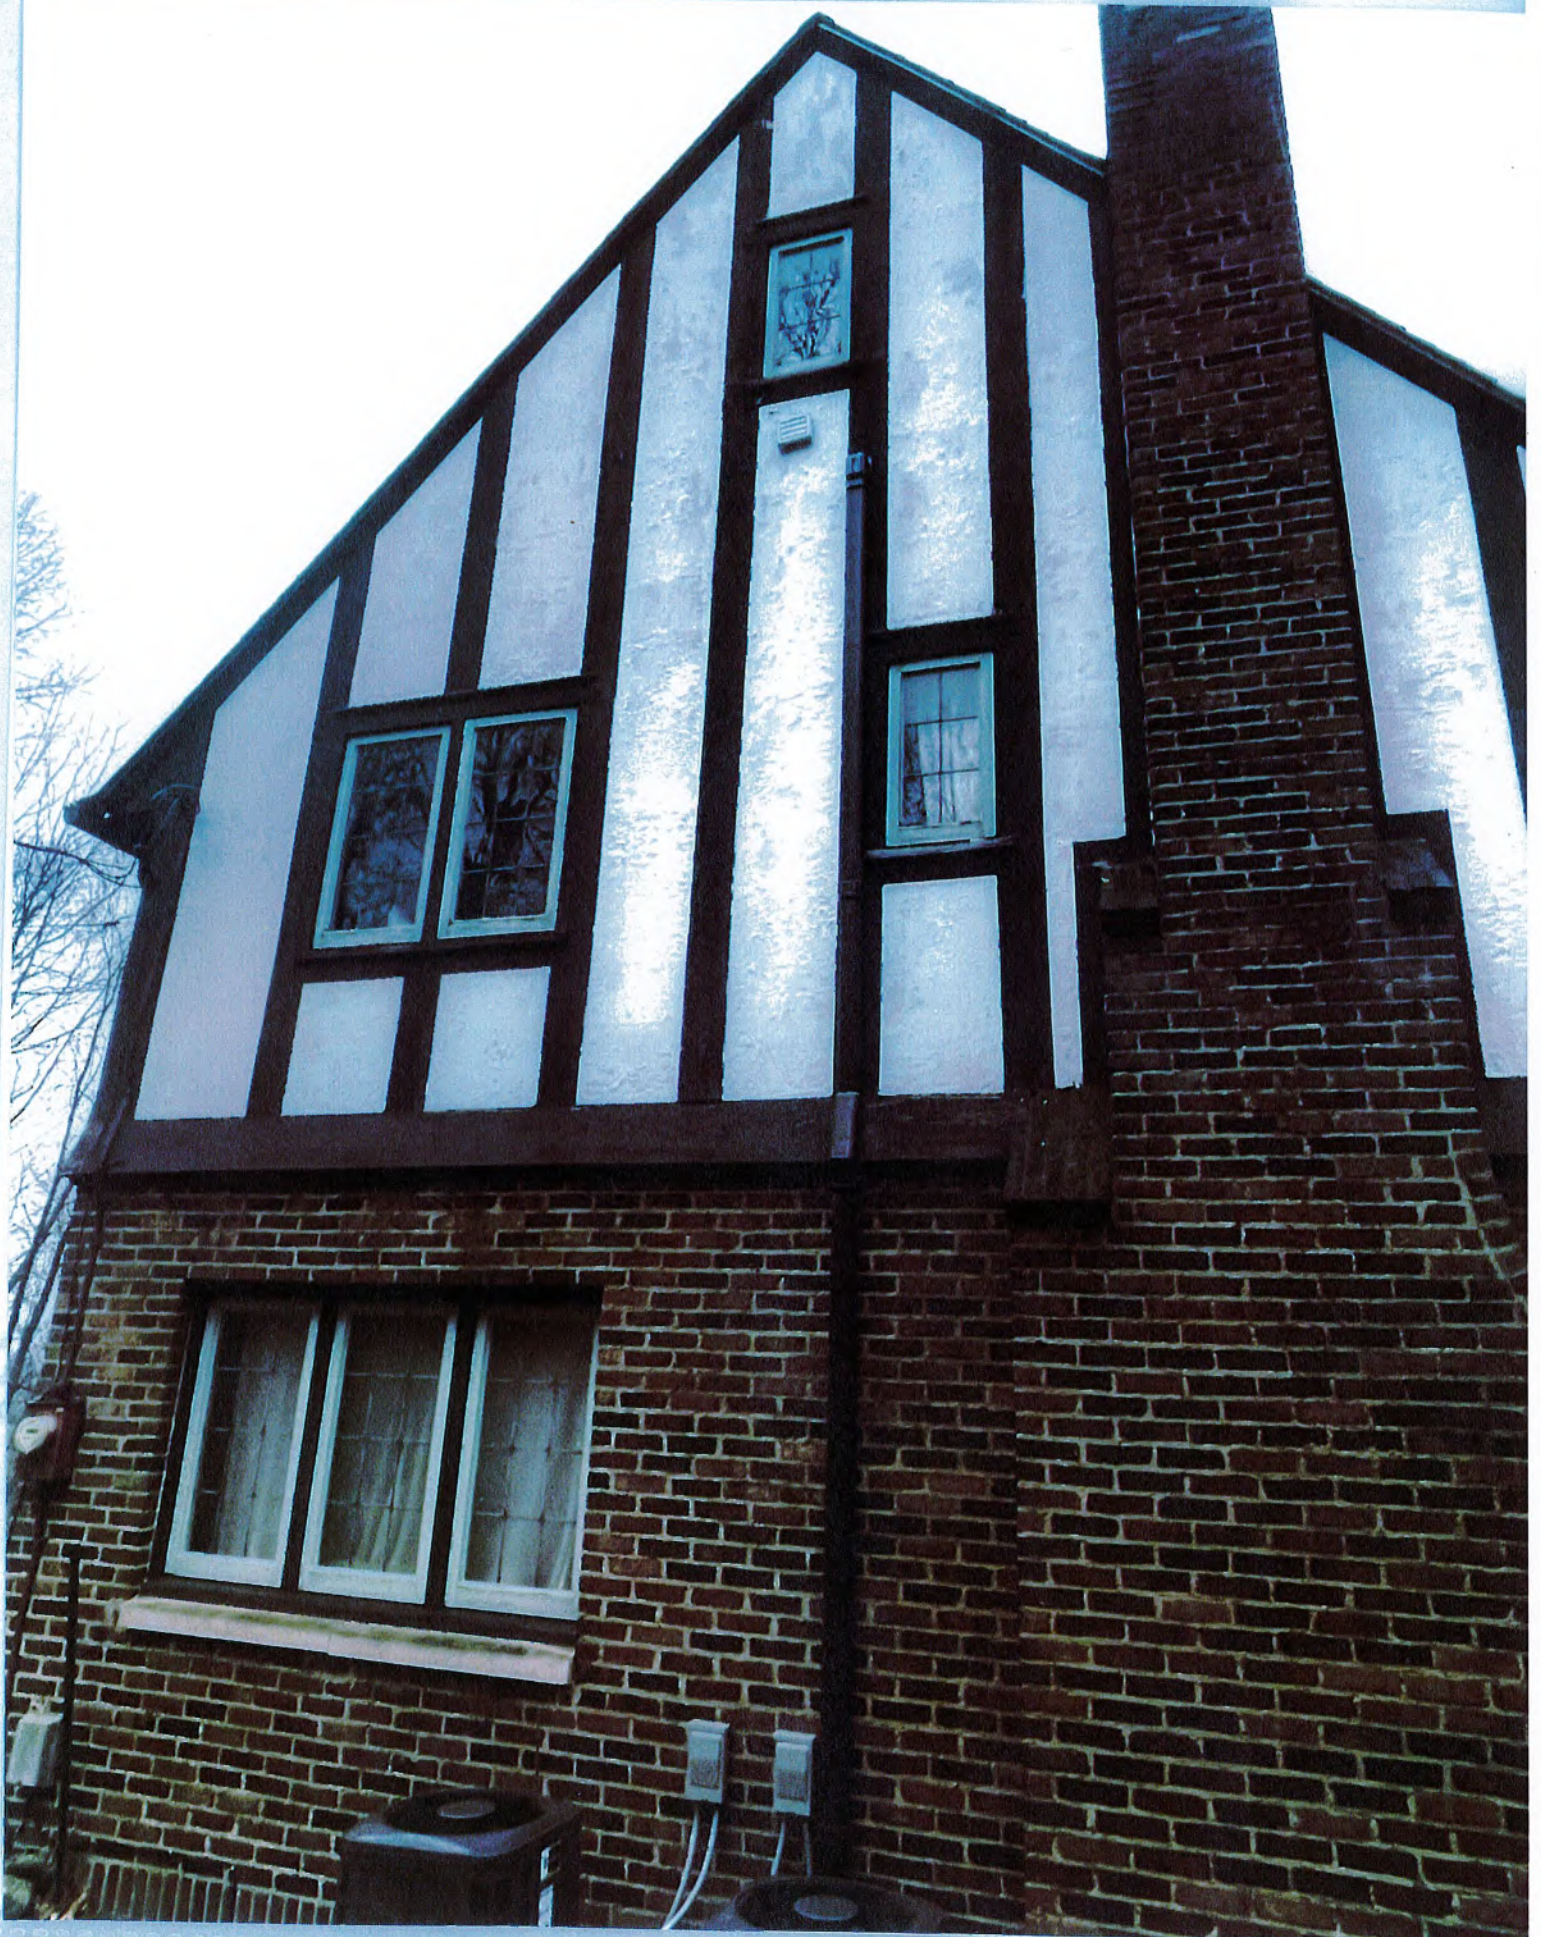
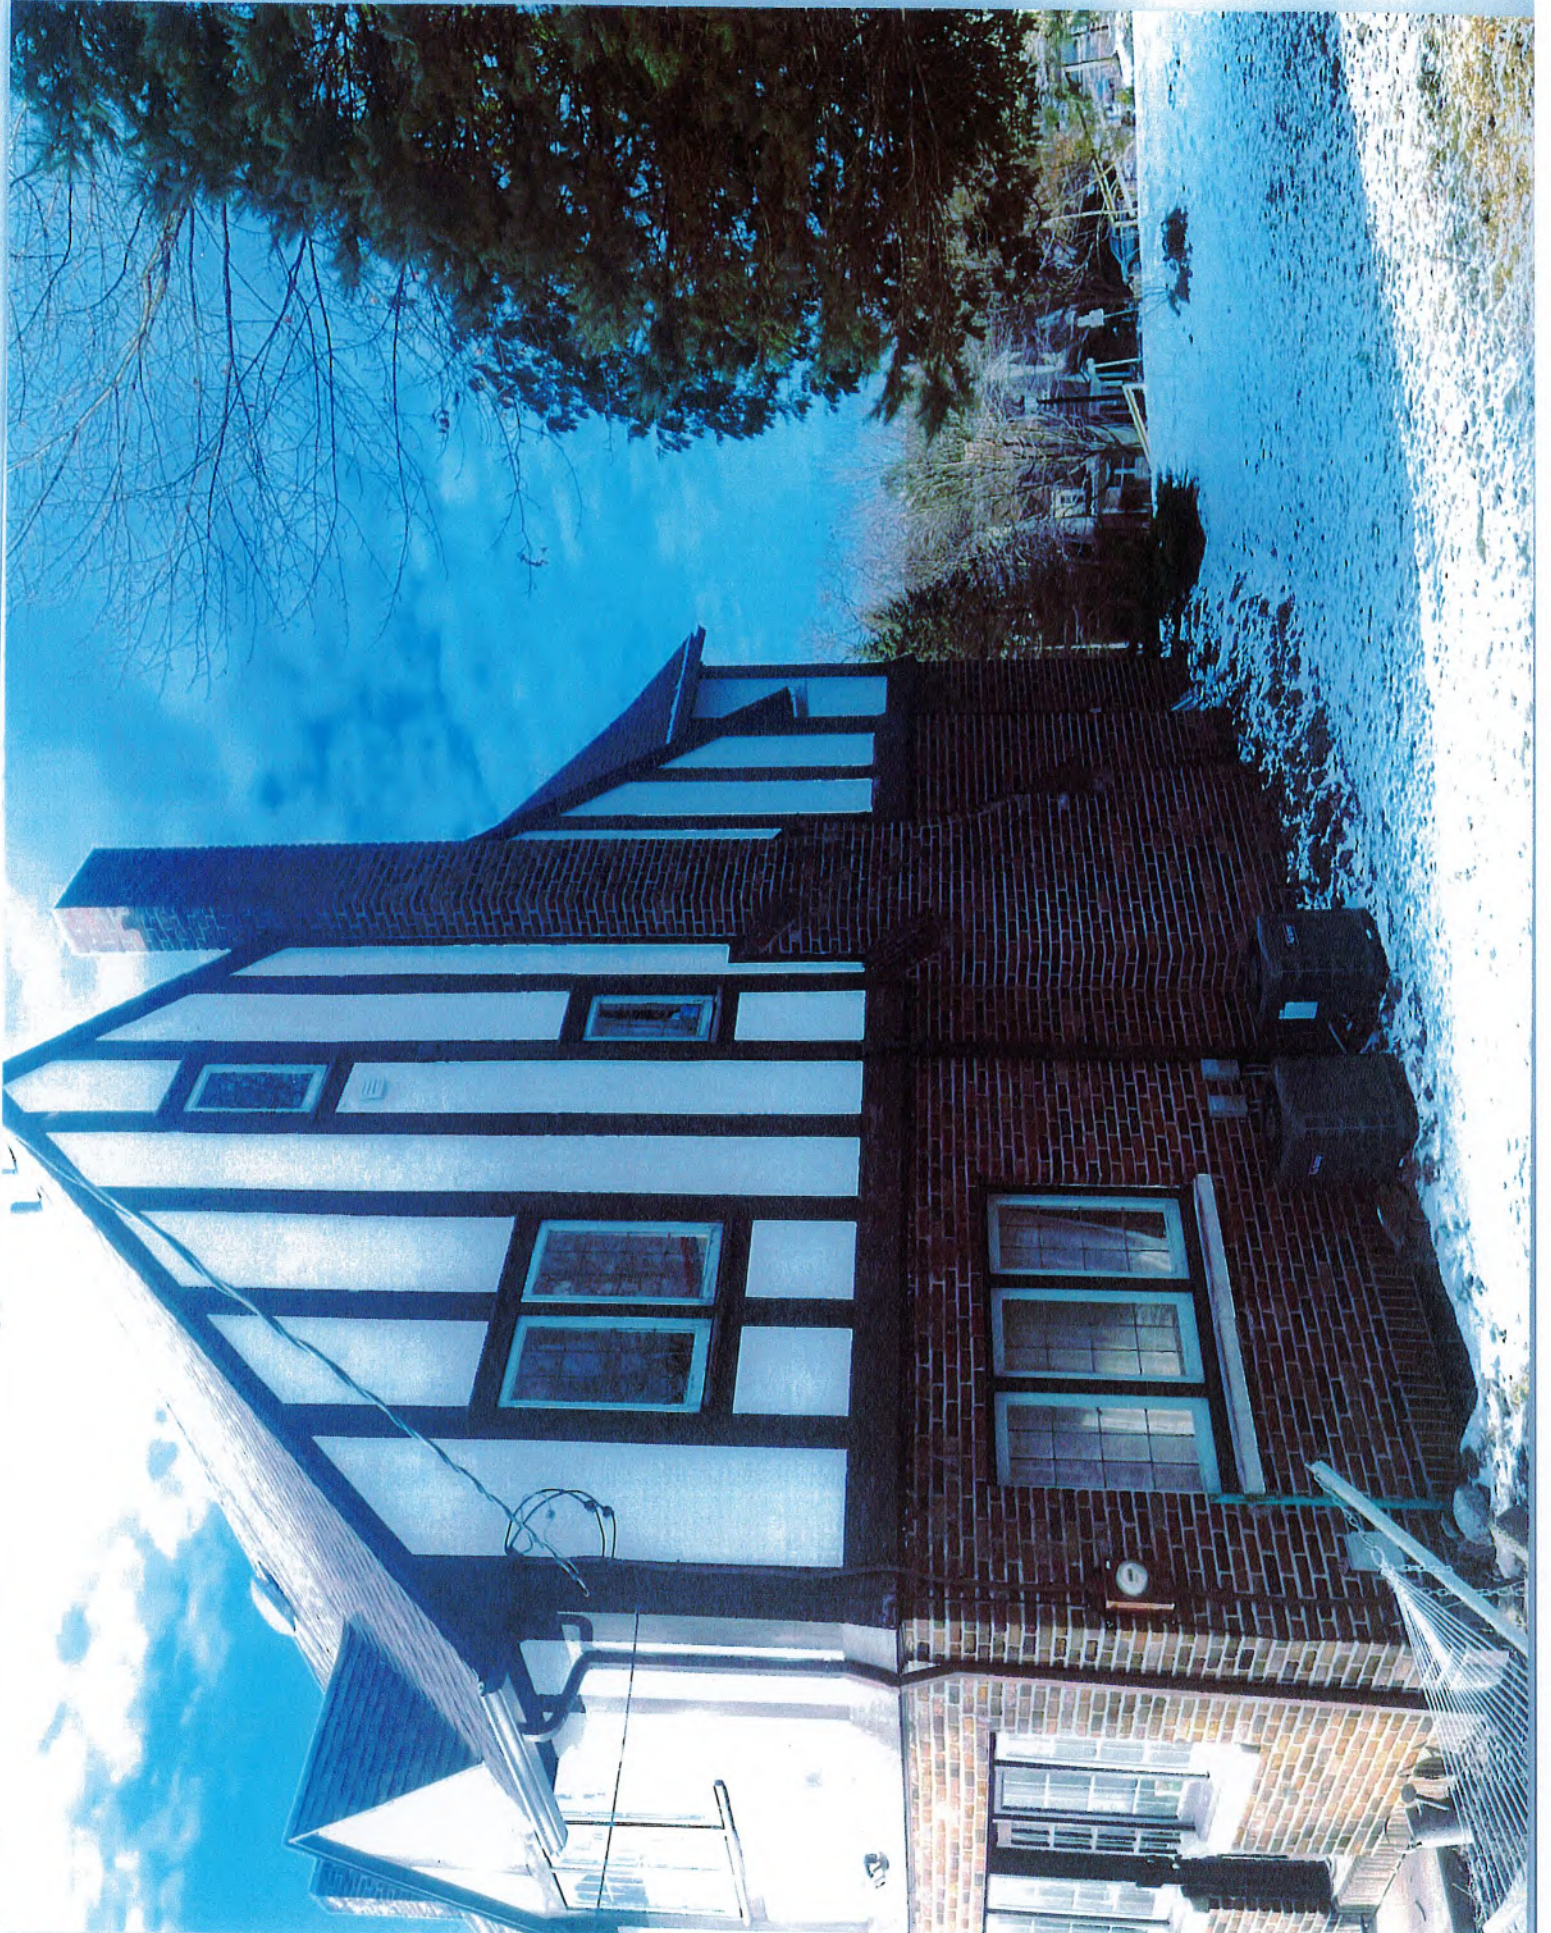
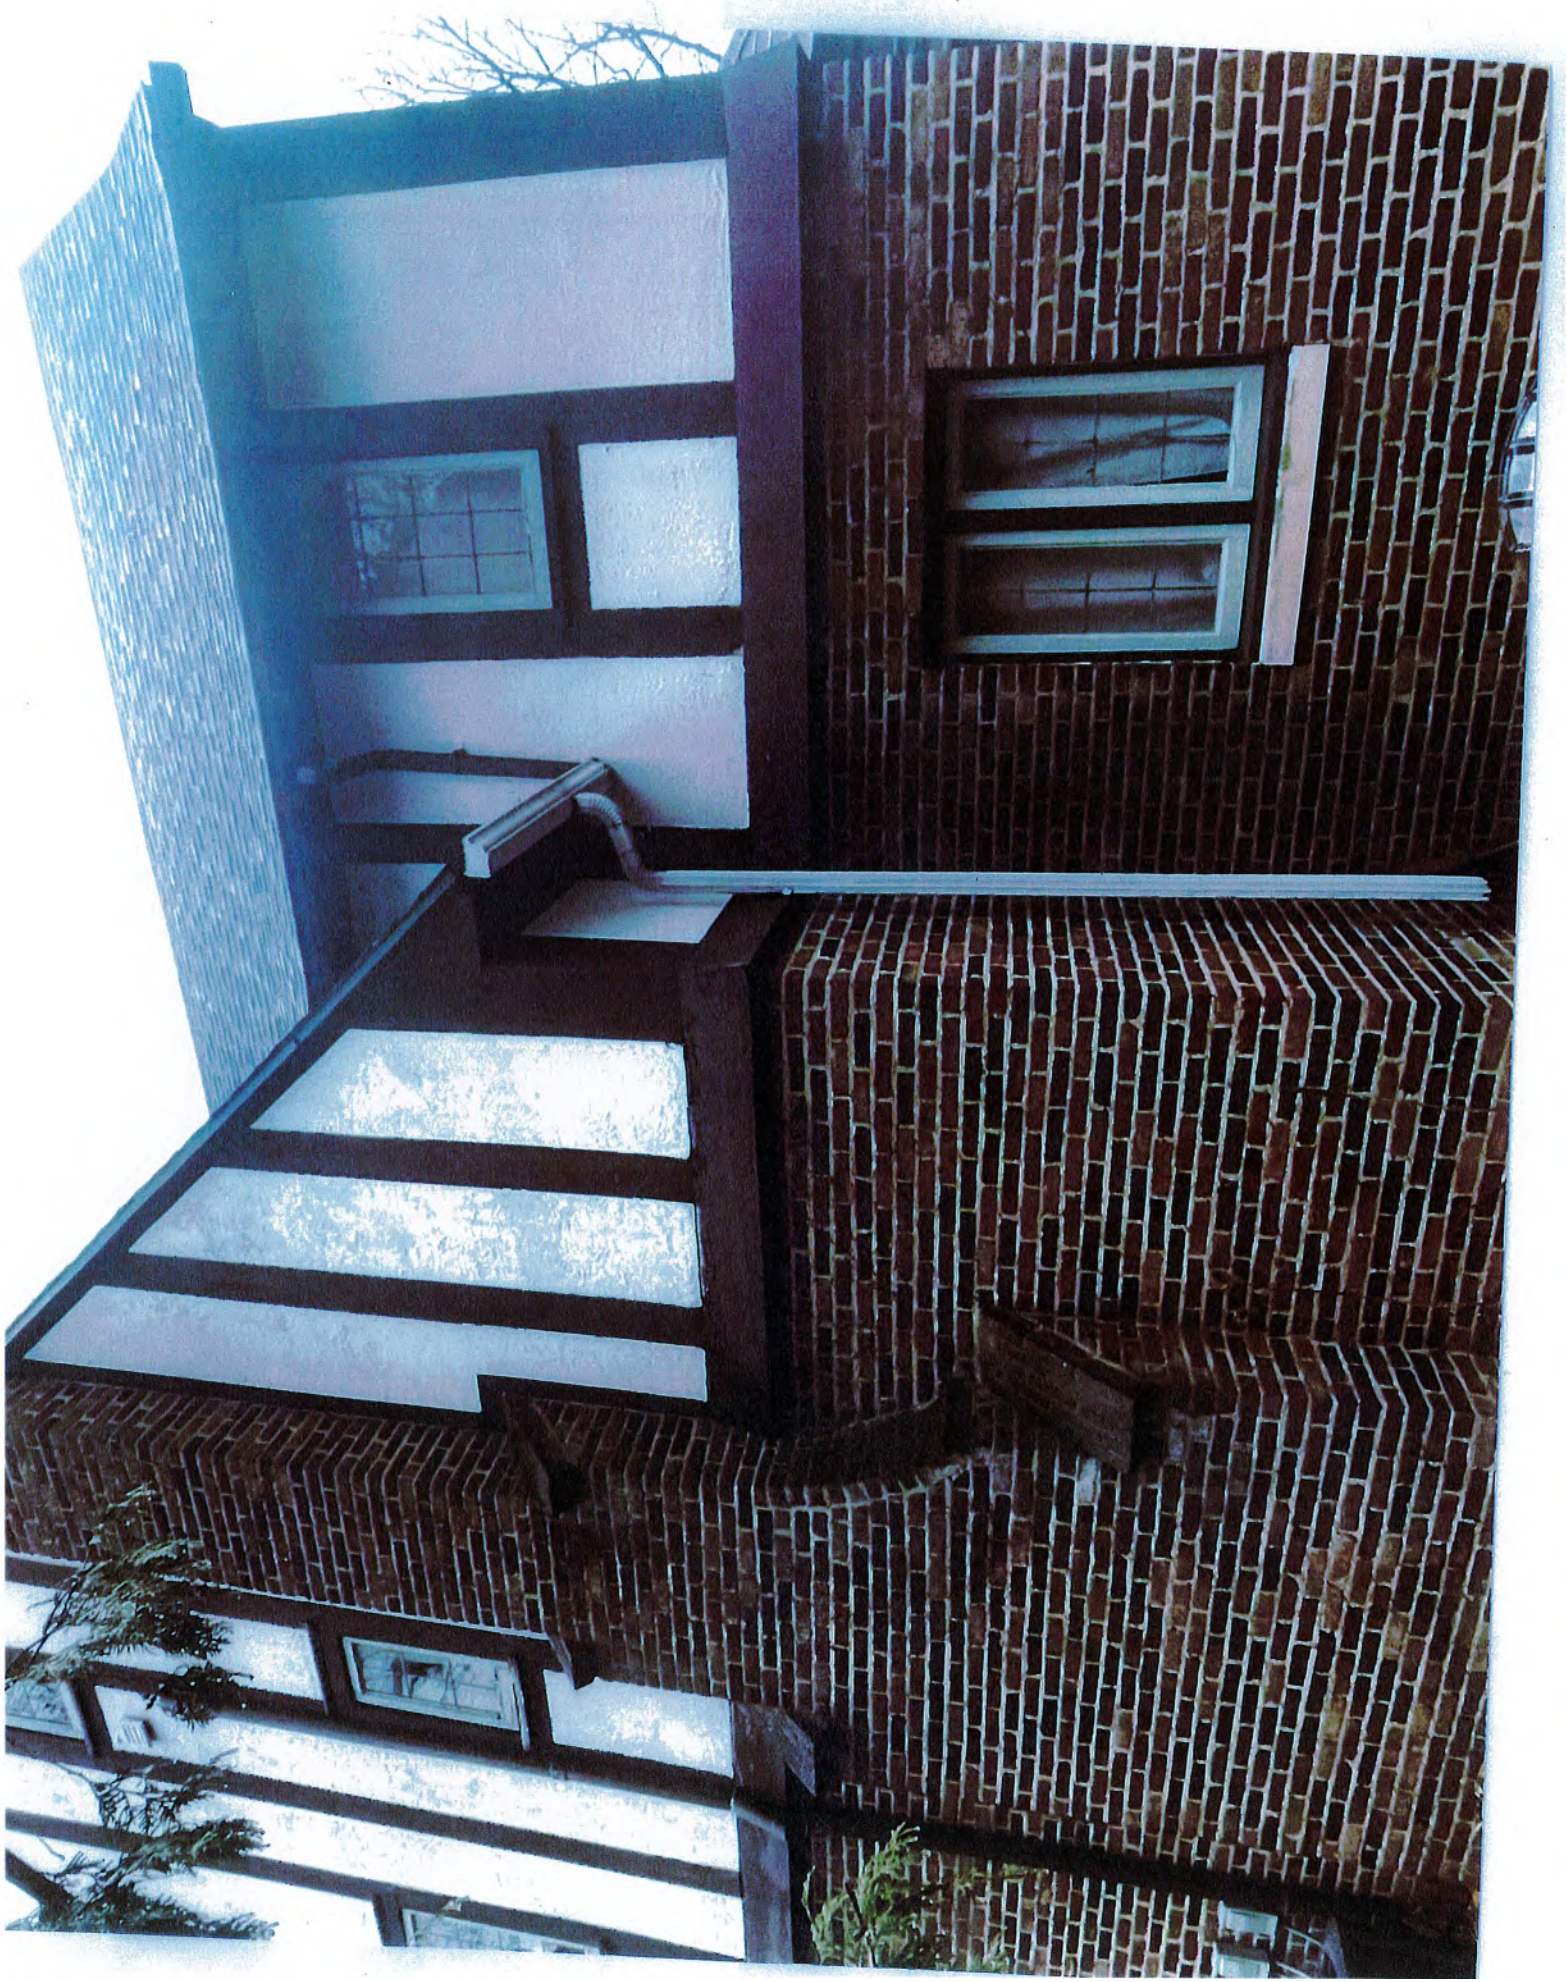
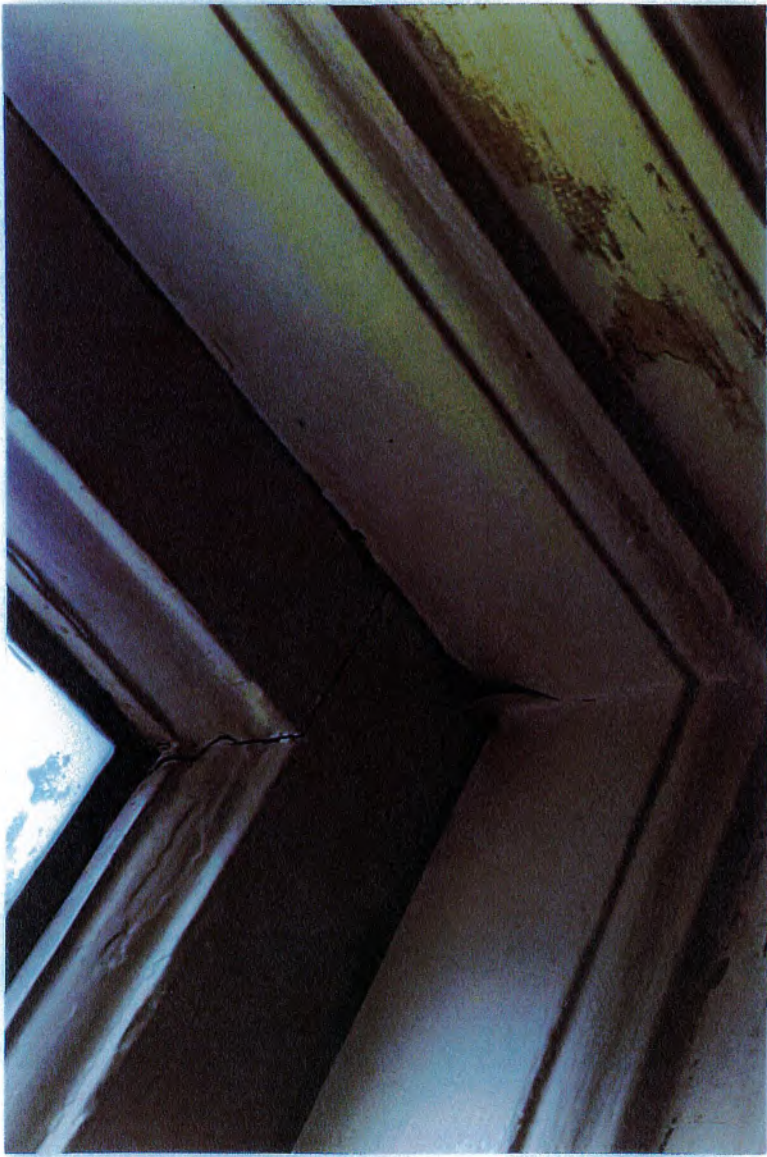
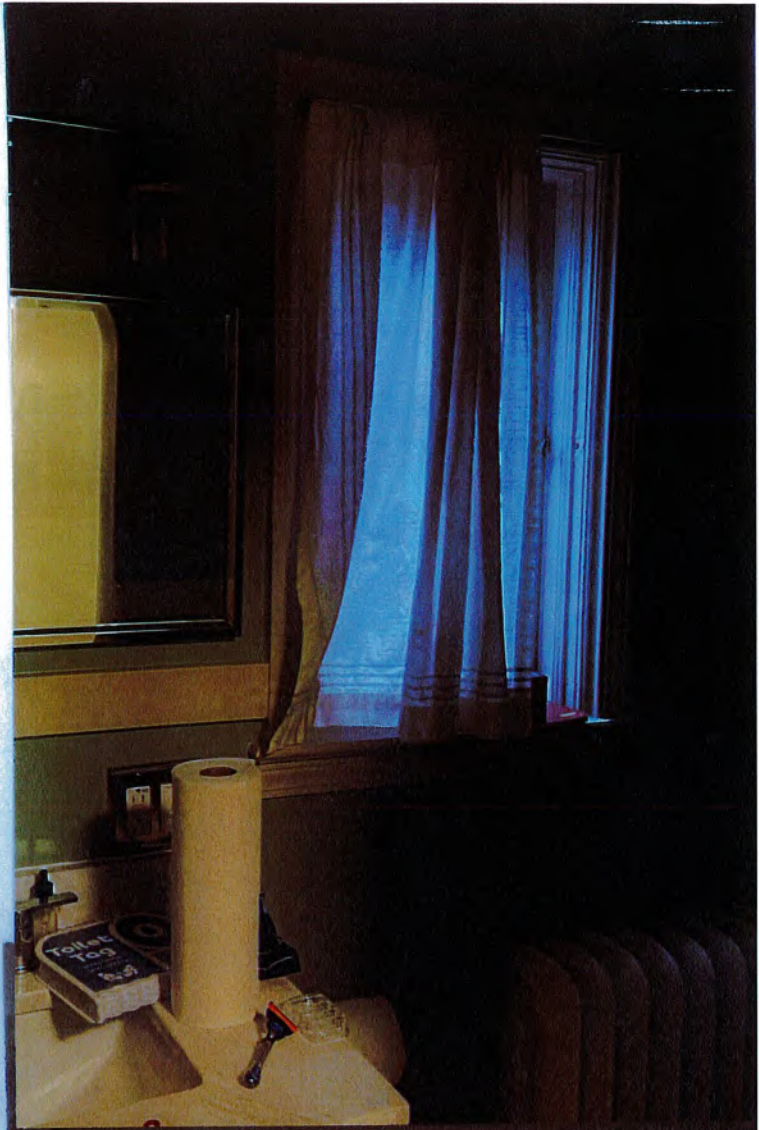
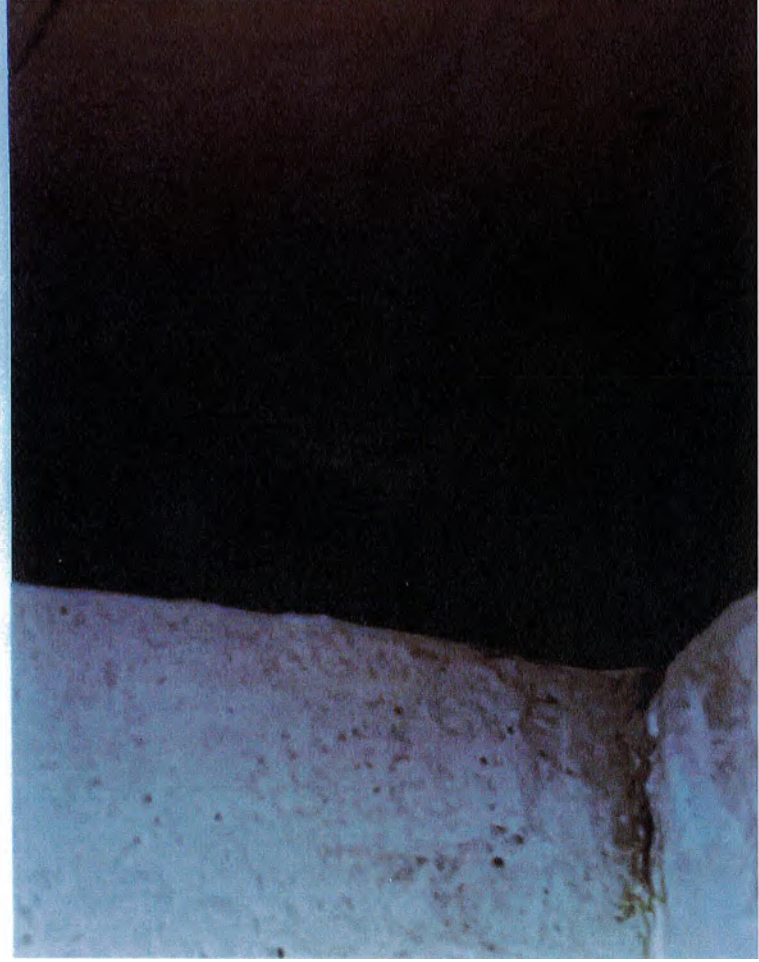
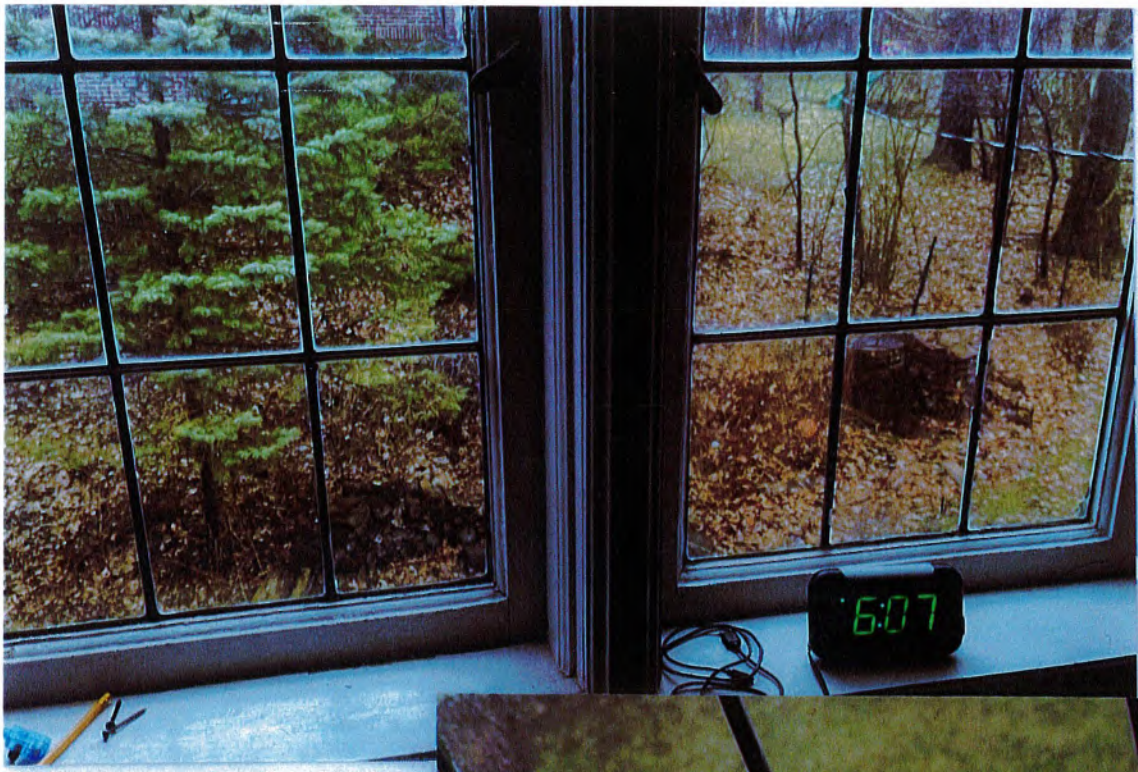
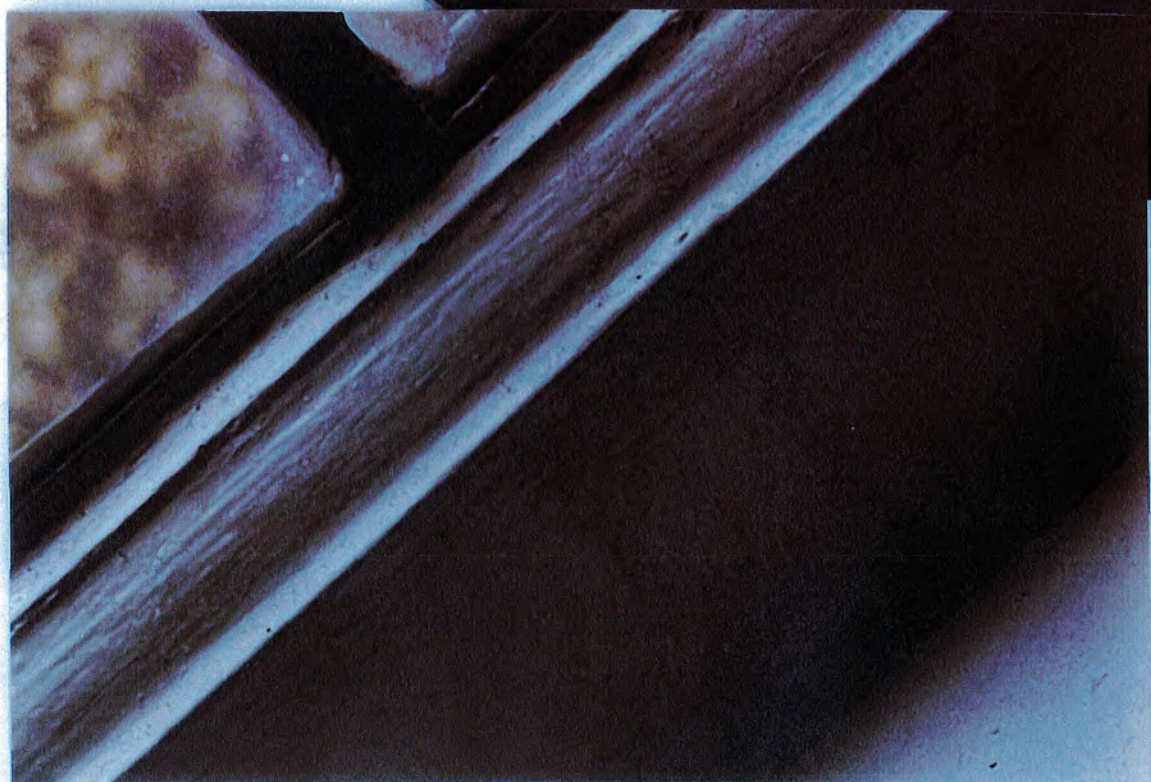
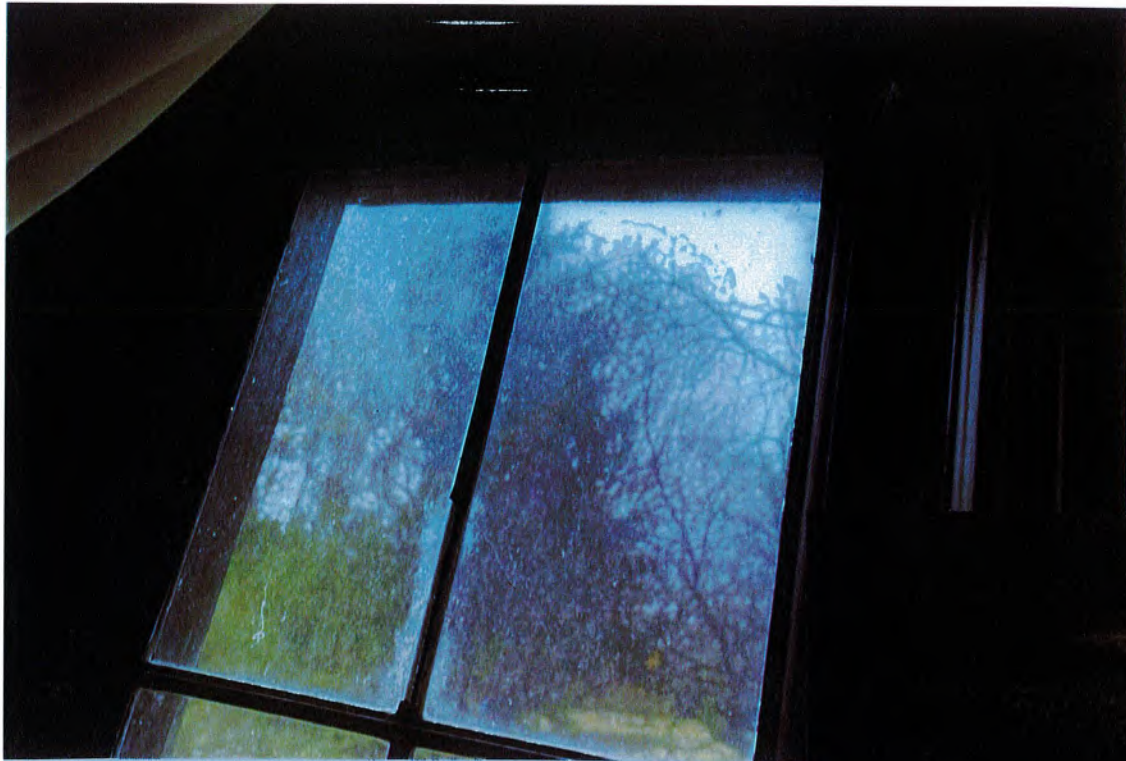
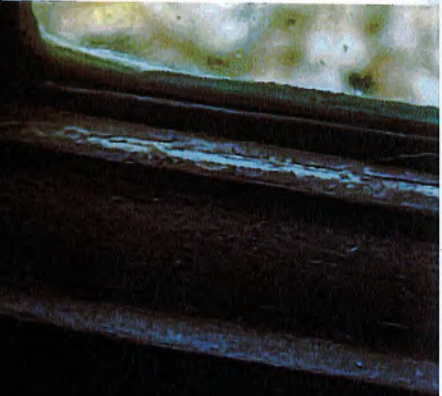
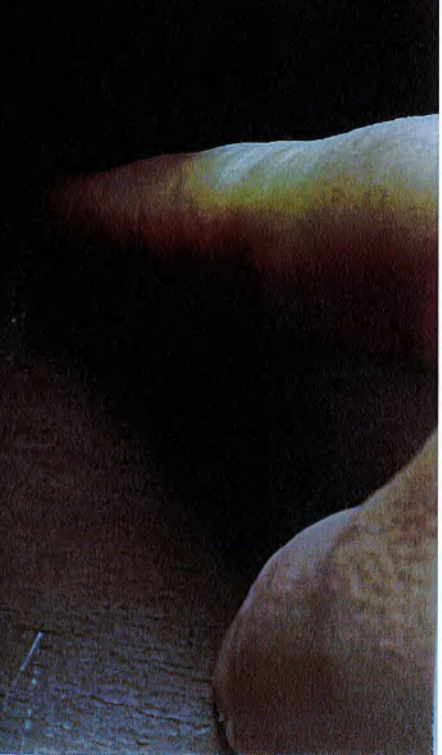
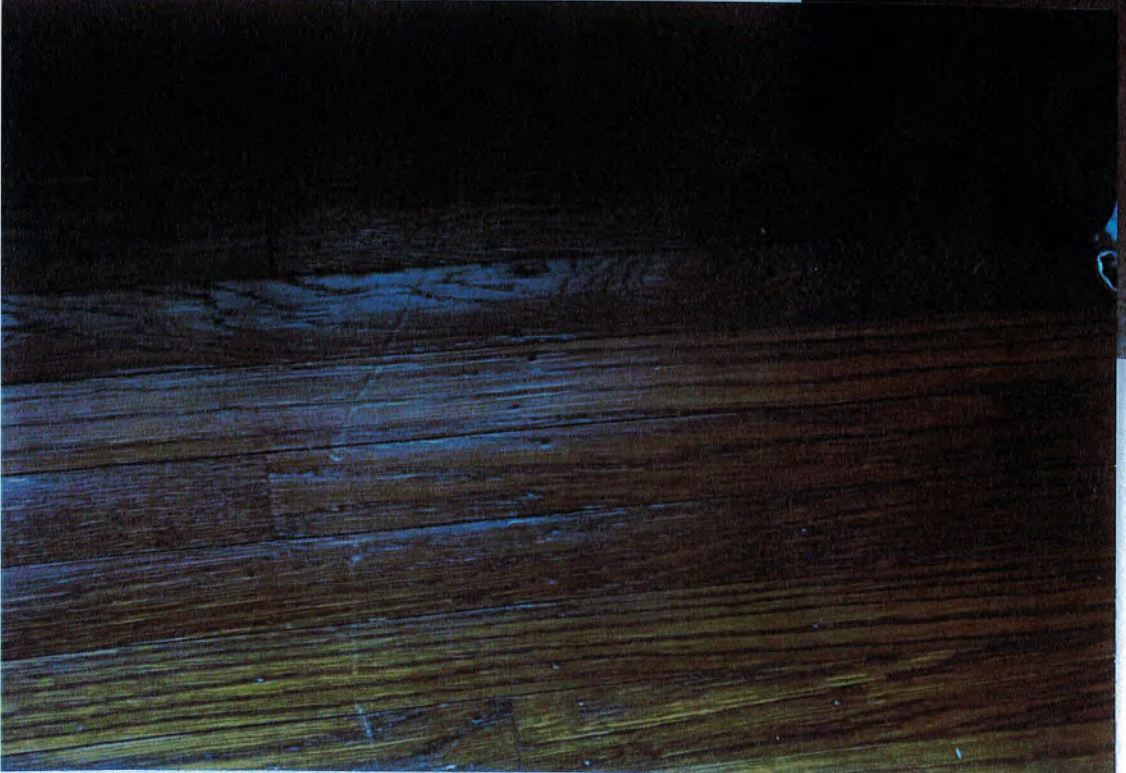
Left Side

The upper left hand corner is a double casement that goes into their youngest son's room. This room has 2 large radiators in it but is still the coldest room in the home. This is due to all 5 casements in the room not closing. There are gaps of 1 ¼" on some sashes. The gaps have caused warping of the sashes so on days that they can manage to get the windows to close there is still a draft. The temperature changes at the windows are causing frost on the room side in addition to the condensation. The family has put towels on most of the interior stools to try to keep the water from going too far, but that led to mildew on the towels and some cases mold under the towels on the stools and window stops.

The small single unit is the master bathroom. The poor ventilation for decades (the family has redone the bath and finally added a bath fan recently) and the age of the home have led to issues with mold in the unit. There is also rotting of the sash taking place. Some of the mold got under the lead paint which created an even larger issue from a safety standpoint.

On the first floor the three wide casement is an enclosed porch that has become part of the living space over the years. The windows leak when it rains. And the units don't shut even when pushing from the exterior. This appears to be swelling in the frame and sash from the high moisture.

The final unit on the left side is a double unit in the living room. This unit was damaged from the same water that caused the ceiling to collapse in that room. There is evidence of water getting in wall as the oak flooring is showing internal rot at the base of the wall directly below this unit. This window suffers like the others from condensation and in extreme weather days large frost build up. The sash is soft enough that the window locks have pulled out and the units cannot be secure.
