**SYRACUSE
LANDMARK
PRESERVATION
BOARD**

Certificate of Appropriateness Application

Case Number: CA-23-06

WINDOW SURVEY FORM

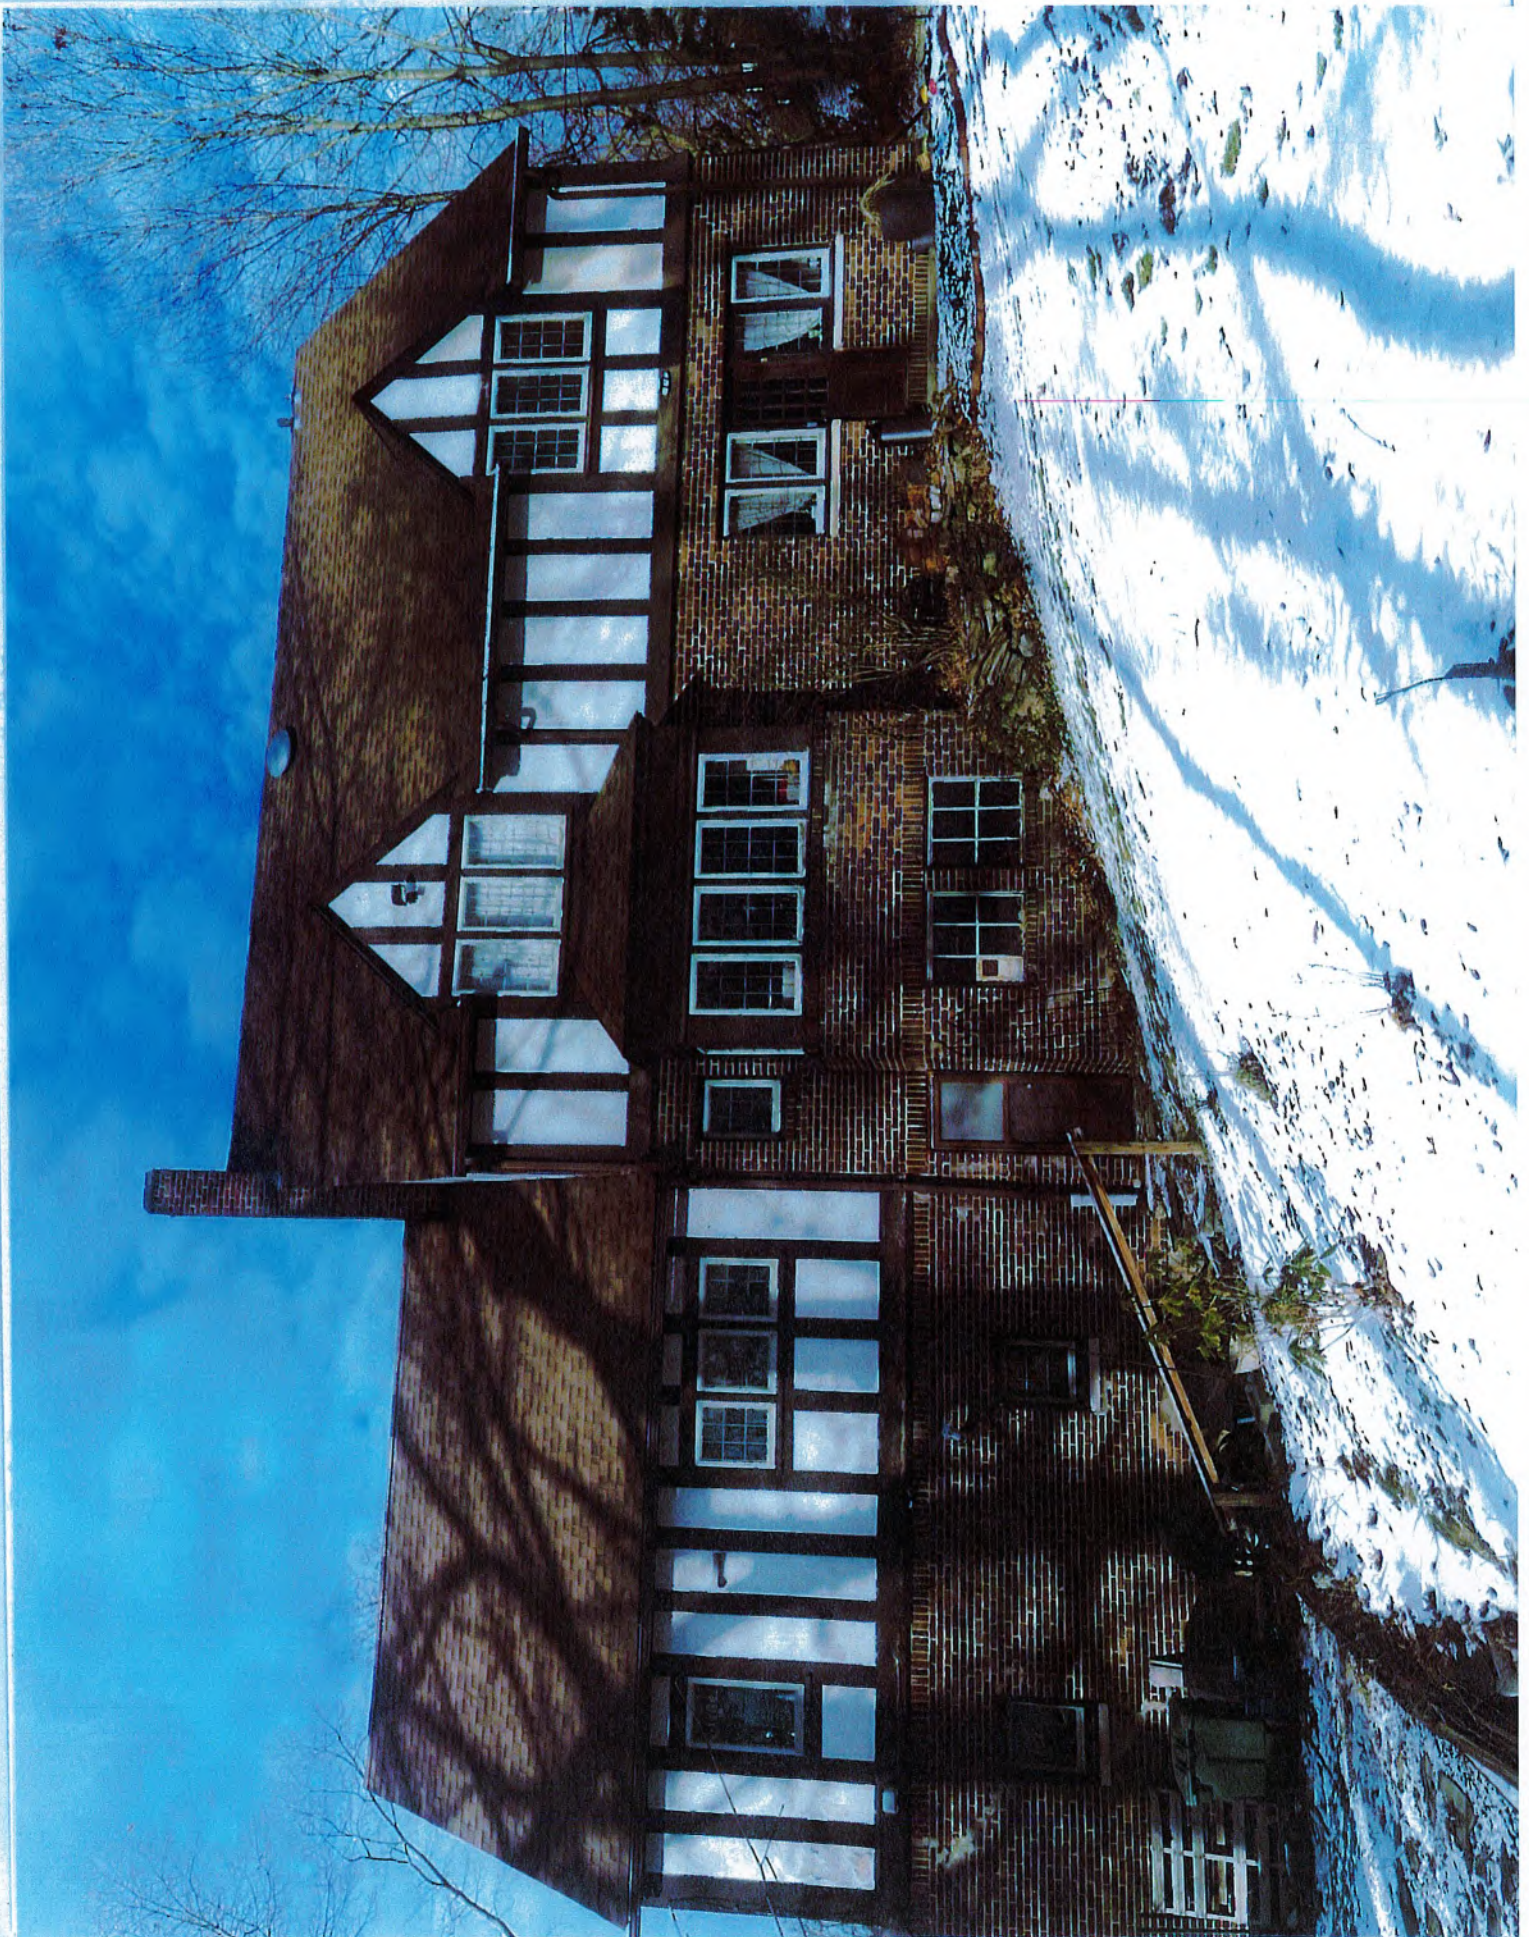
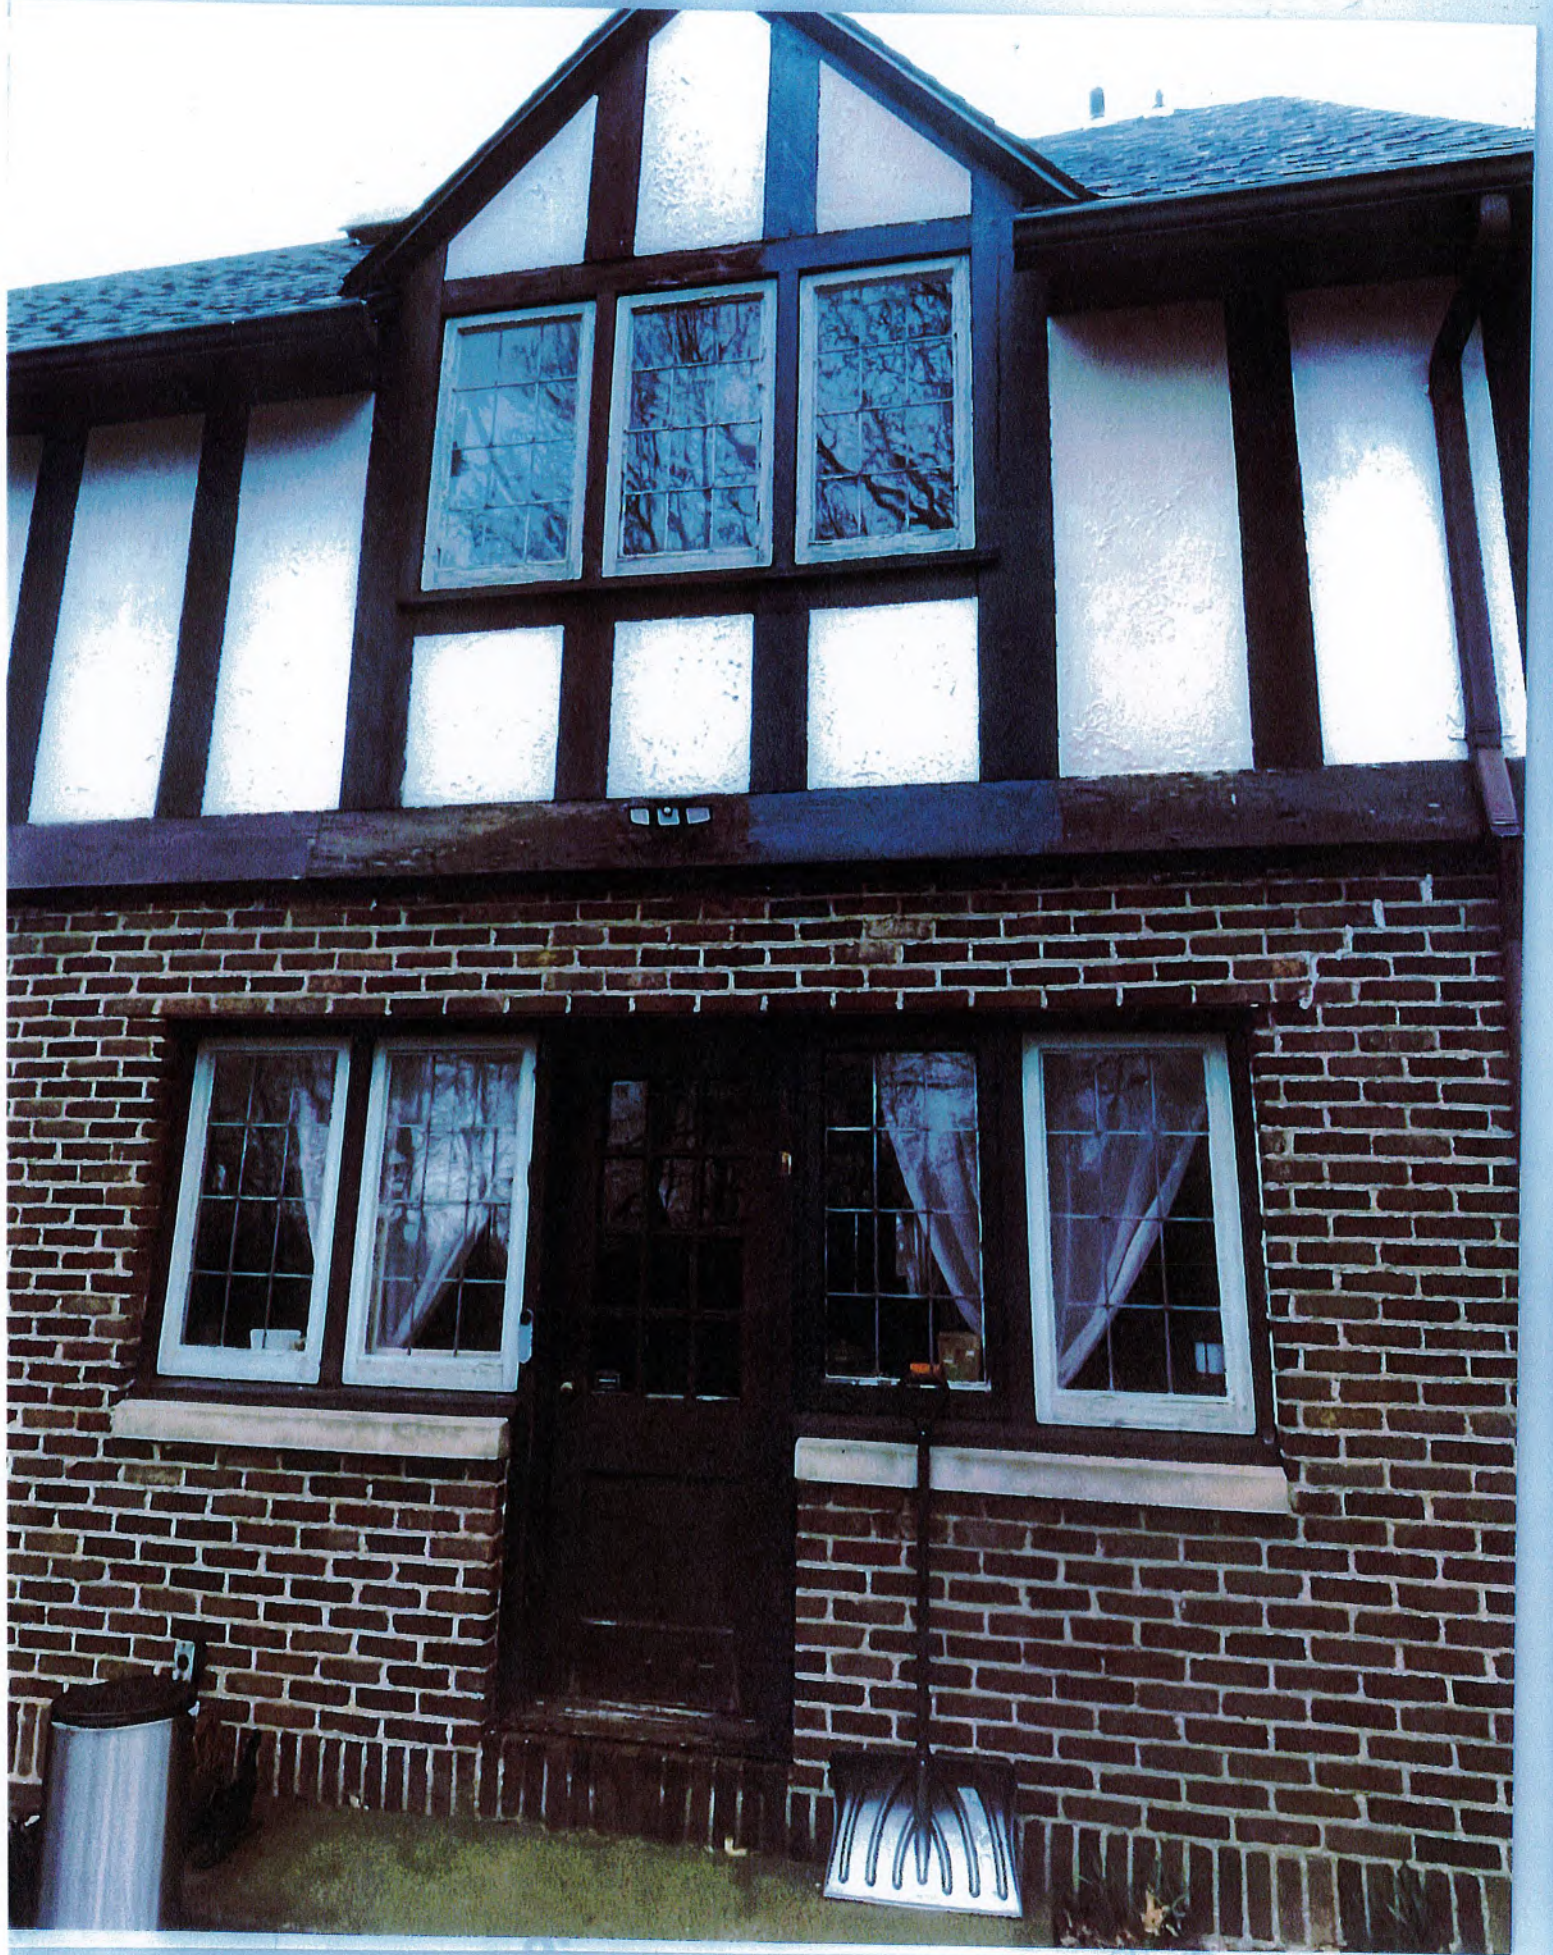
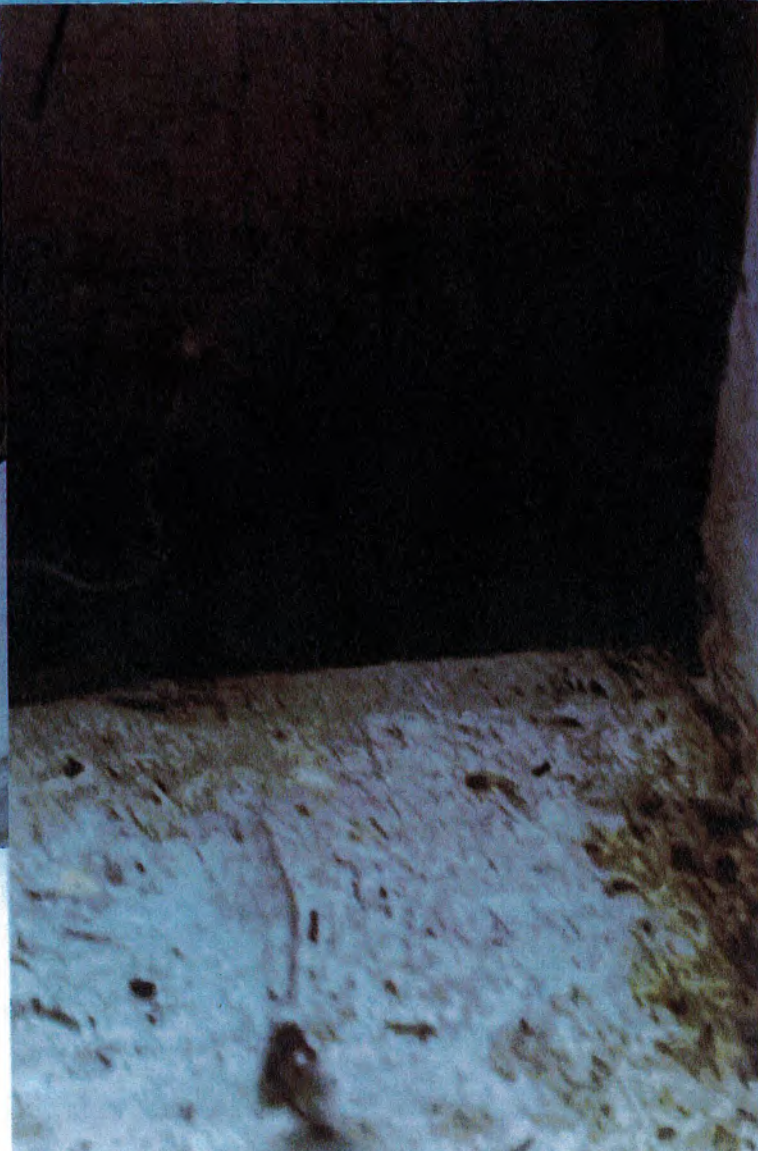
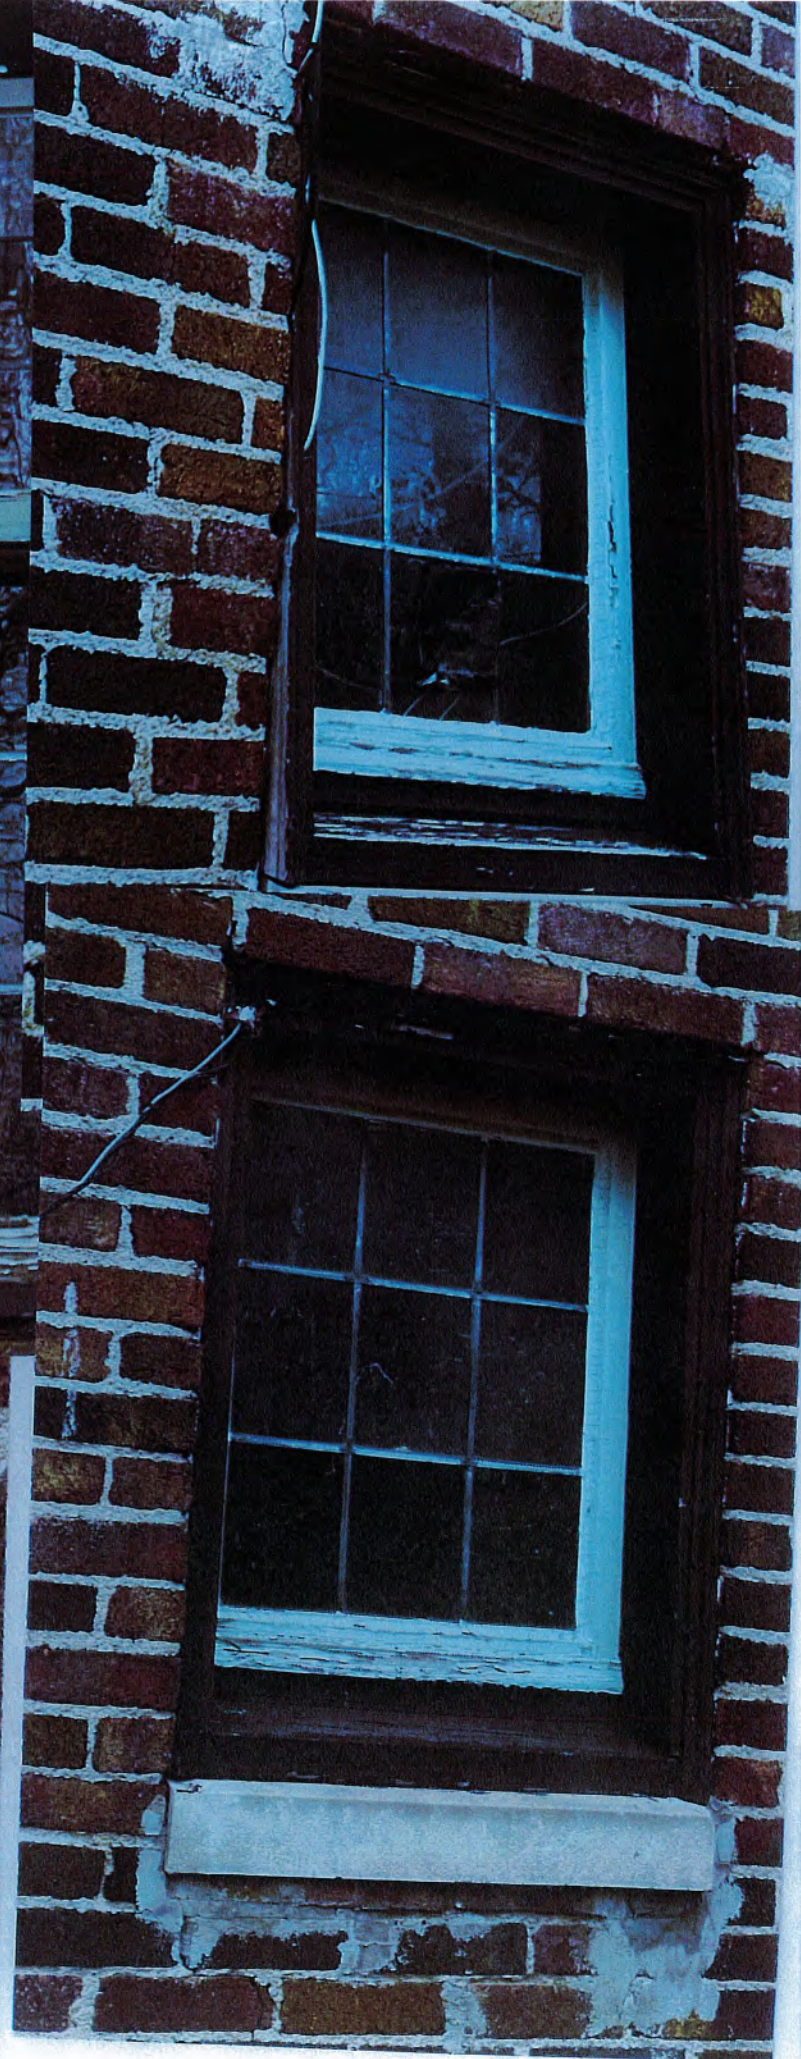
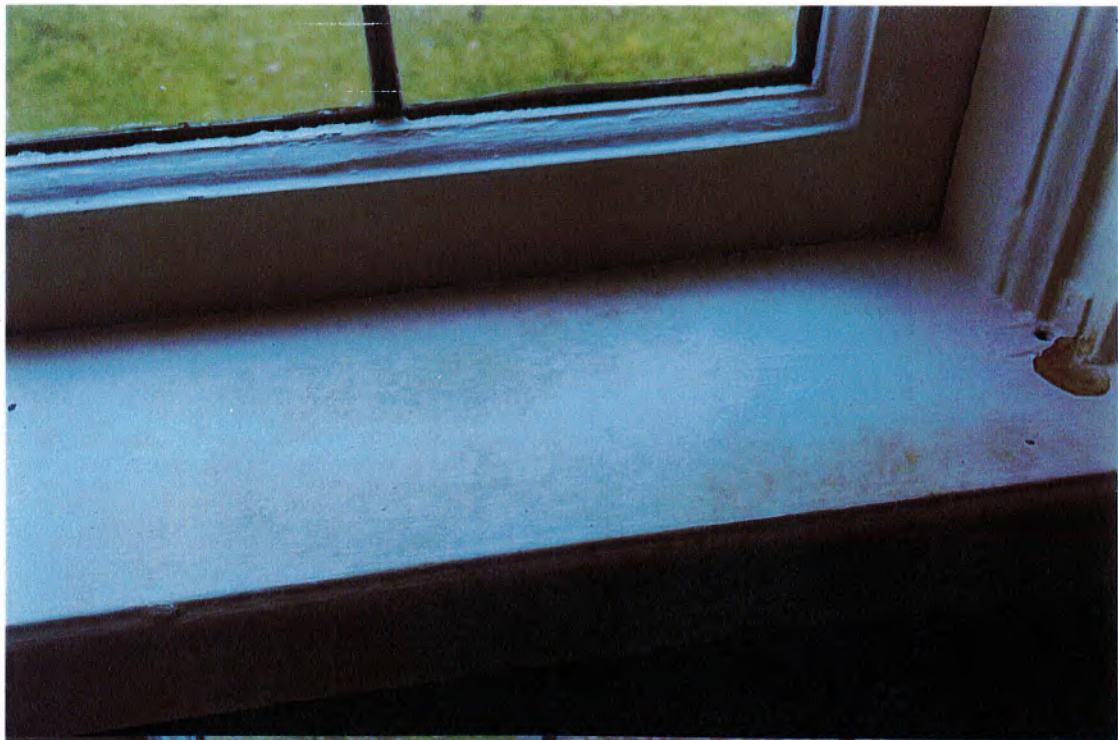
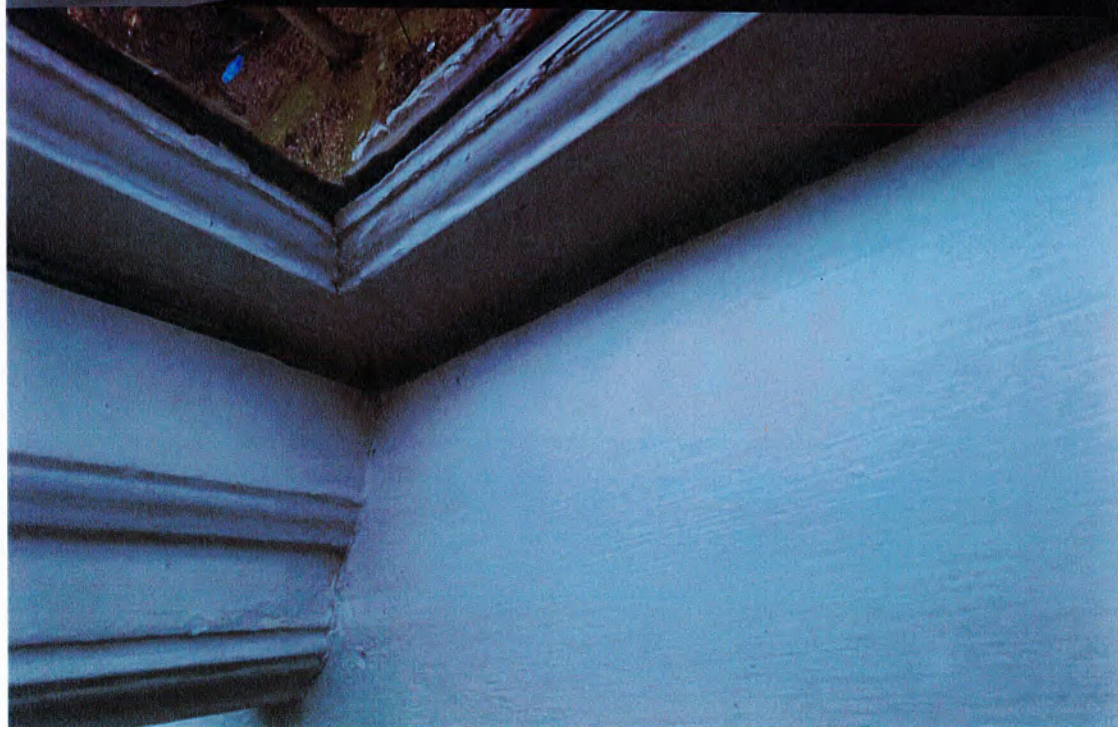
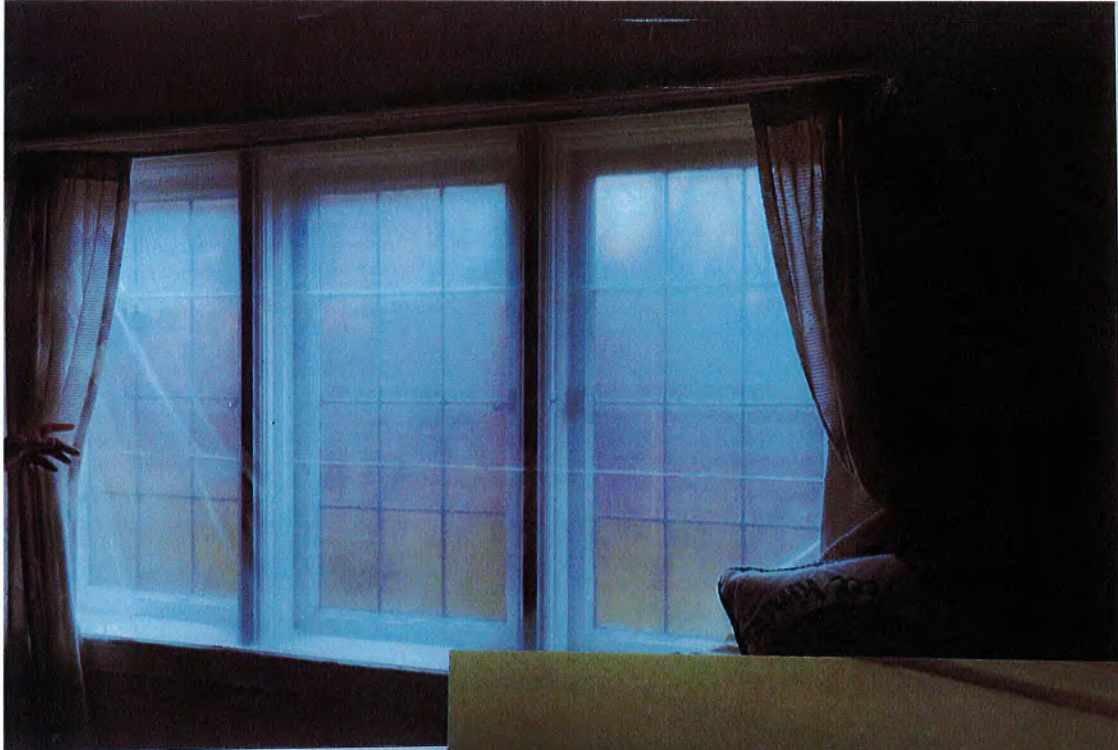
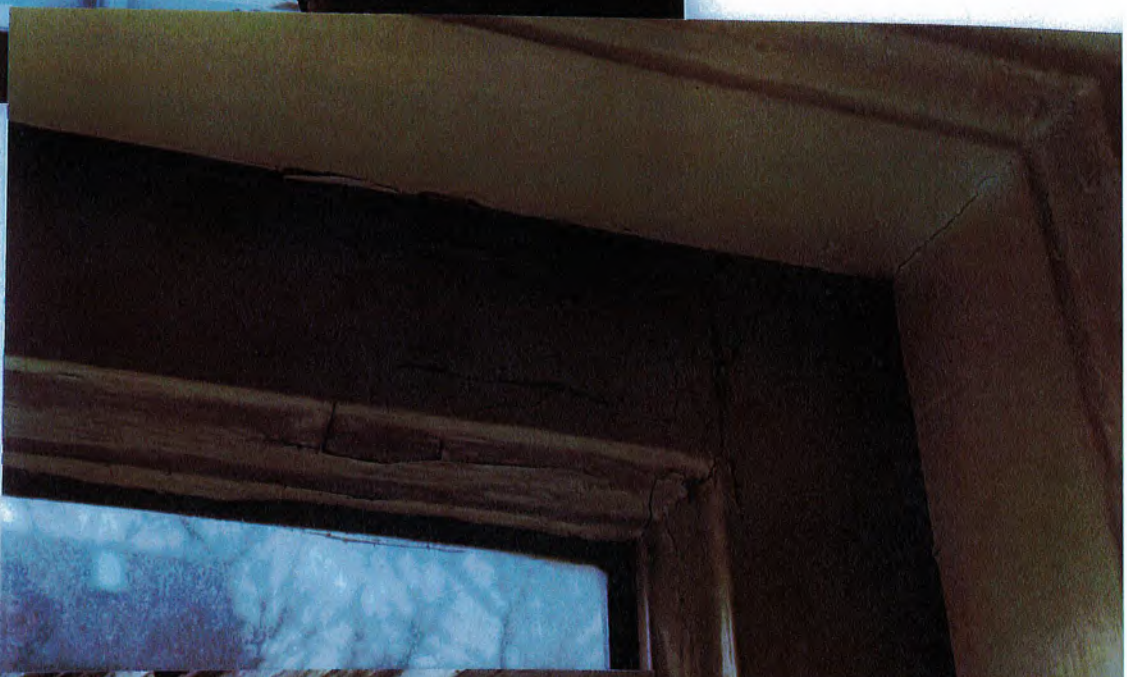
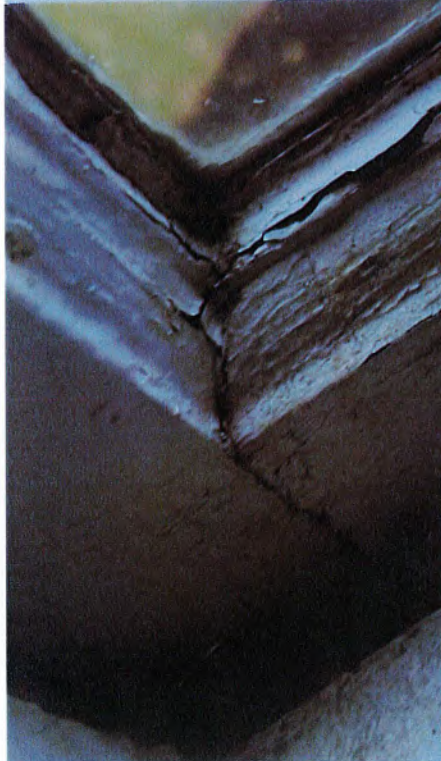
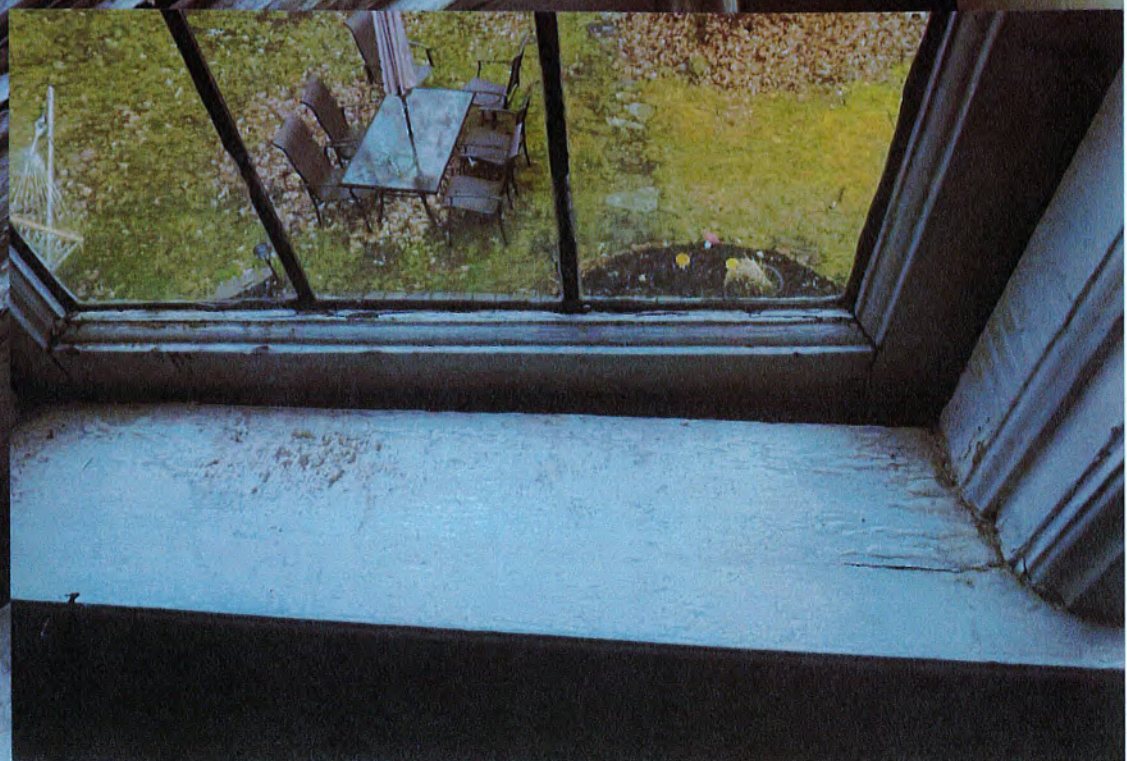
Back of the House

The first 4 units on the left are all in the kitchen. None of the units are operable at this time. The units were all supposed to work. But years of neglect and then a few botched patch jobs have left the family with these windows being unable to open. There appears to be very heavy lead dust content trapped between the units and the sills appear to have rotted and then had filler added. The lack of maintenance has taken its toll on these. There is a steady build up of condensation between the sash and the storm on the 3 over the kitchen sink. The previous repairs have left no place for that water to go. This is adding to the deterioration of the sills.

The single unit in the brick is the butler's pantry. This window is in the best shape at the back of the house. There is evidence of lead paint and some type of repair. But overall, this window isn't terrible.

The 6 second story windows are the casements in the middle son's room and the 3 remaining casements in the youngest son's room. These are all not functional. The problem is that the units are all stuck in partially open positions due to the sagging of the sashes, the swelling of the sills, and the warping of the sashes. The lack of closing is making these rooms extremely cold and causing condensation leading to mold and mildew.

The 4 casements in the build out are actually 6. What you can't see from the pictures are the fixed units on either side causing the build out to have depth. The sills are curling and separating from the brick allowing water in. The water is making a reappearance in the basement below this unit. The units as a whole look solid. There are the beginning signs of the sills starting to cause operational issues with the sashes dragging on them. The sashes don't appear to have rotted, but due show signs of leaking over the years.

The 4 final units separated by the door are back in the old porch that has become part of the home. These units are not closing and have sill damage as well as sagging sashes that show signs of decay.
