**SYRACUSE
LANDMARK
PRESERVATION
BOARD**

Certificate of Appropriateness Application

Case Number: CA-23-06

WINDOW SURVEY FORM

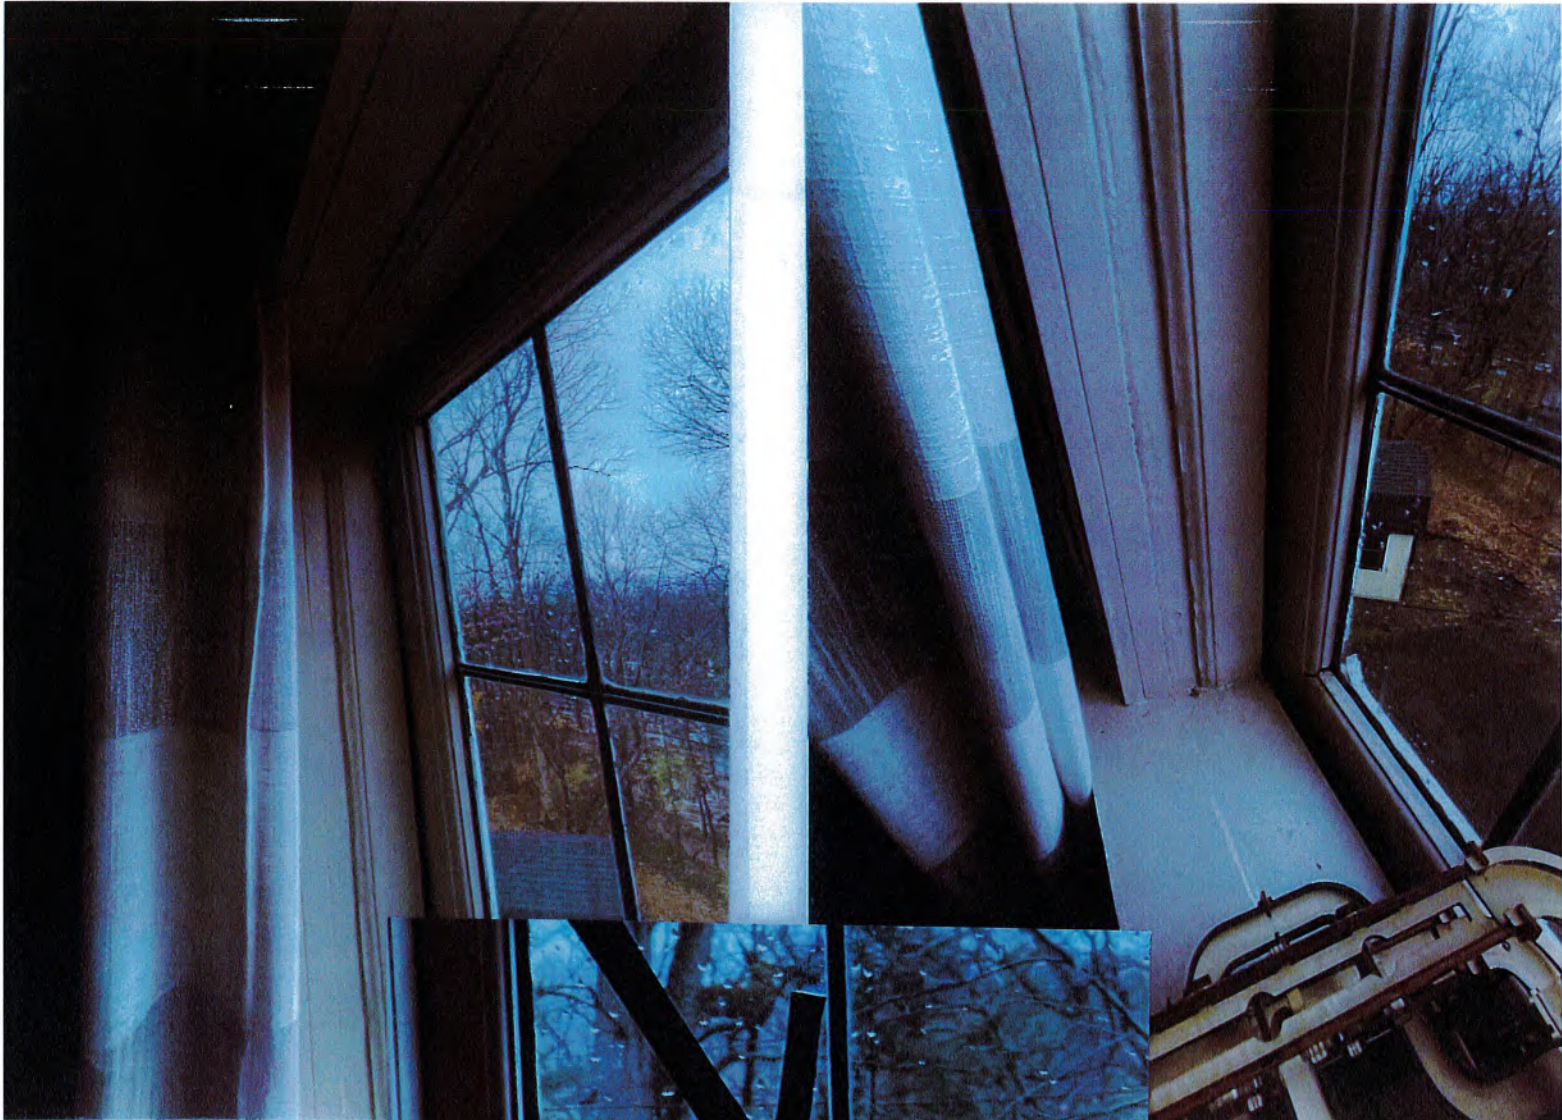
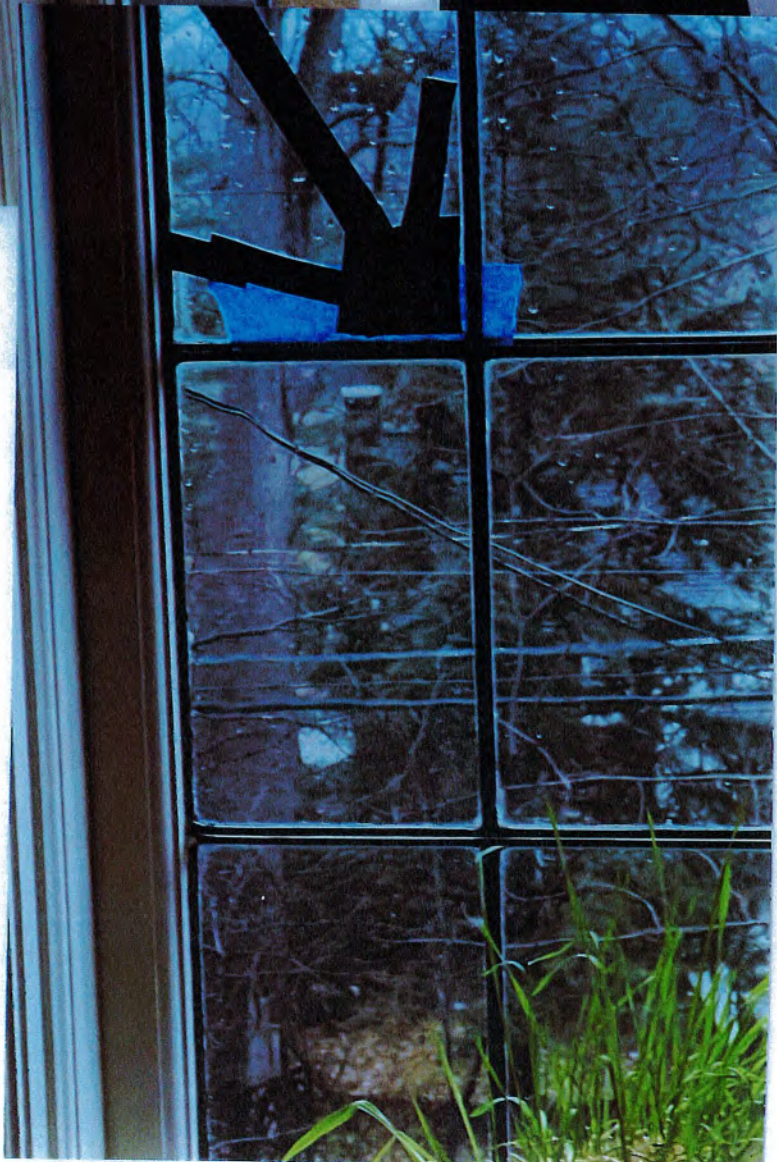
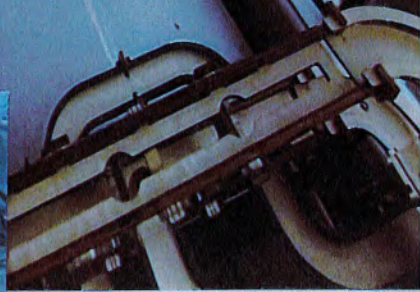
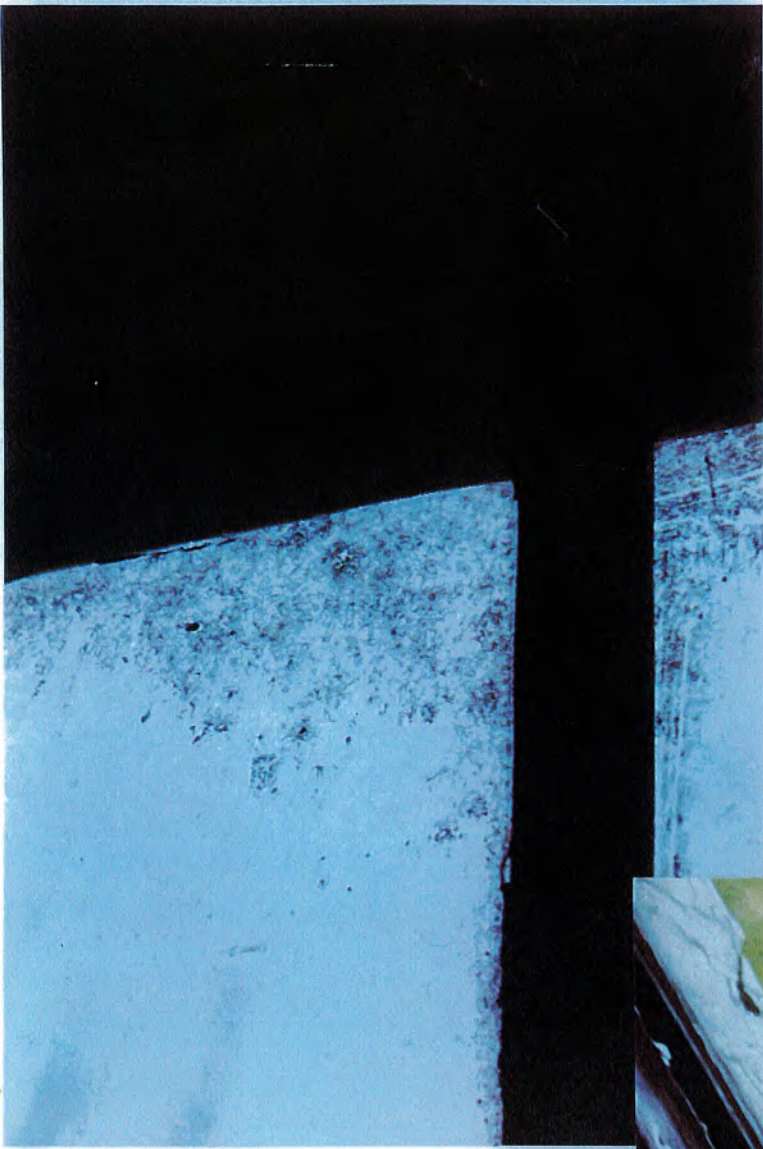
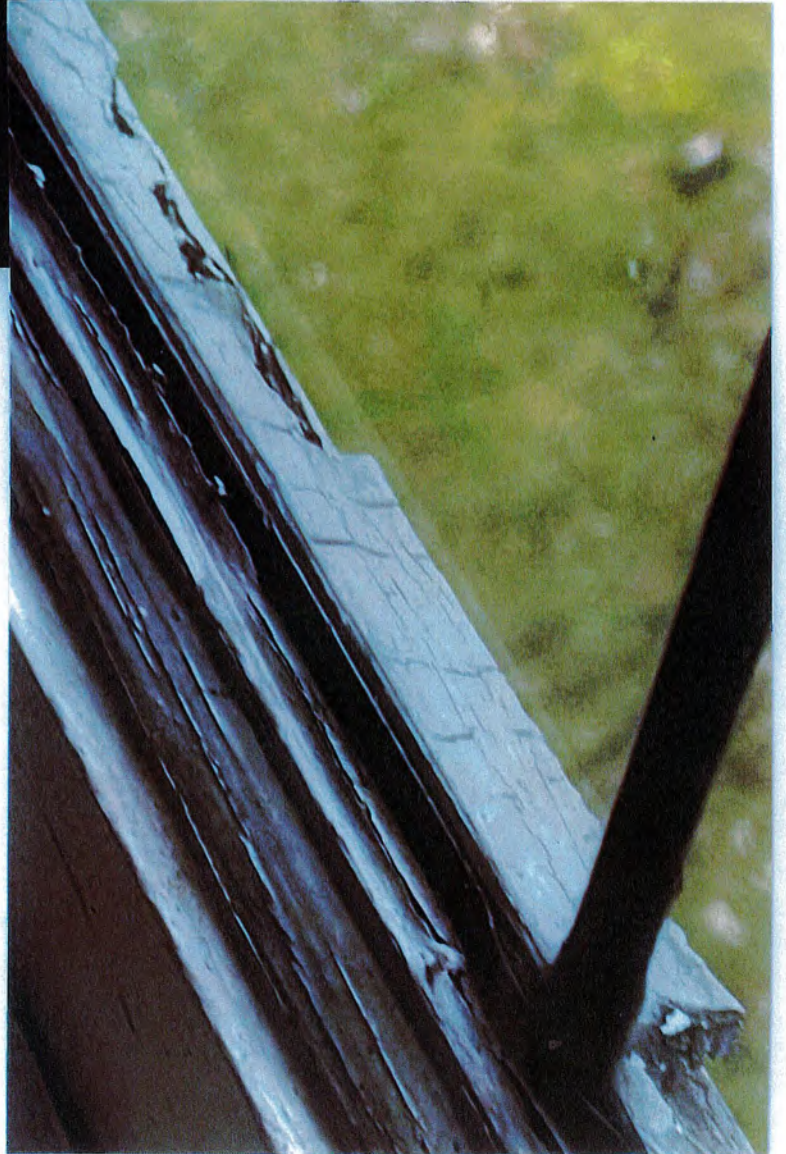
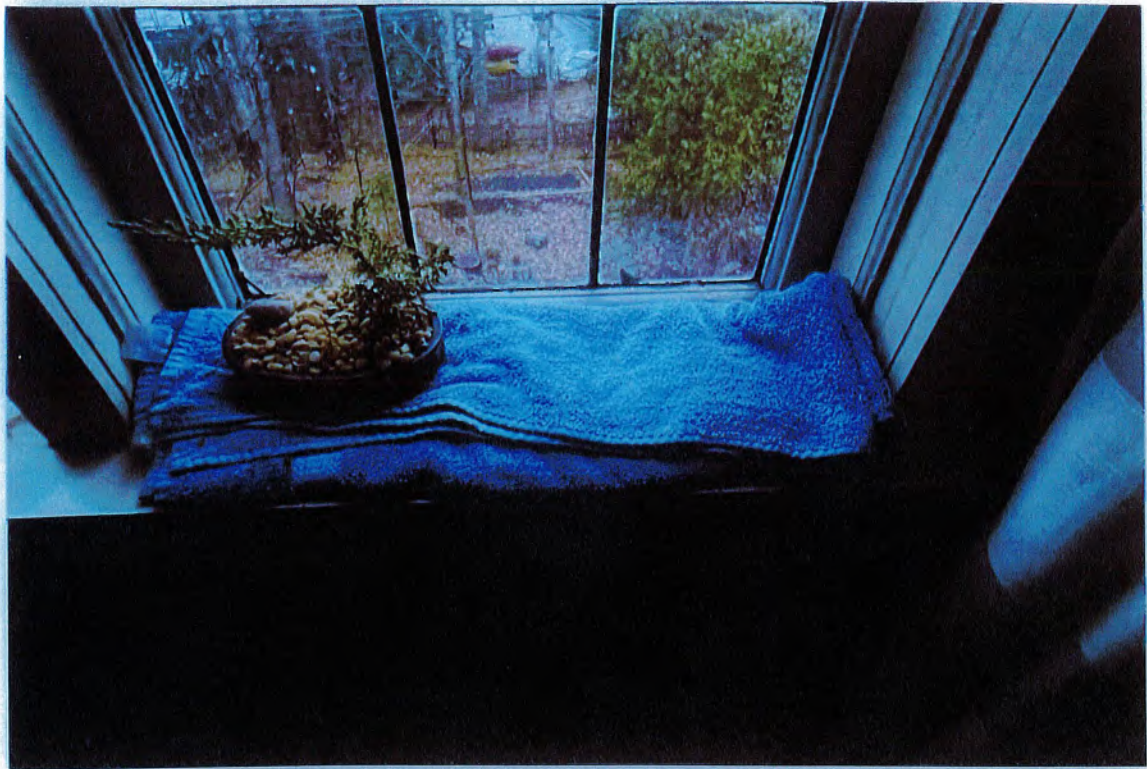
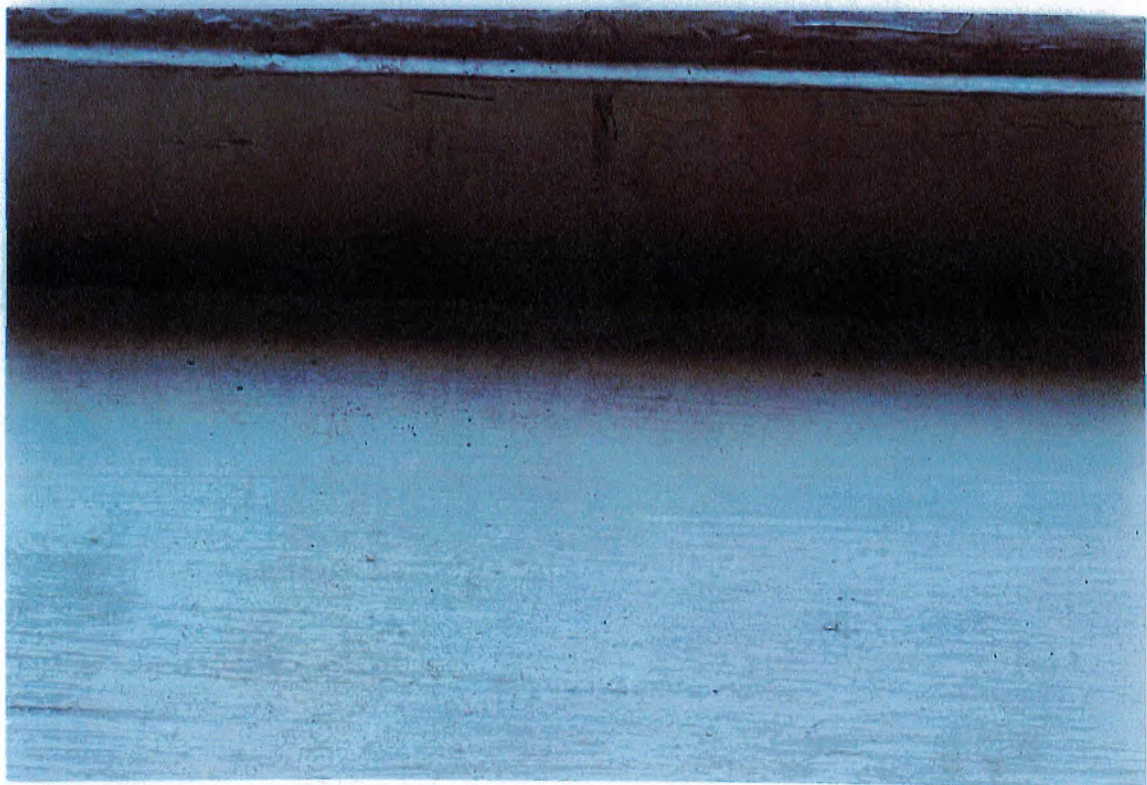
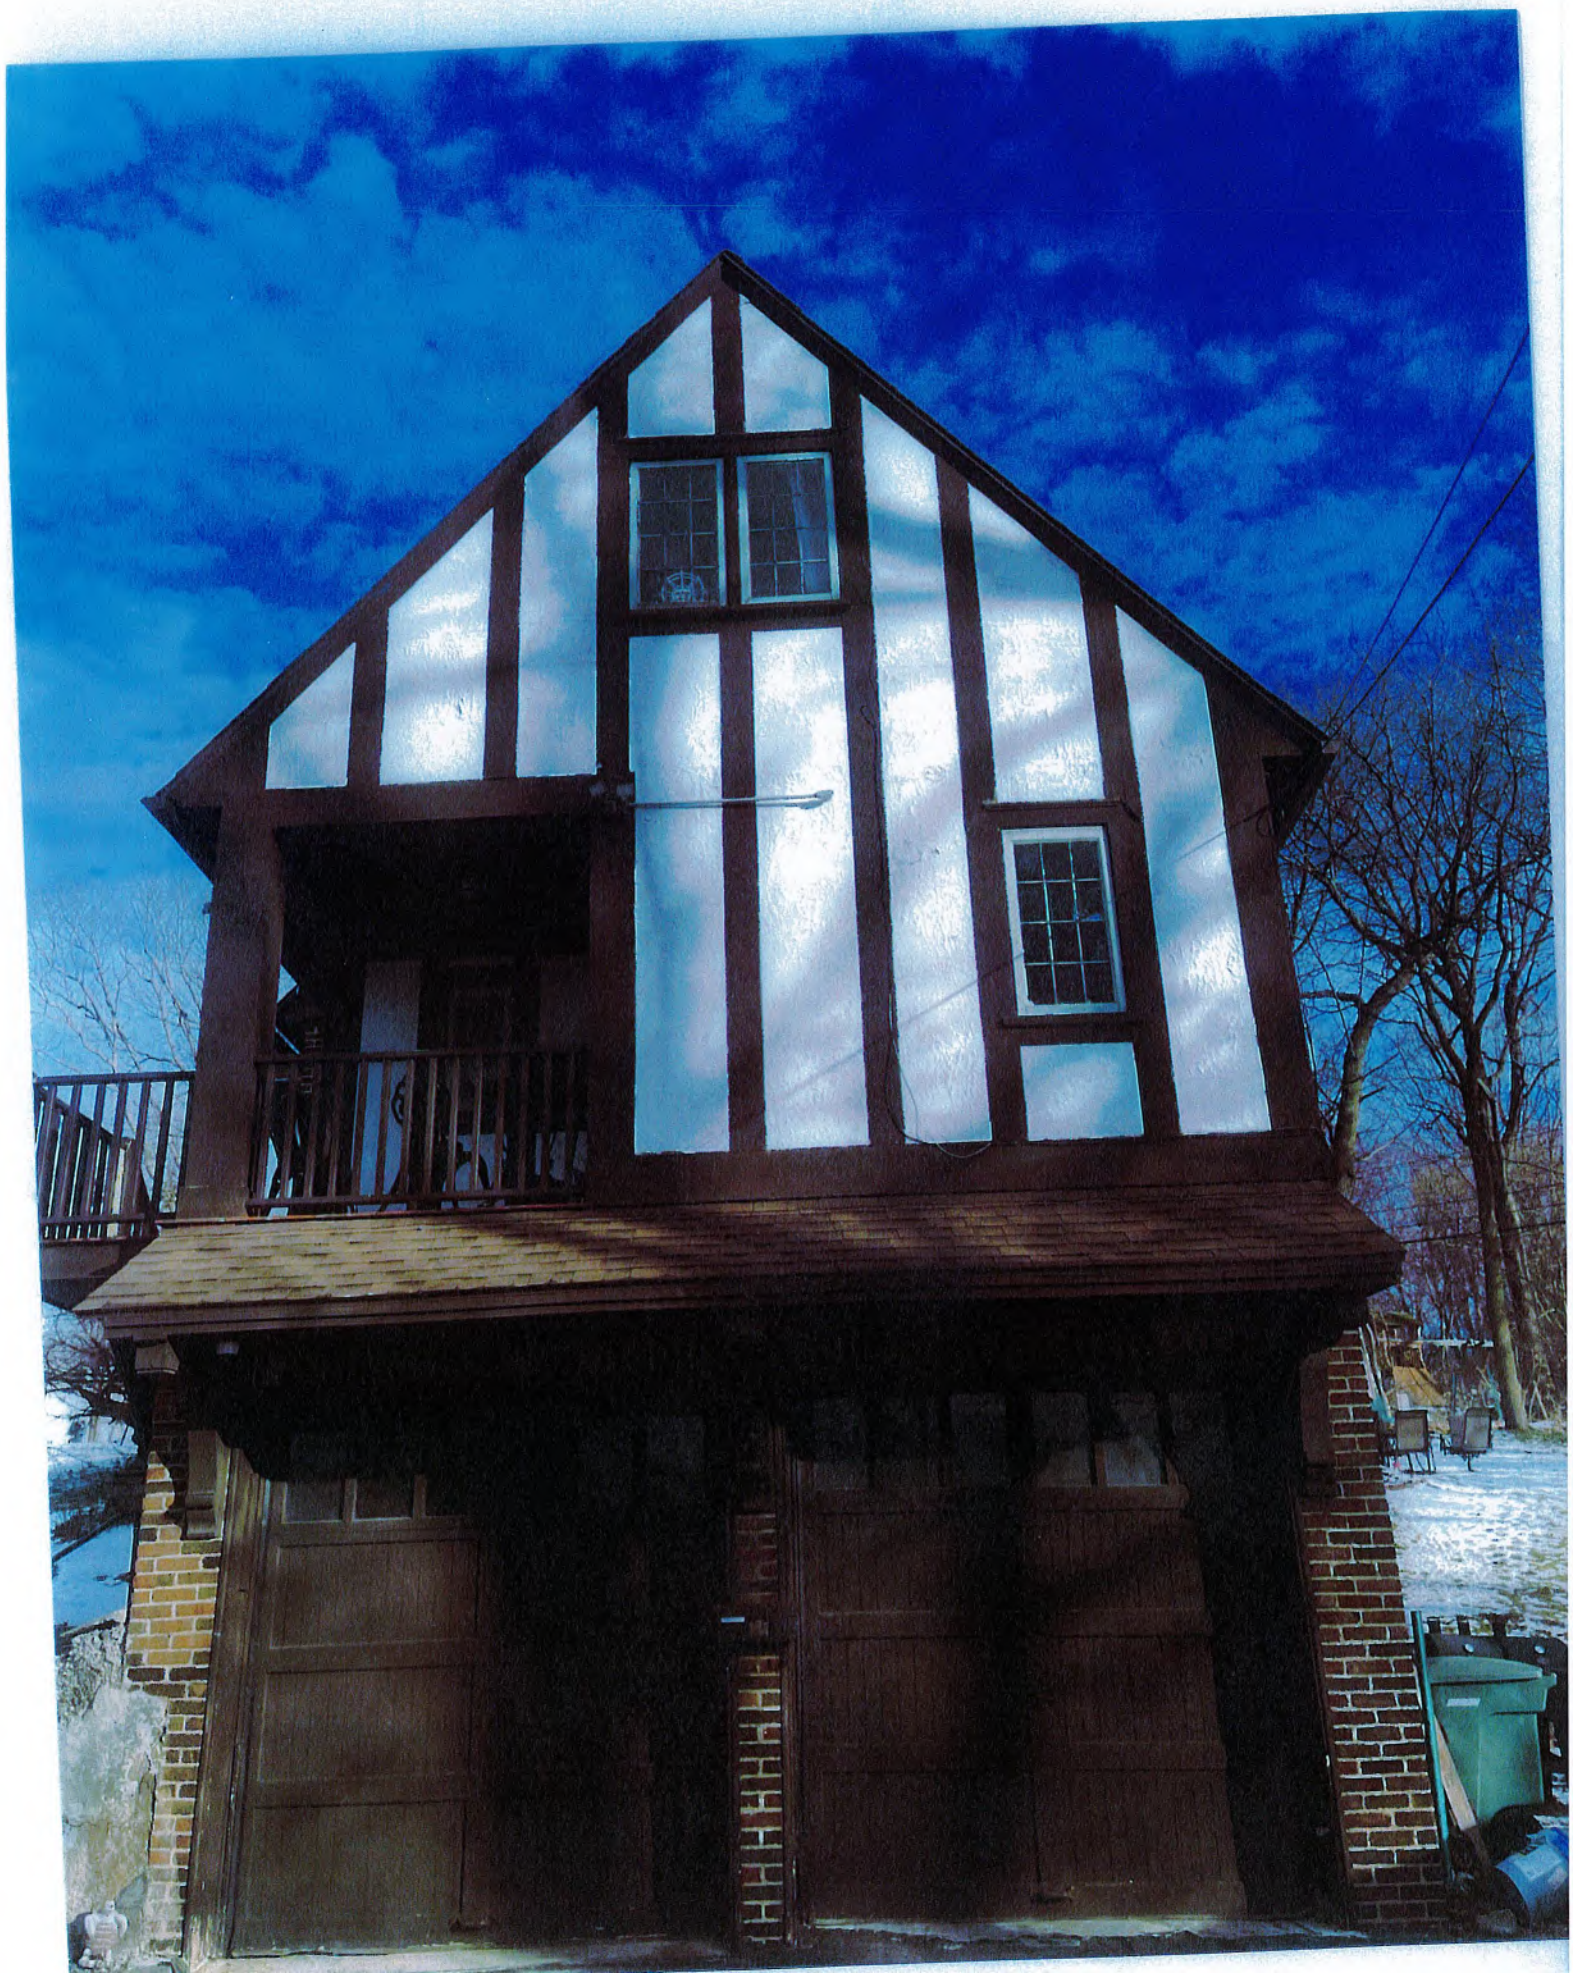
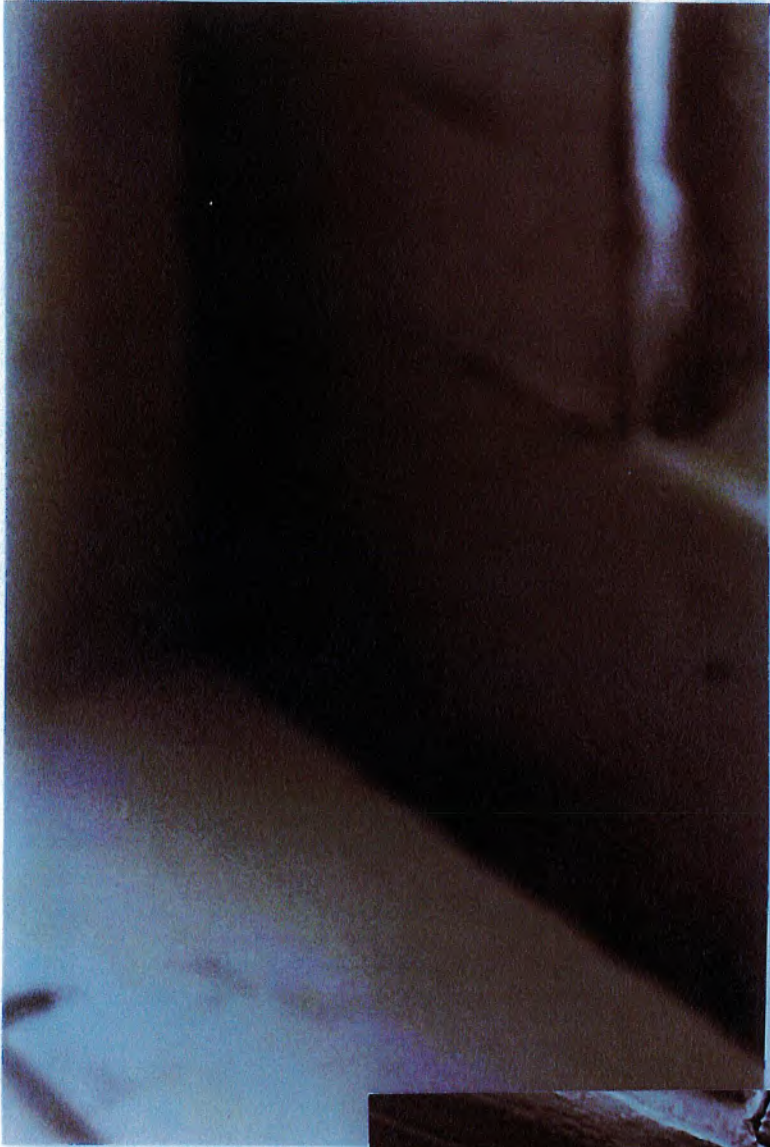
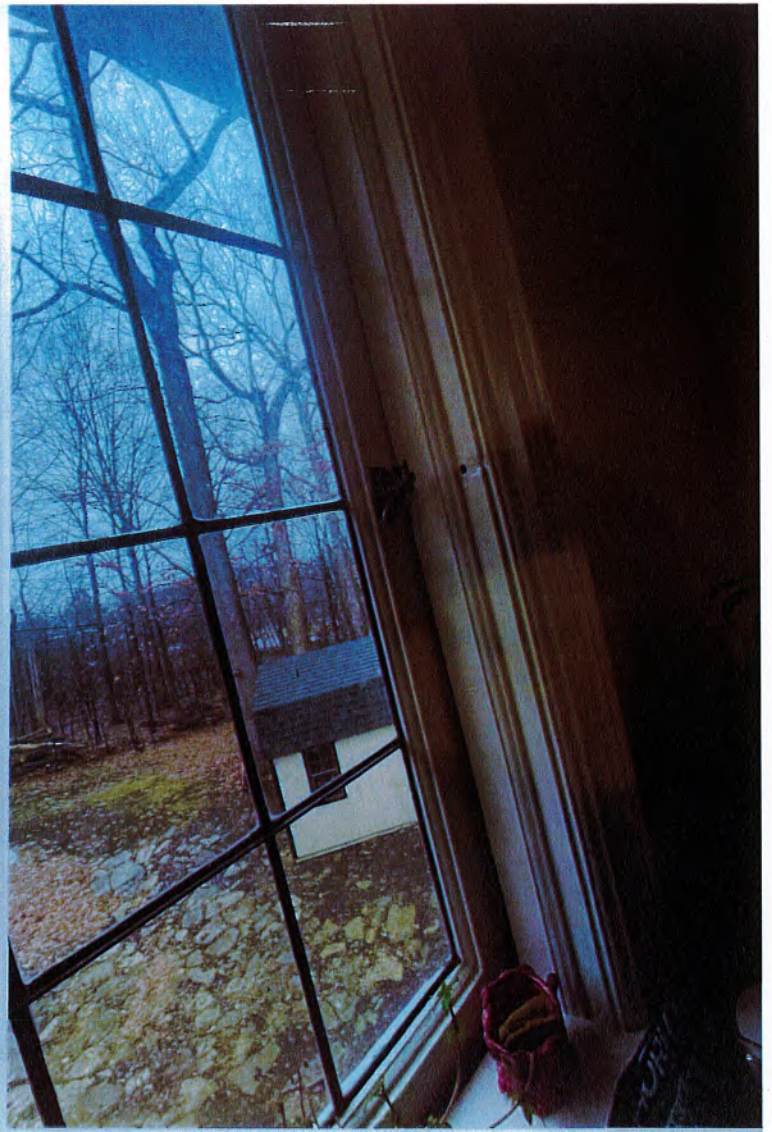
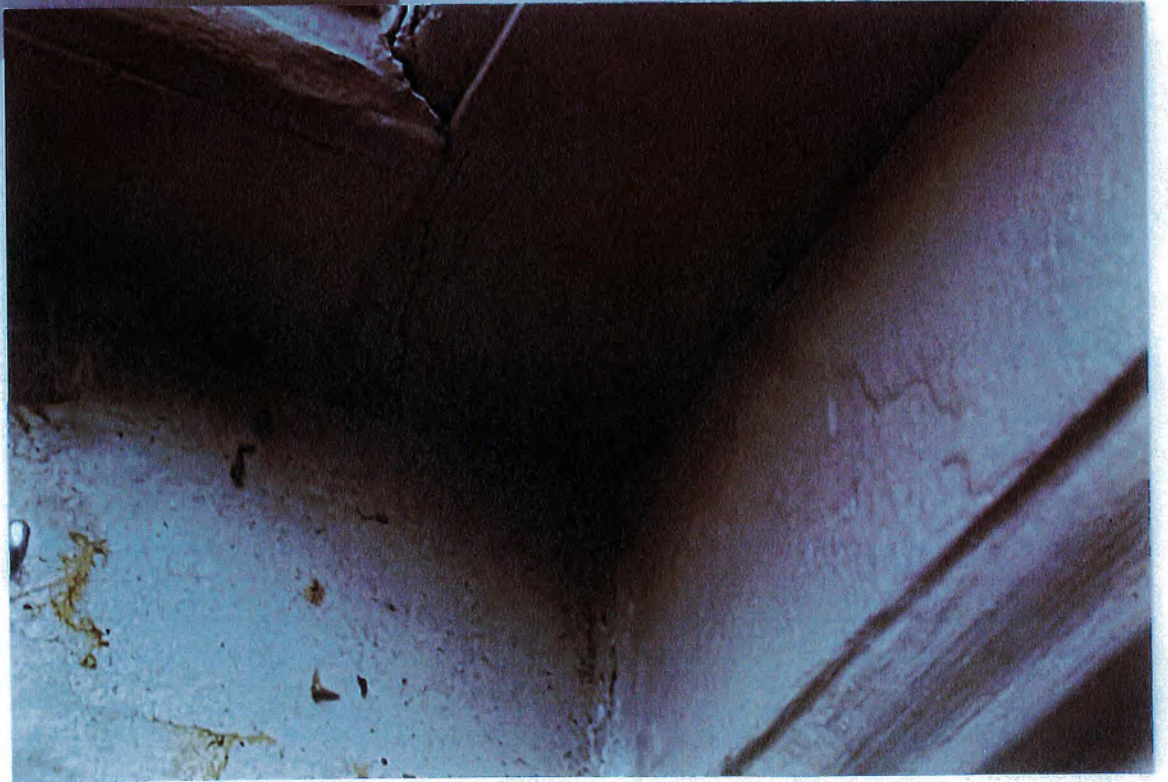
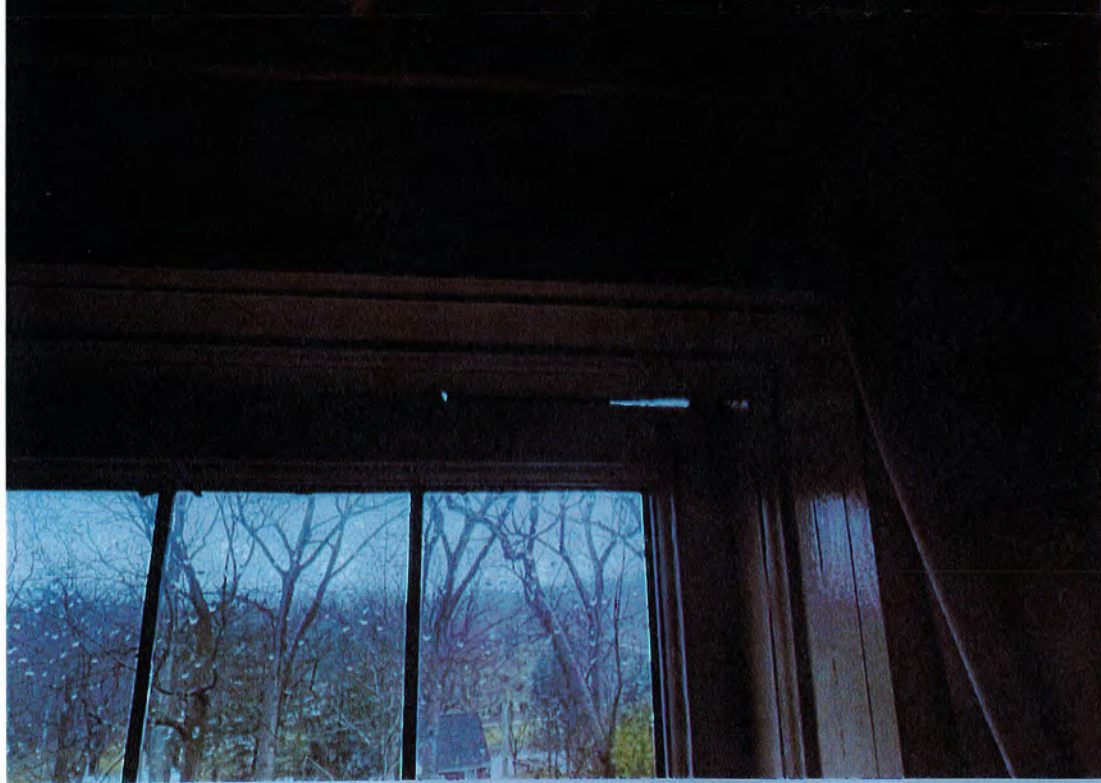
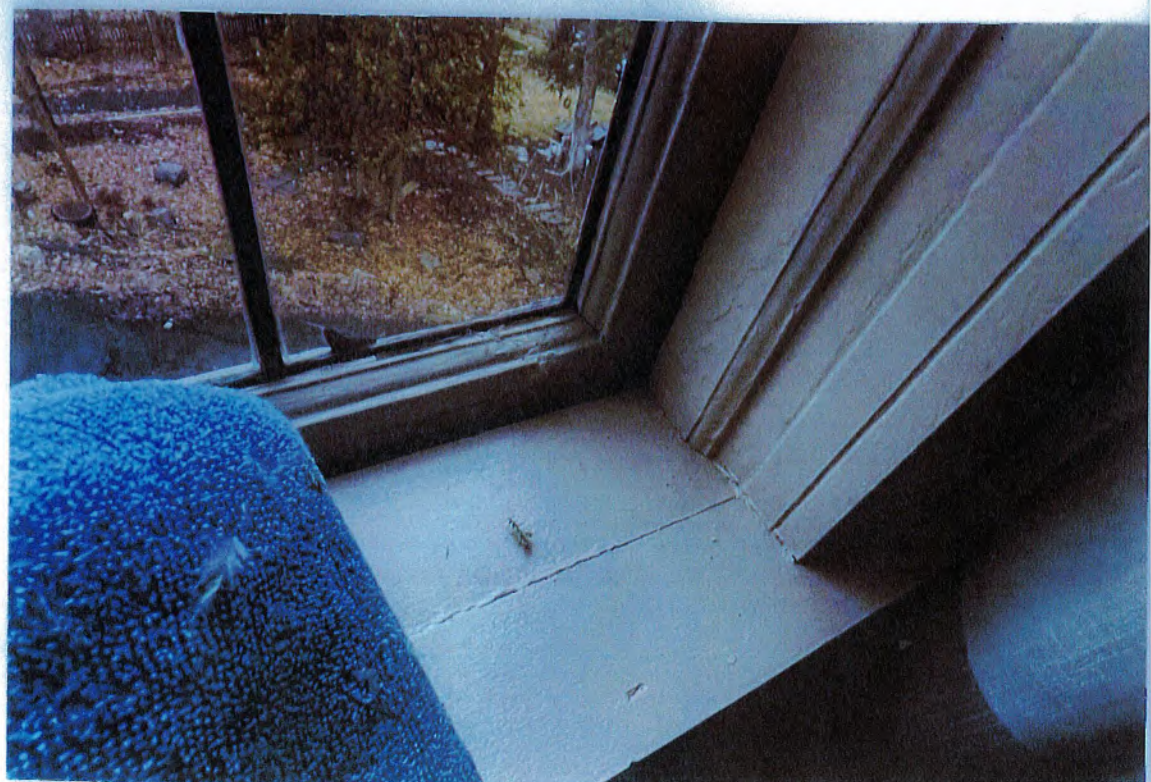
Right Side Over Driveway

The double window at the top of the peak is the oldest son's room. This window has always towels on the stool due to multiple water issues. The sashes are rotting on the top from what appears to be years of rain coming in. Now every time it rains the water comes in. If it isn't raining but is cold at all the condensation rains down these windows room side. The sills are showing signs of decay from the water as well. The family is chasing mold and mildew build up in this room as there is also a baby present from time to time. The health risks of this particular unit are the highest in the home.

The window hiding under the porch roof should be one of the better windows in the home, but for some reason is warped and will not close at the bottom. The top will pull tight, but the bottom is $\frac{3}{4}$ " from coming closed. It causes draft most of the winter. The condensation does build up, but due to the gap is able to drain back outside most of the time. On extremely cold days the condensation forms ice as it tries to drain out and can build up on the stool. This has caused cosmetic damage to the paint.

The single window in the stucco over the garage is at the end of the kitchen counter. This unit opens and partially closes. The sash is warped, and the glass has broken recently. Due to the condition of the sash prior to the breakage it isn't able to just have a glass replacement. The sill on this unit is showing wear and starting to curl up and away from the stucco.
