**SYRACUSE
LANDMARK
PRESERVATION
BOARD**

Certificate of Appropriateness Application

Case Number: CA-23-06

WINDOW SURVEY FORM

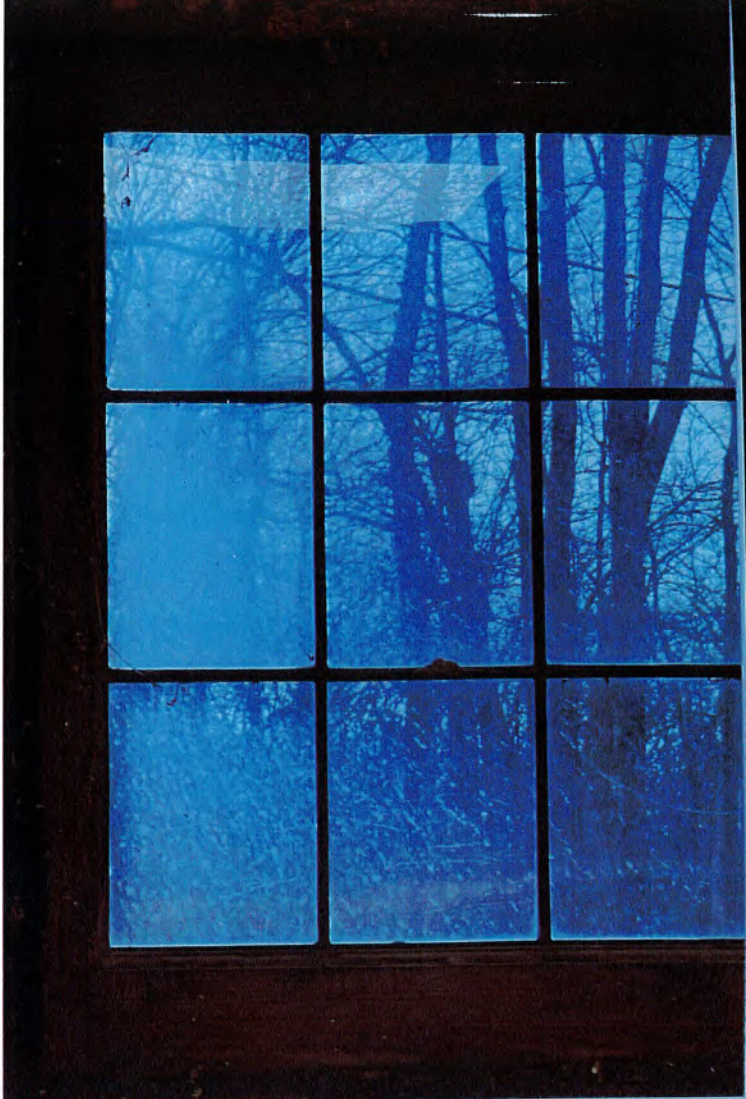
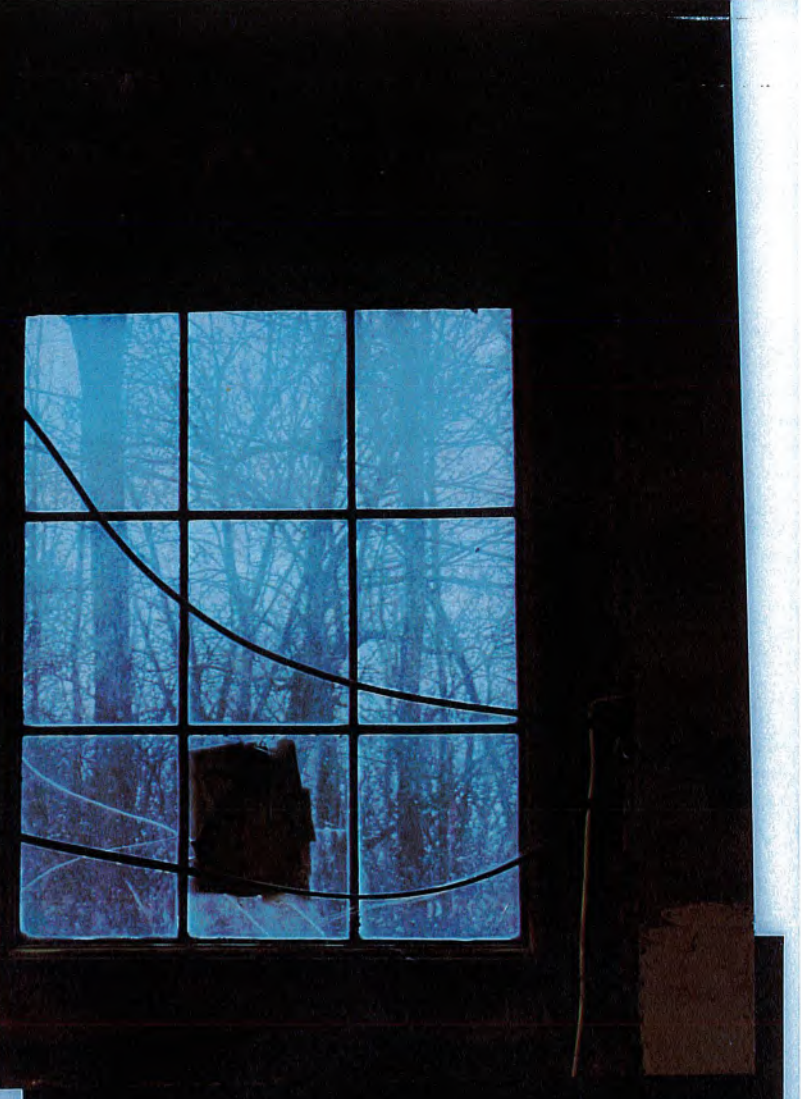
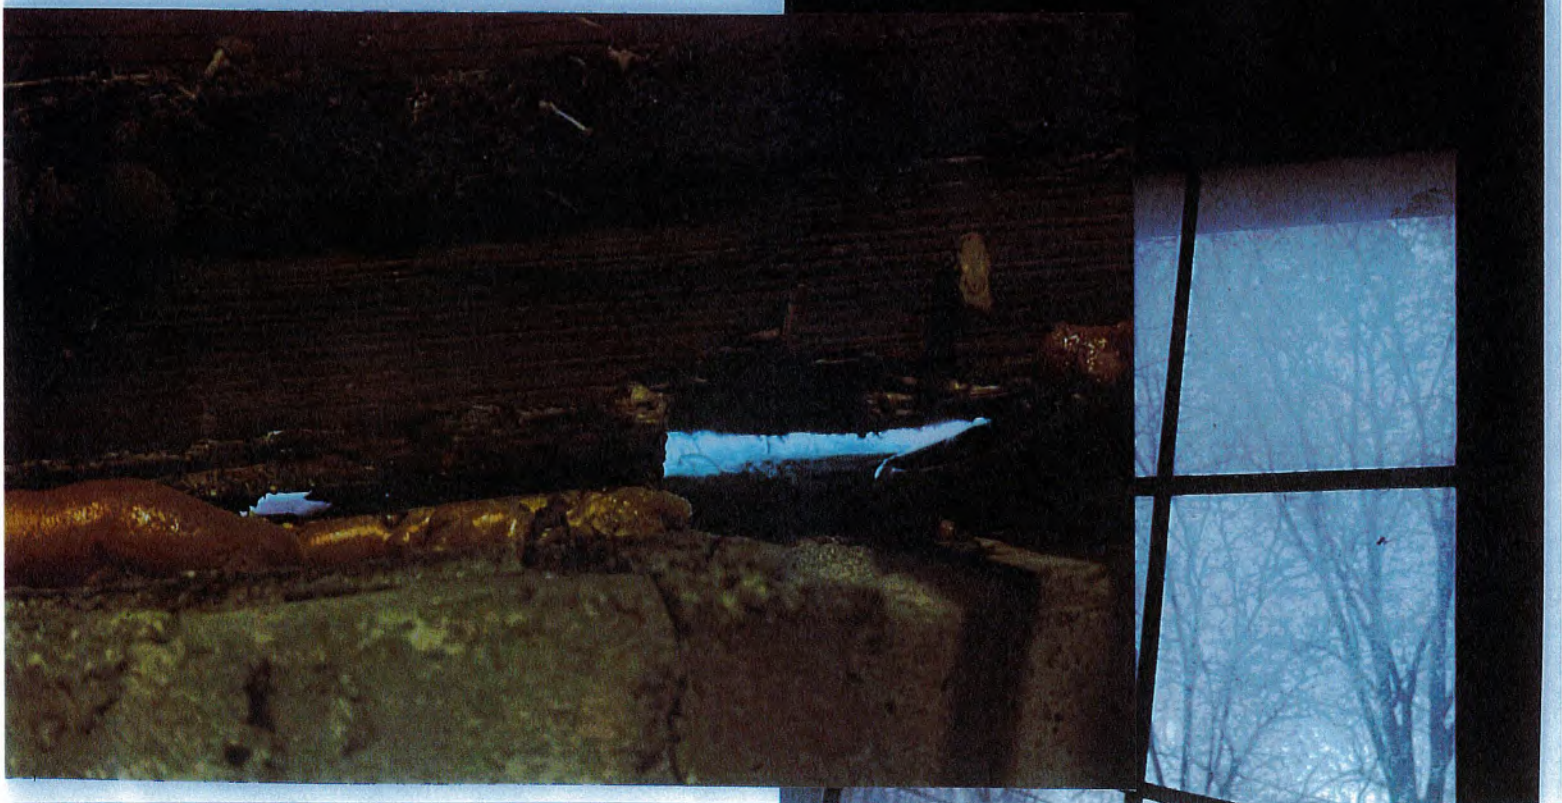
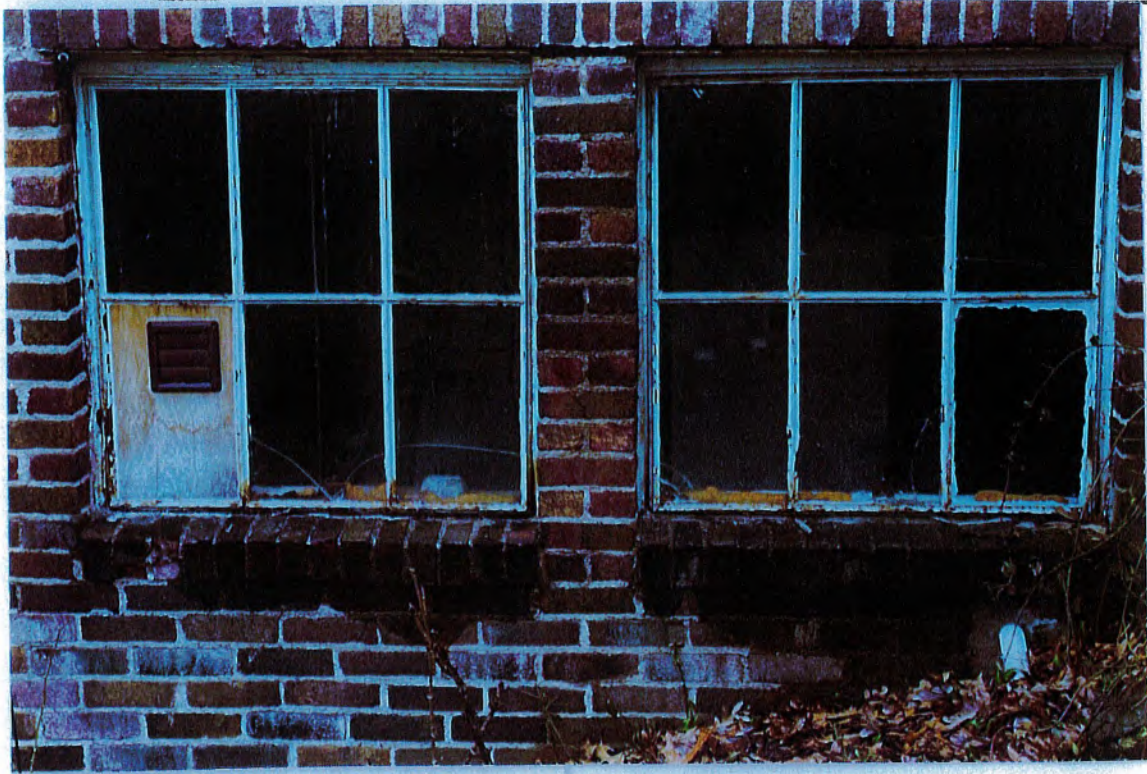
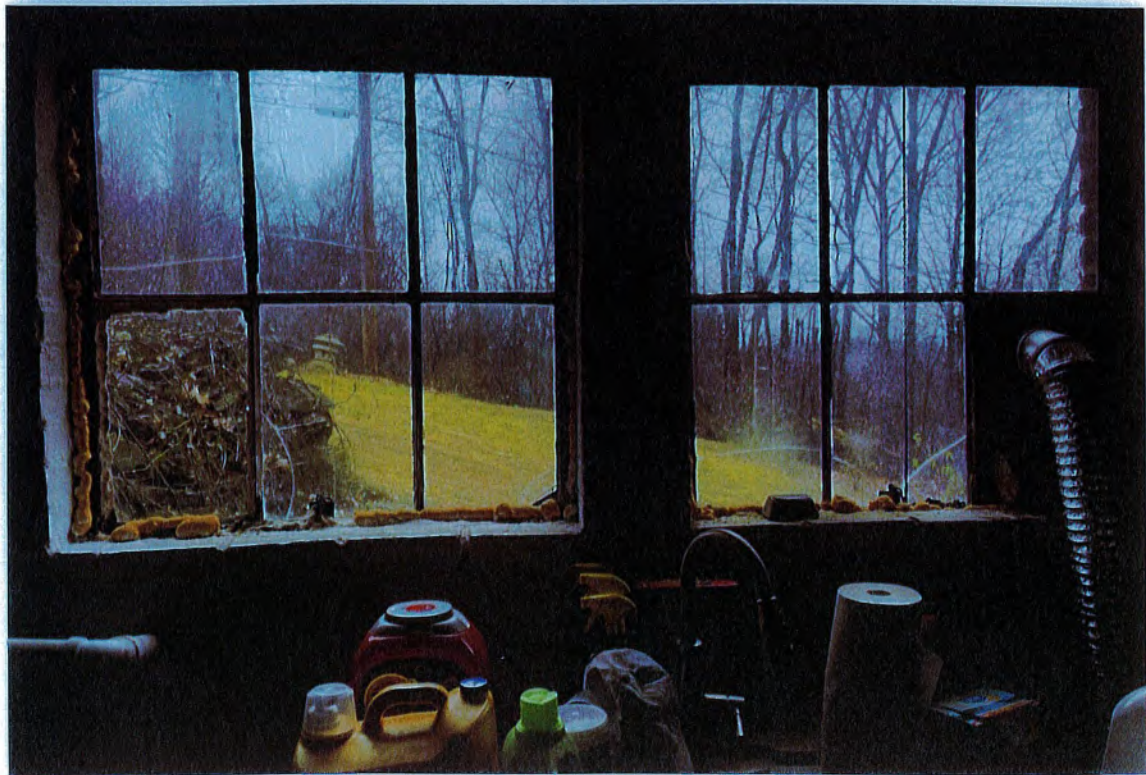
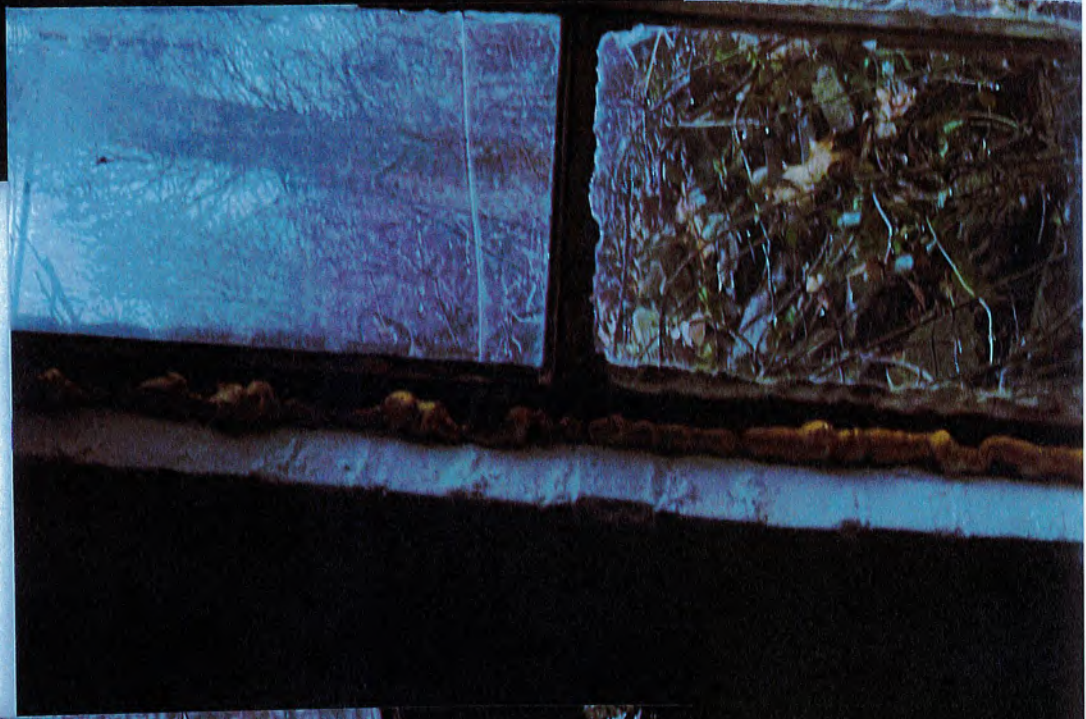
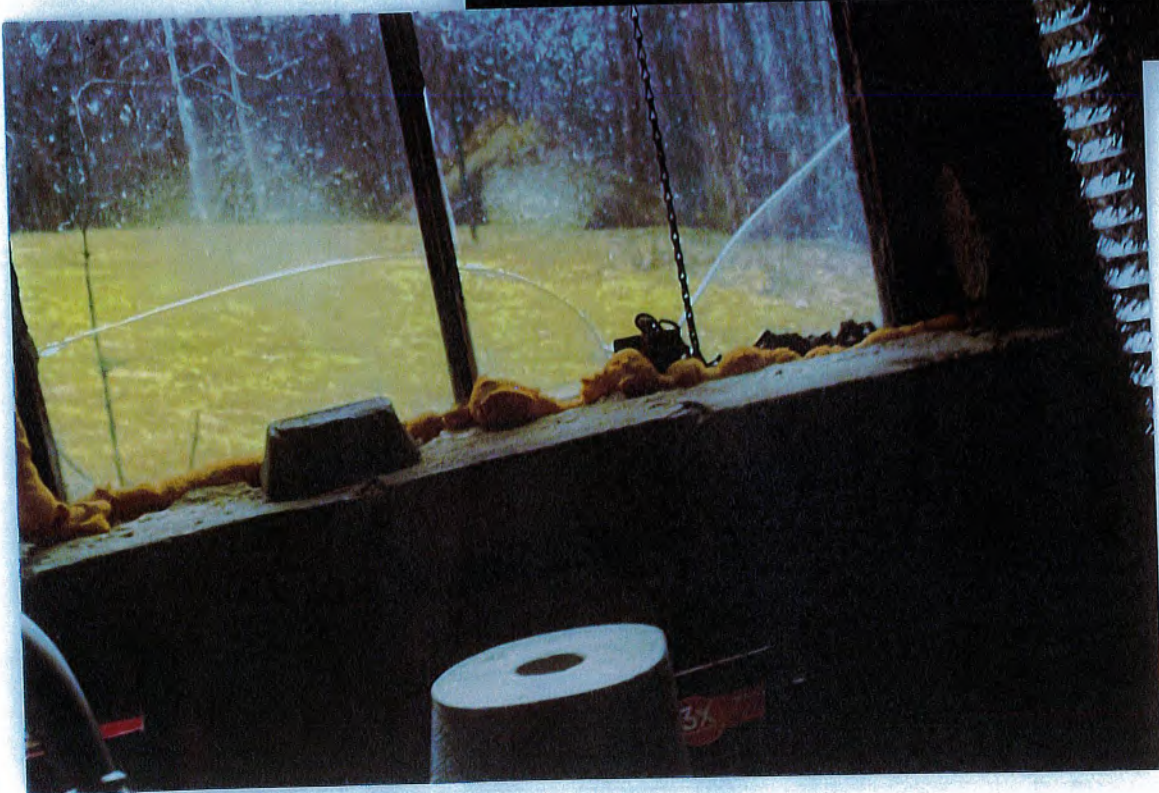
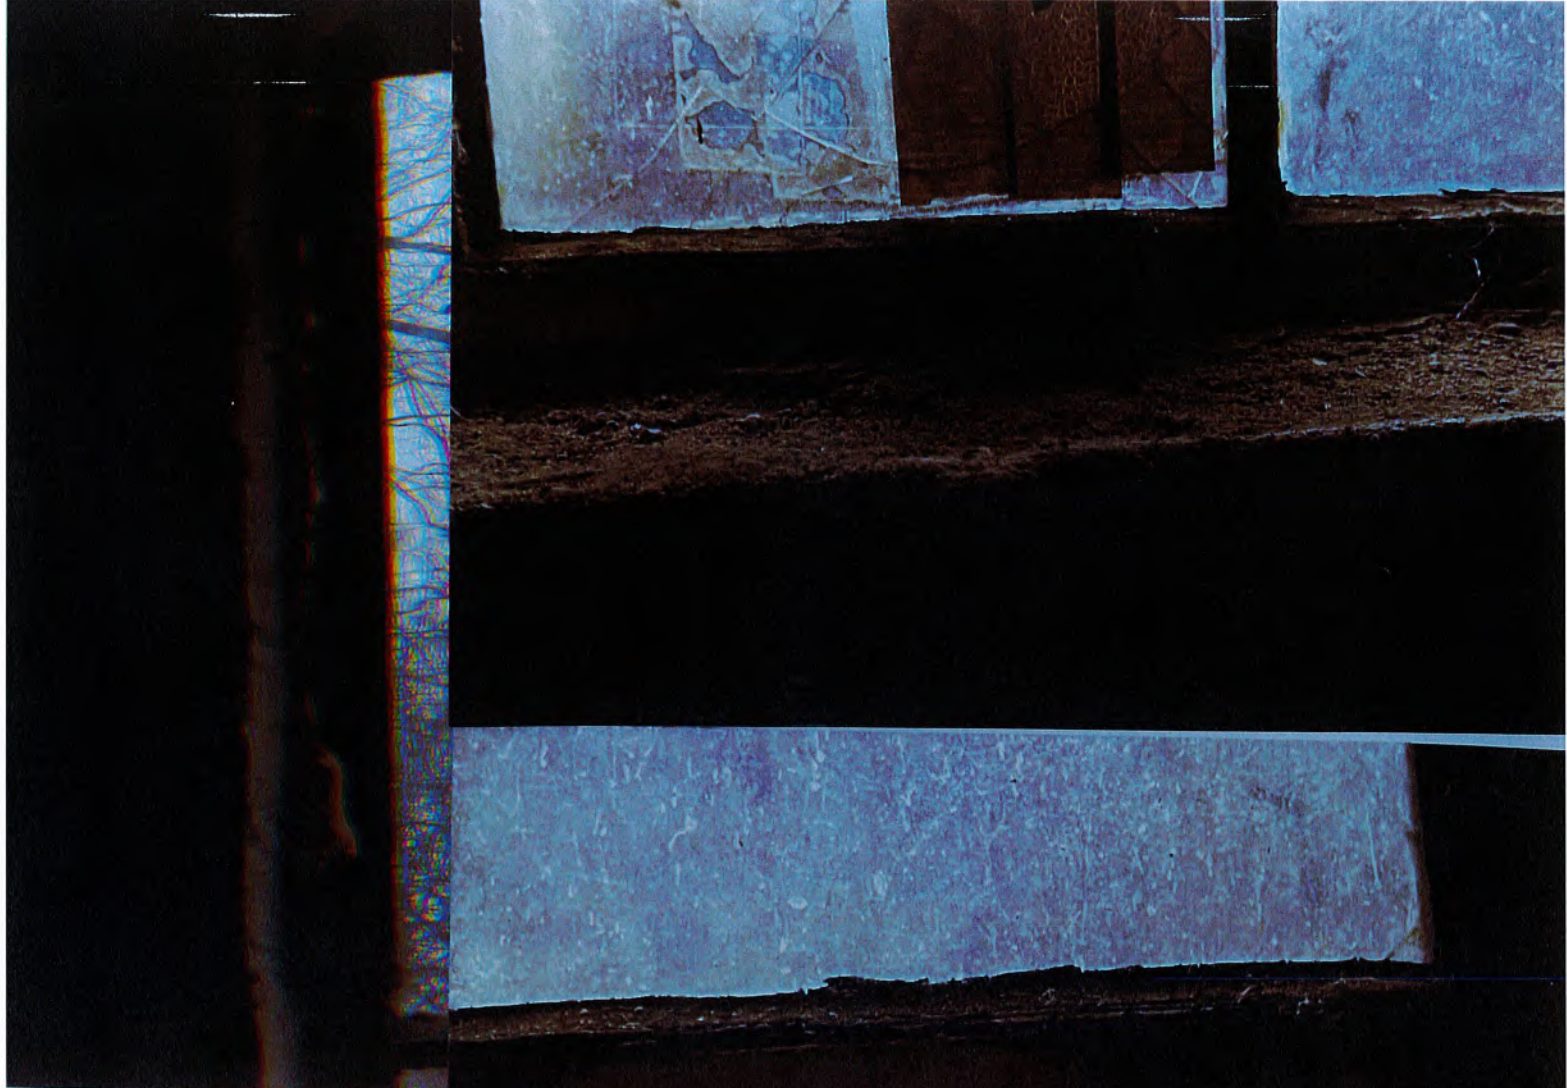
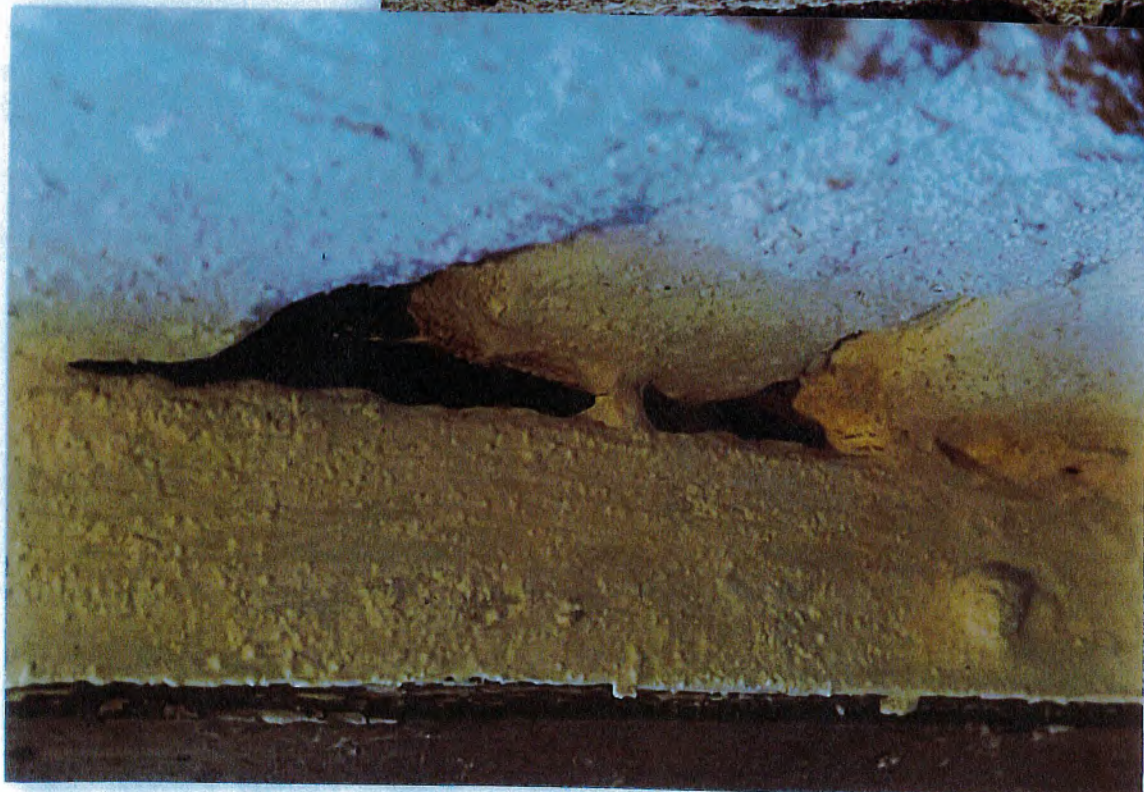
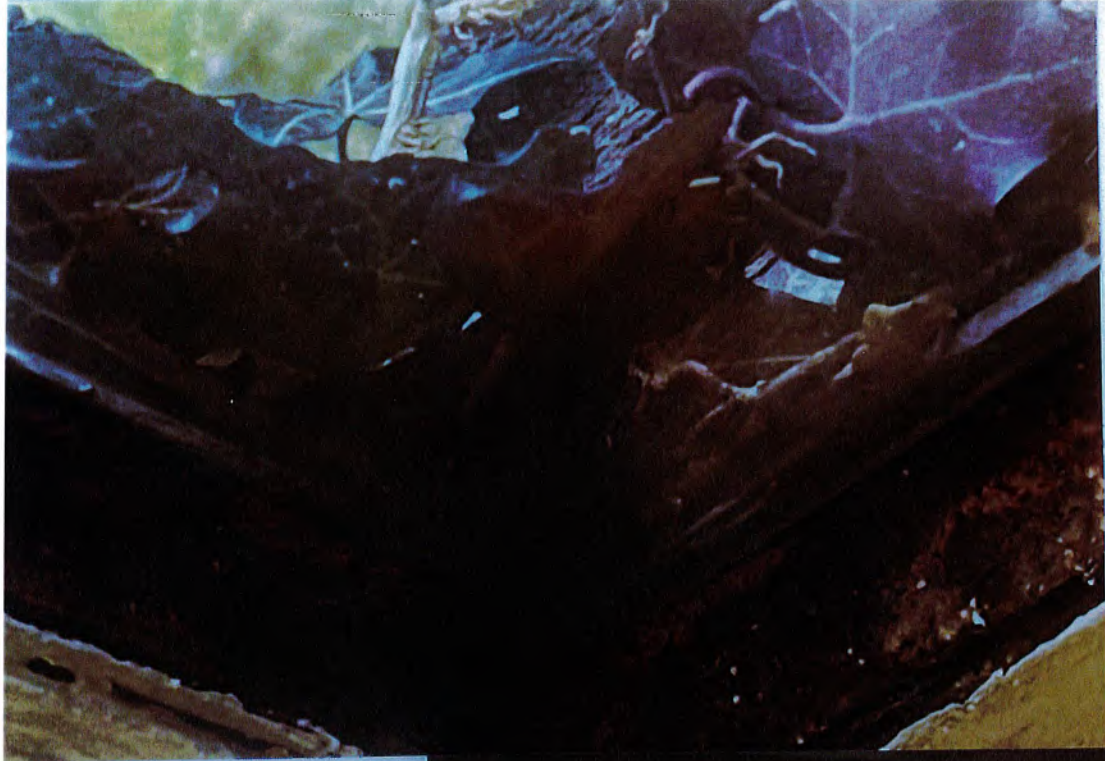
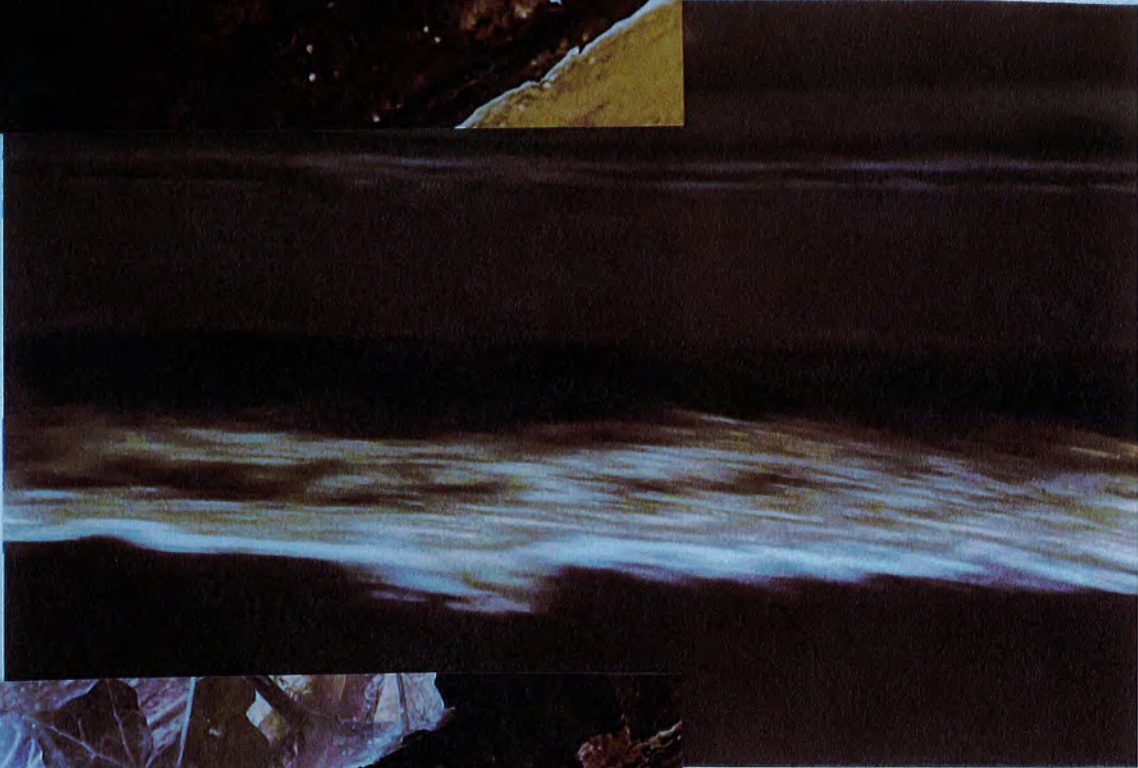
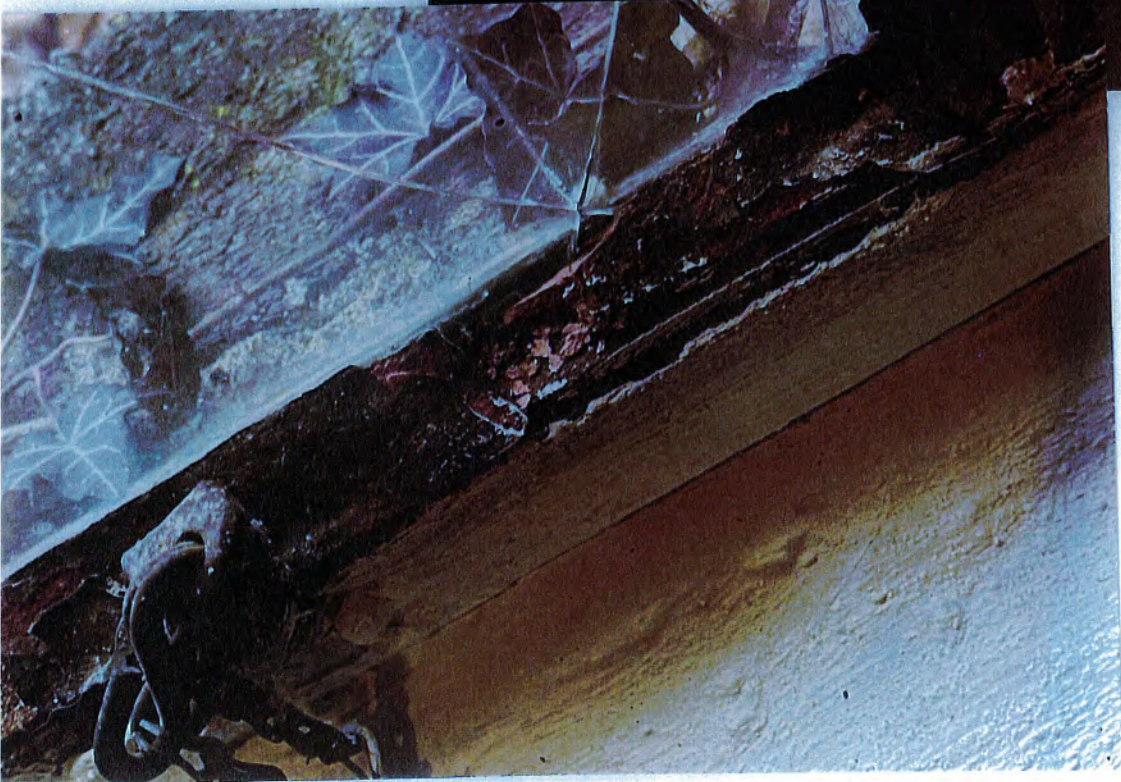
Basement/Garage

The basement is a little different. There are windows on all sides of the home. The landscaping prevented the pictures from showing most of them.

We have 5 steel hopper style windows that prior to the family moving in were in most cases buried under dirt, mulch, leaves, or style of vegetation. All the units are completely rusted in place. The windows are not salvageable. The steel is beyond saving and the units need to be replaced for the long term health of the home. There has been spray foam added over the years to try to stop leaks. The temporary fixes failed long ago. The units will be removed and replaced.

The laundry room is in much the same situation. These units are supposed to be fixed over awning. Doing that this time will mess up the look as in the old units the separation bar was $\frac{3}{4}$ " the new unit to do fixed over awning would give you a separation bar of 6.25". To combat this and still have airflow to the laundry room we will be doing 2 single hungs in place of the side by side units. This will still give us a larger separation bar, but of $1\frac{1}{2}$ " it will be much closer than other alternatives. These units, as you can see from the pictures, are being held together with spray foam. The laundry is creating moisture issues that the single pane units and the steel aren't able to handle at this point in time. We will solve the issues with the new fiberglass units.

The last units in the home are in the garage. These are the absolute worst units in the house. The frames are no longer attached to the home and are in danger of slipping off the brick and falling out completely. Over the years these units were drilled through, not maintained and then patched back together with spray foam. If we don't act soon on these units they will be sitting in the back yard in the very near future.
