**SYRACUSE  
LANDMARK  
PRESERVATION  
BOARD**

Certificate of Appropriateness Application

Case Number: CA-23-07

Re: Limited Removals Project at the Gustav Stickley House, Syracuse, NY

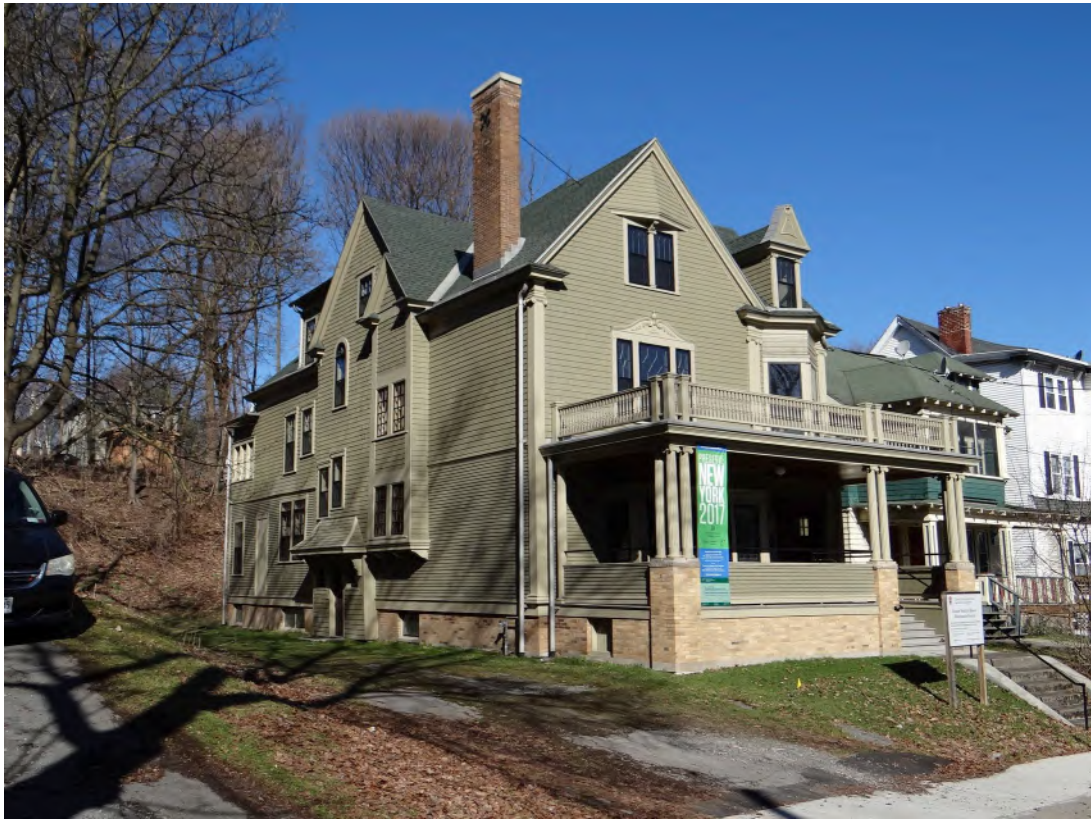
**GSH-2 Photo 1 / Existing Exterior.** Existing conditions. No removals or modifications proposed. 3/15/23, Crawford & Stearns, Architects.

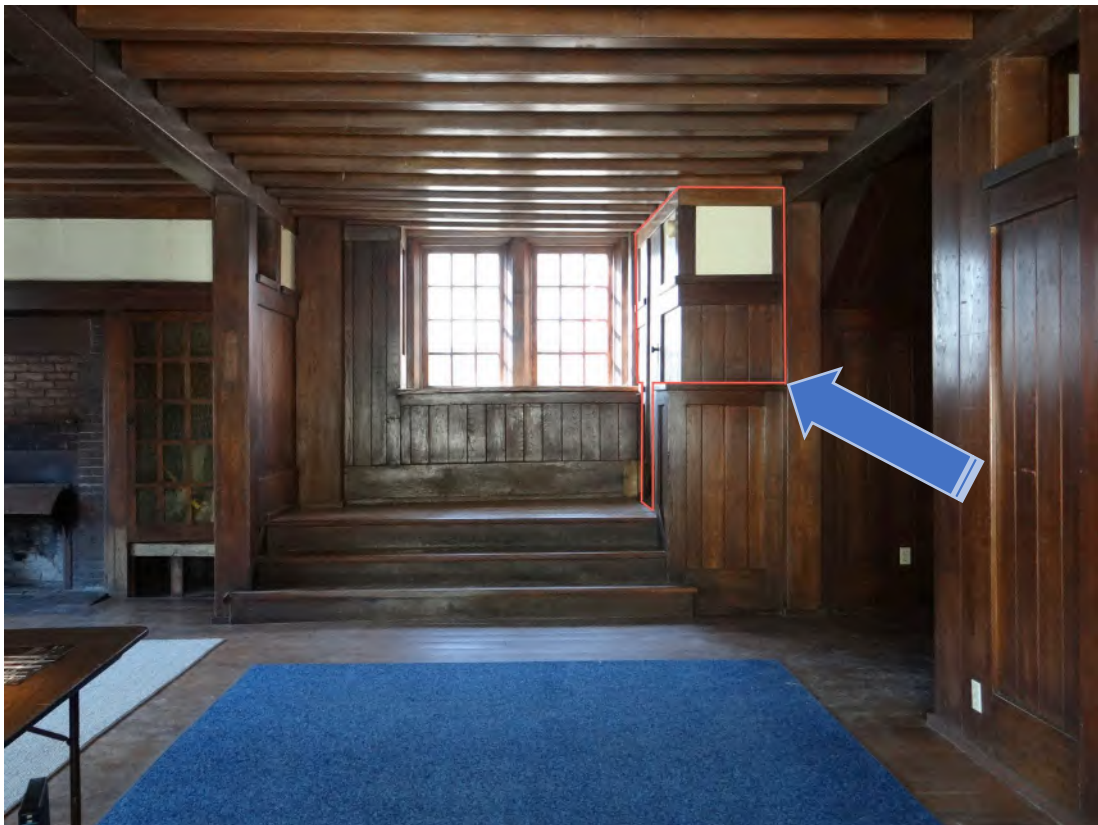
**GSH-2 Photo 2 / Stair Hall Looking South.** Photo shows the mid-1940s enclosure, outlined in red, built of salvaged chestnut from elsewhere in the house and gypsum wall board. This enclosure was constructed mid-1940s during the Wiles family occupancy. See also Photo 3. 3/15/23, Crawford & Stearns, Architects.

- a. **Front Stair at First & Second Floor:** The historic 1902 stair was enclosed as part of the renovations in the mid-1940s when the house was divided into apartments. We plan to carefully disassemble the enclosure at the First floor, salvaging any chestnut wood, and then remove the floor framing infill and plywood floor on the Second Floor. We expect to uncover evidence of the locations of the 1902 newel posts and railing locations. (Photos 2-7 and 10-11)

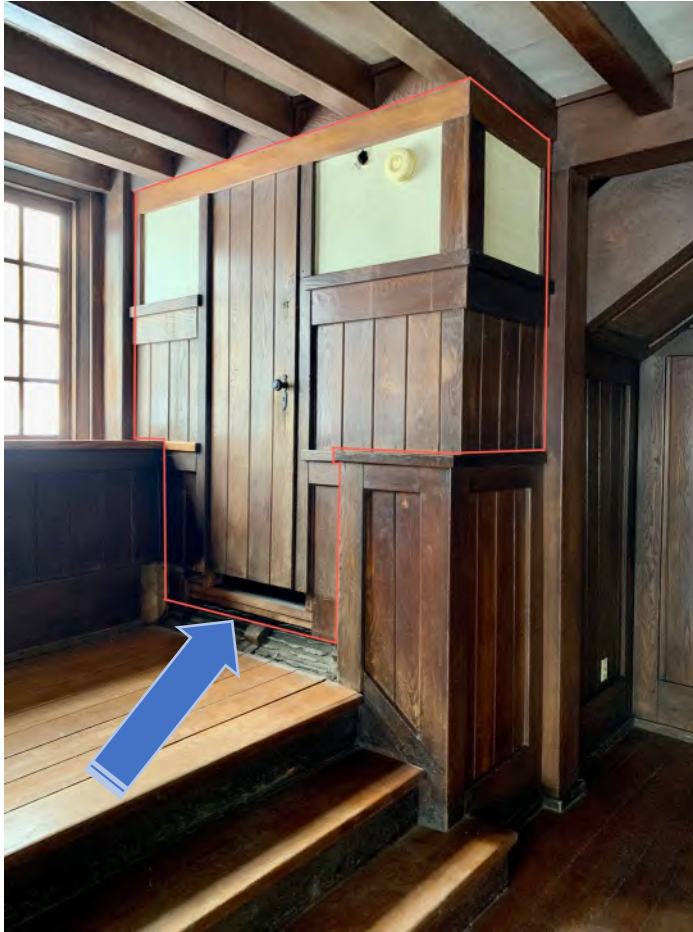
**GSH-2  
Photo 3  
Stair Hall Looking SW**

Photo shows the mid-1940s enclosure. This enclosure was constructed mid-1940s during the Wiles family occupancy. The enclosure and the infilled floor above the stair allowed the construction of a new kitchen in the 1940s for the Second Floor front apartment. See Photo 4 below for 1902 image of the open stair.

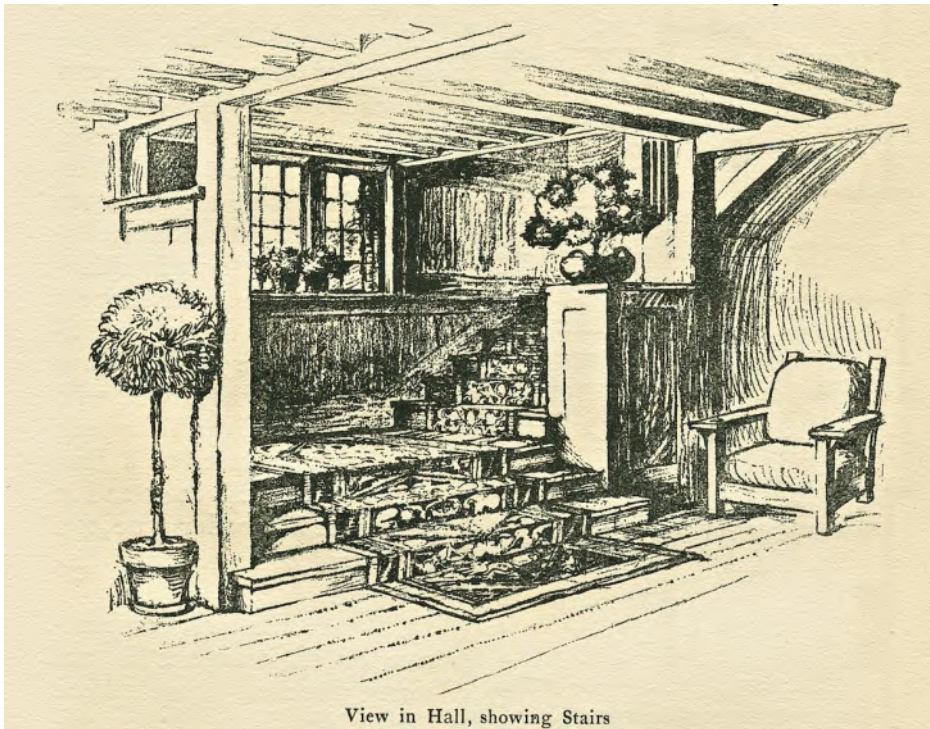
**GSH2 Photo 4 / First Floor – Stair Hall 1902**  
First Floor – Illustration of stair from Stickley's Craftsman Magazine showing the 1902 Gustav Stickley open stair case.

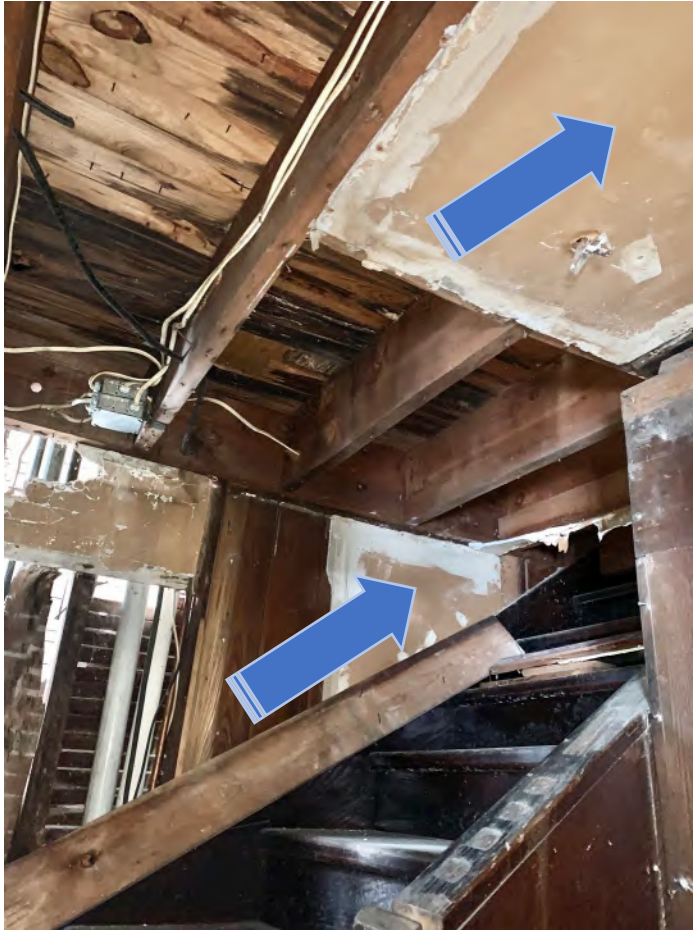
**GSH2 Photo 5  
First Floor  
Stair Enclosure**

Photo shows the historic 1902 Gustav Stickley chestnut stair (at bottom of photo) with mid 1940s modifications including gypsum wall board (with blue arrows to wall board) and infill floor framing above

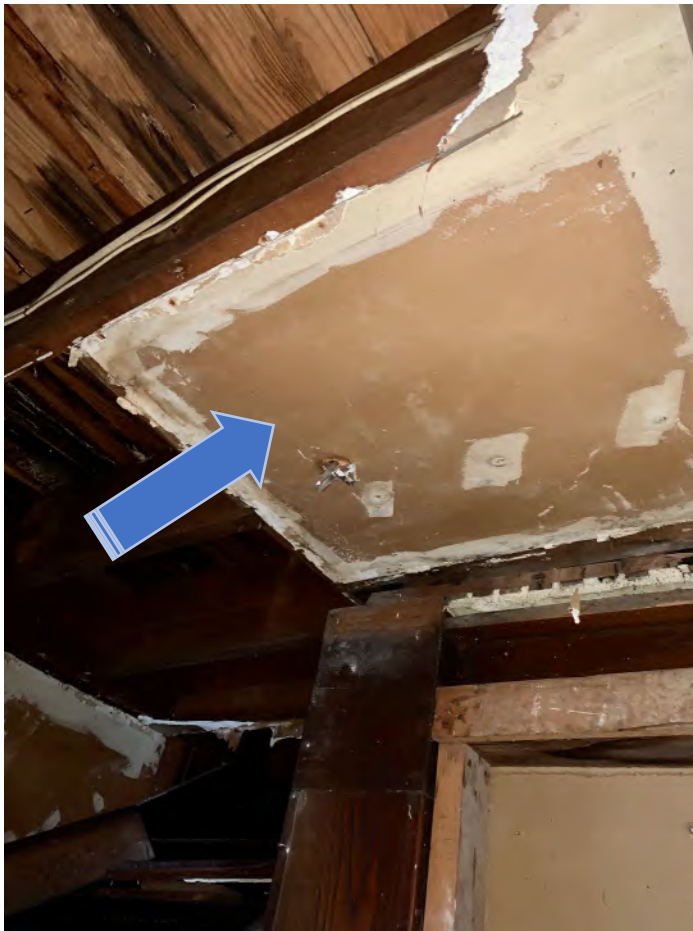
**GSH2 Photo 6  
First Floor  
Stair Enclosure at Ceiling**

Photo shows mid 1940s modifications including gypsum wall board and infilled floor framing at ceiling above with Stair Enclosure.

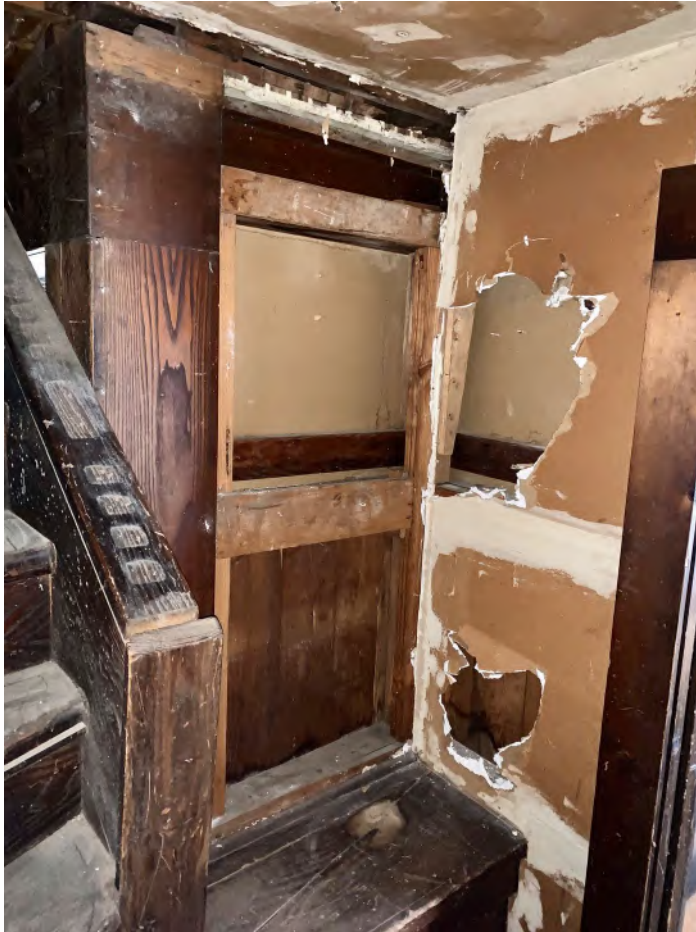
**GSH2 Photo 7**  
**First Floor**  
**Stair Enclosure**

Photo shows the historic 1902 Gustav Stickley chestnut stair (at left) with mid 1940s modifications including gypsum wall board at walls and ceiling.

Note evidence at left side of photo of the former spindle pattern on the bottom rail of the stair rail.

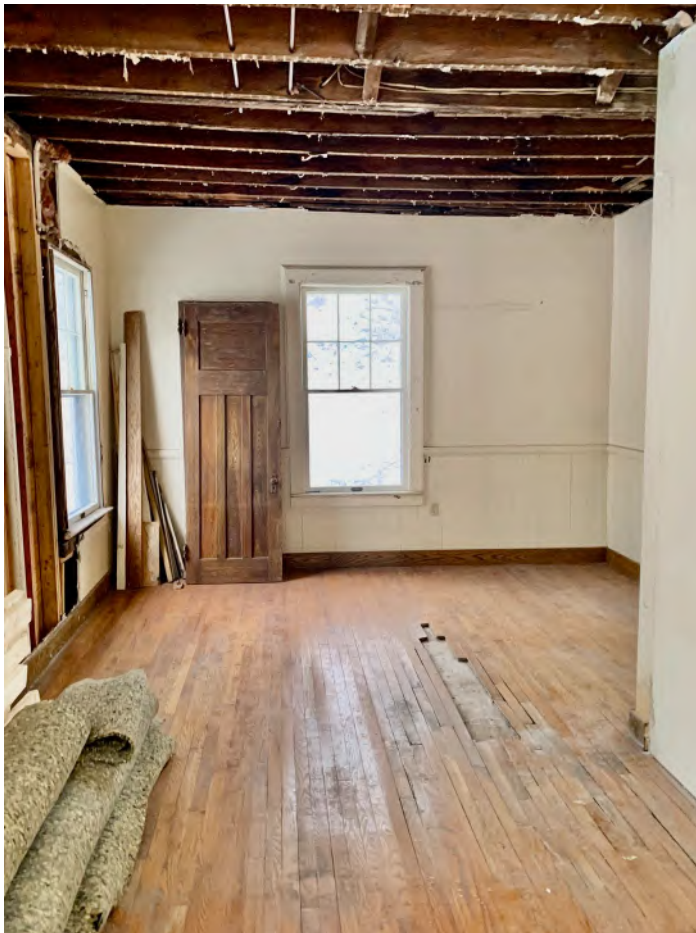
**GSH2 Photo 8**  
**First Floor**  
**Southwest corner**

Area of Kitchen from 1900-±1960s  
Bedrooms ±1960s-1990s

Photo shows 1985 hardwood flooring and plywood underlayment to be removed. If time allows we also propose removal of 1985 gypsum wallboard on walls.

All historic plaster, beadboard wainscoting, and trim to remain.

- b. **SW Room Flooring:** The hardwood floor was installed in the SW rooms in 1985. Proposed work includes removals of the tongue & groove hardwood floor and plywood underlayment. We expect to uncover evidence of historic partitions. (Photos 8-9)

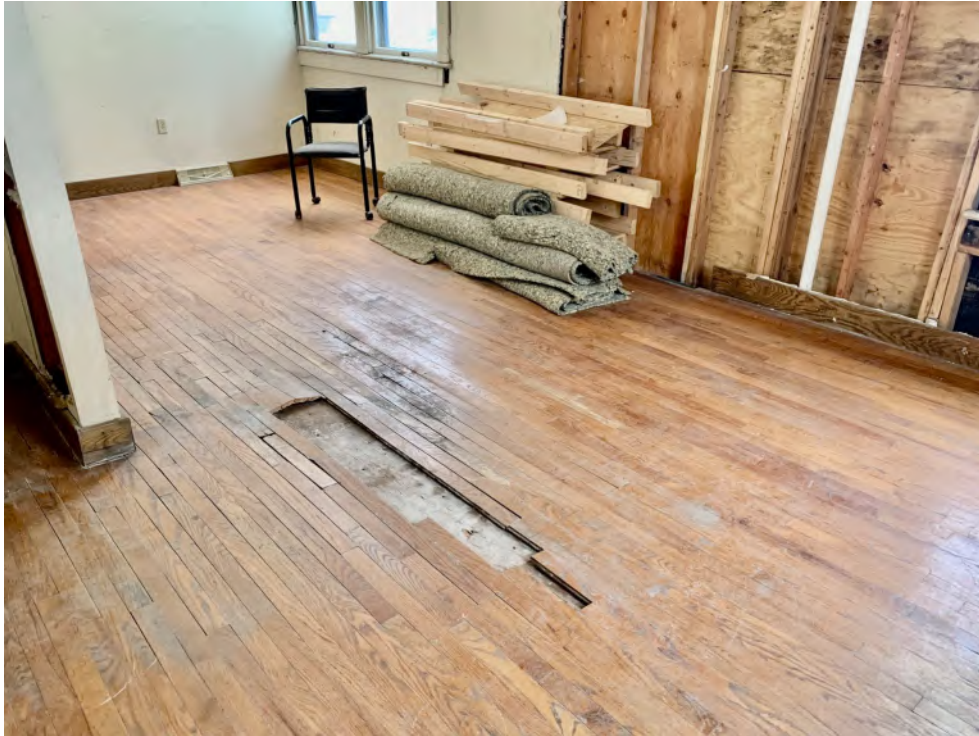
**GSH2 Photo 9 / First Floor / Southwest room.** Area of original Kitchen from 1900-±1960s / Bedrooms ±1960s-1990s. Photo shows 1985 hardwood flooring and plywood underlayment to be removed.  
2/3/23, Crawford & Stearns, Architects.

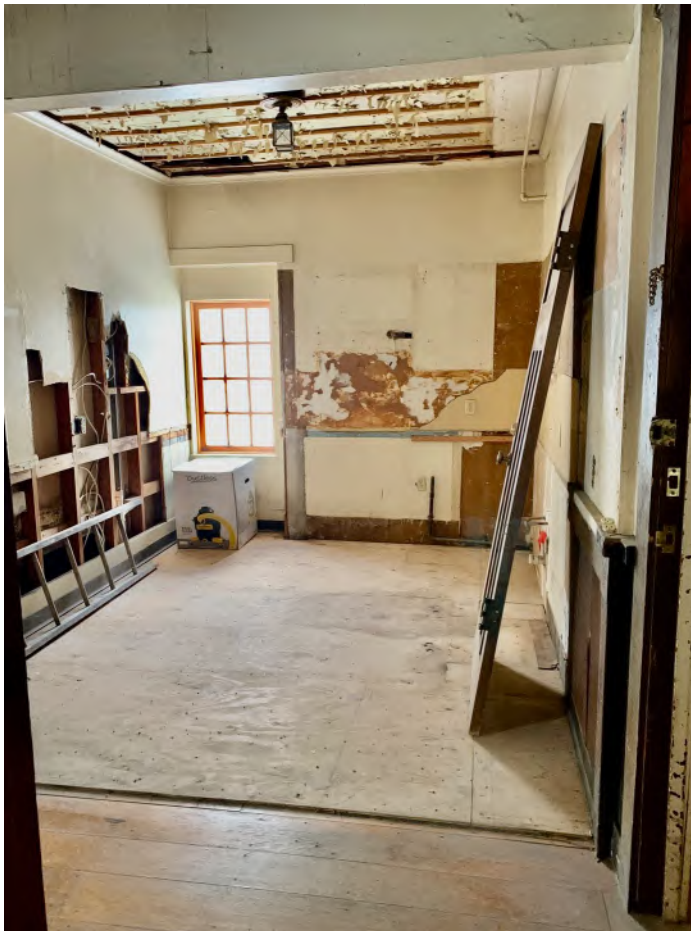
**GSH2 Photo 10  
Second Floor  
Stair Hall**

Photo shows the area of the historic 1902 stair that was framed over in mid-1940s so the room could be used for an apartment kitchen. Historic risers and treads exist under the plywood and floor framing. Removals of plywood and floor framing will most likely reveal the original locations of the newel posts and handrails. No cabinetry or appliances remain from the subsequent 1985 kitchen renovations. See Photo 11 for evidence of former half newel on south wall.

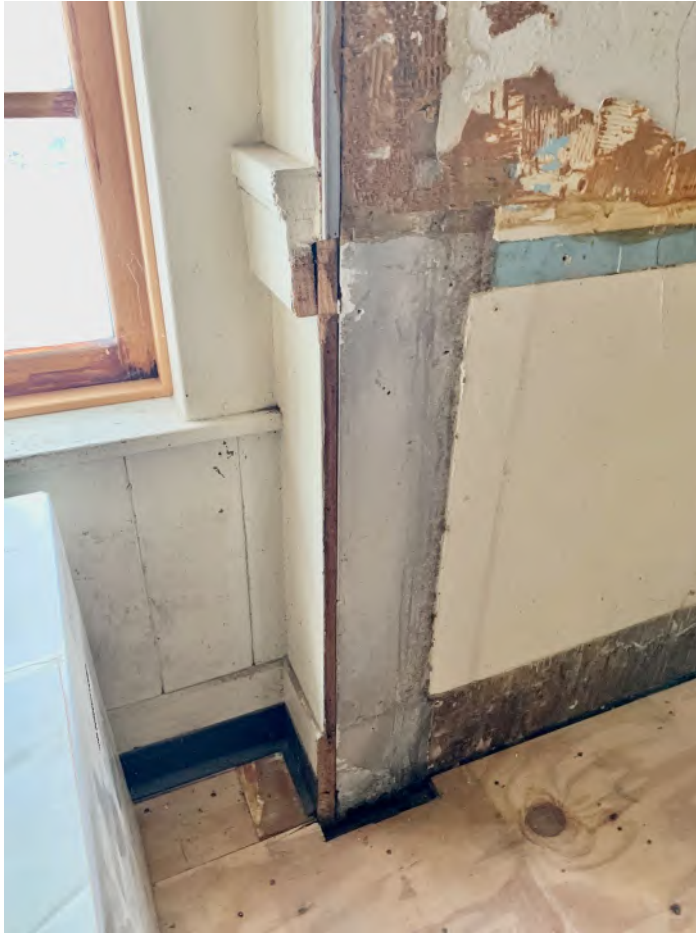
**GSH2 Photo 11**  
**Second Floor**  
**Stair Hall**

South Wall Half Newel location

Photo shows evidence of the historic 1902 half newel at Second Floor Stair Hall.

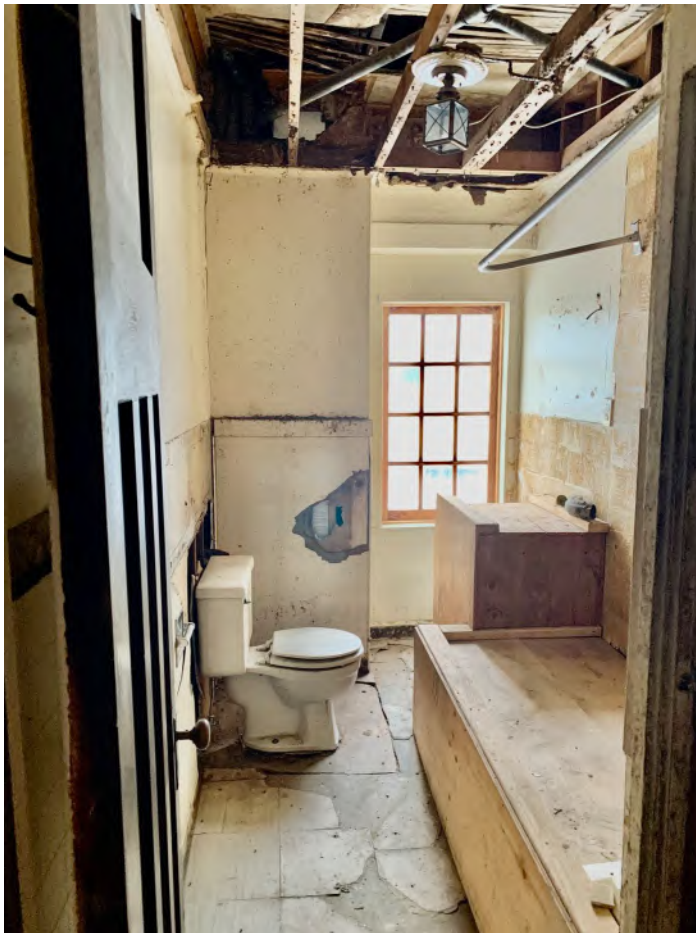
**GSH2 Photo 12**  
**Second Floor**  
**Front Bathroom**

Photo shows Front Second Floor Bathroom which was added by the Wiles Family during their ownership. Removal scope to include flooring, and drywall removals at walls and ceiling.

- c. **Second Floor Bathroom:** The Front Second Floor Bathroom is severely deteriorated due to previous water damage and the removals scope includes removals of wall, ceiling and floor finishes, and if time allows the non-historic toilet fixtures. (Photo 12)

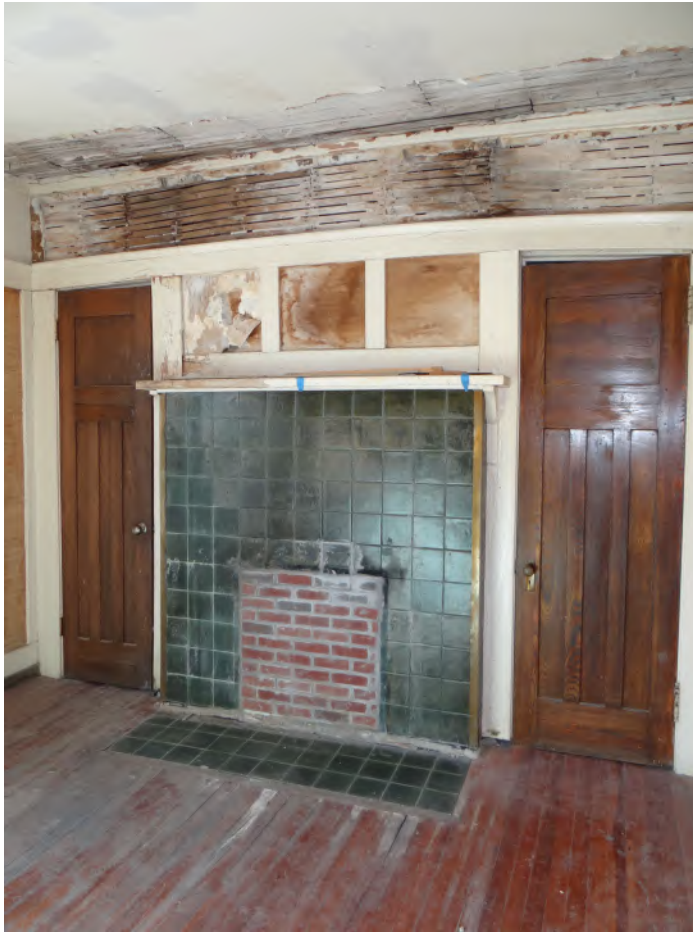
**GSH2 Photo 13**  
**Second Floor**  
**Stickley Study**

Photo shows South wall of the Stickley Study. Proposed scope includes careful removal of c.2000 brick infill of fireplace. All historic tile and trim to remain.

- d. **Fireplace Infill:** Proposed scope includes the careful removal of the c.2000 brick infill of the two fireplaces at the Second Floor. All historic tile and trim will remain. Once the brick is removed we will be able to scope the hearth and interior side walls. (Photos 13-16)

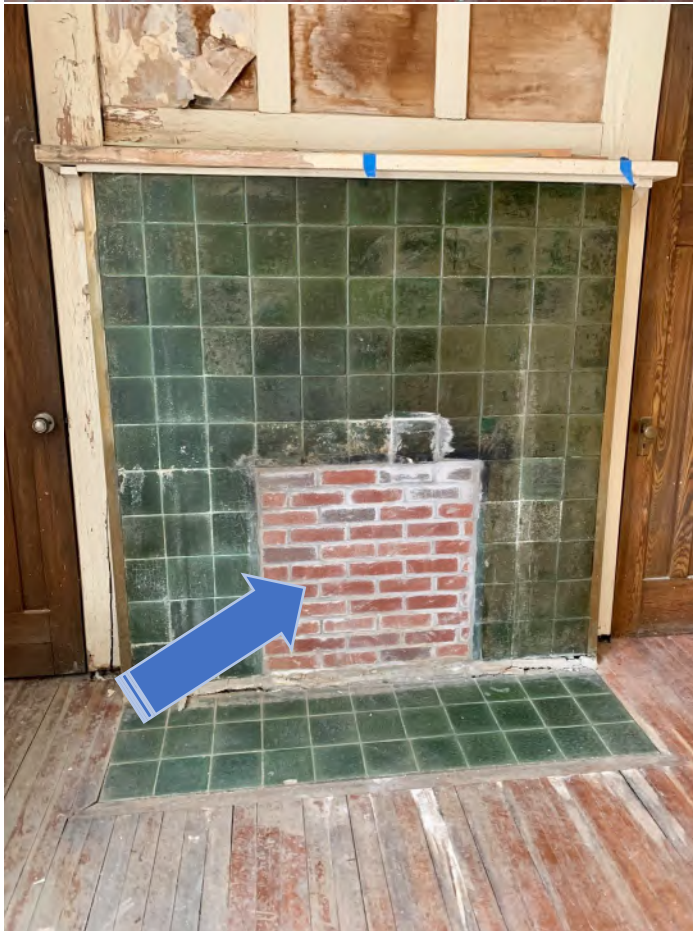
**GSH2 Photo 14**  
**Second Floor**  
**Stickley Study**

Photo shows fireplace of Stickley Study. Proposed scope includes careful removal of c.2000 brick infill of fireplace. All historic tile and trim to remain.

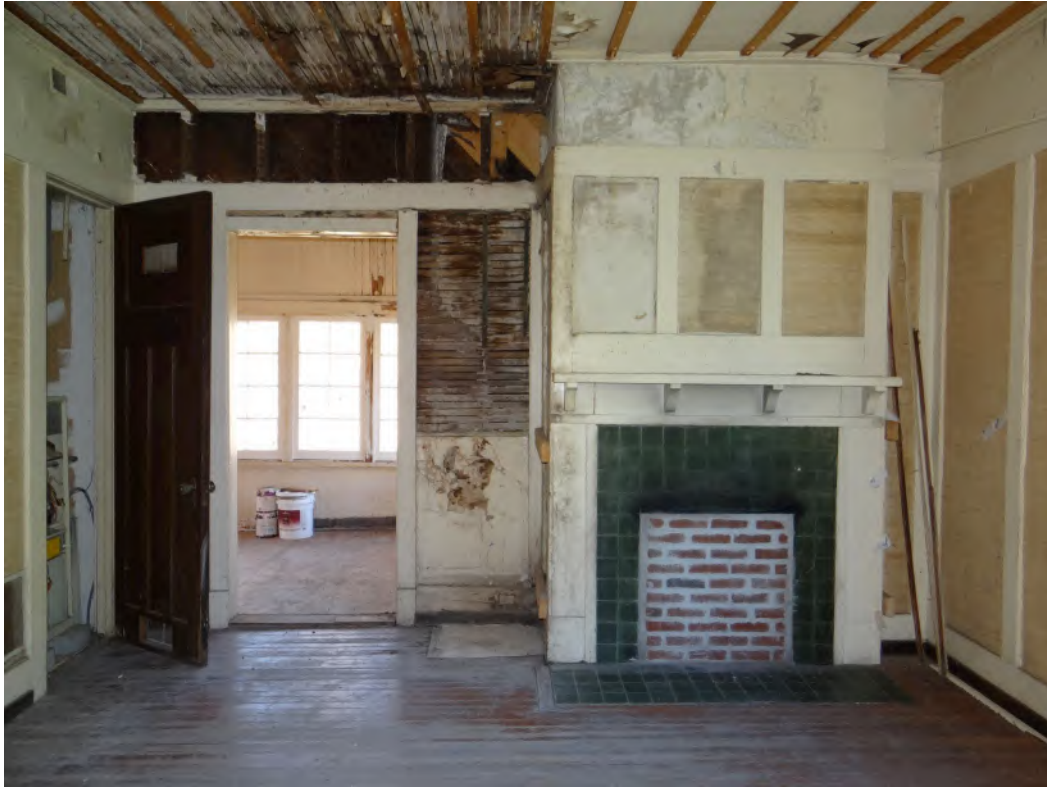
**GSH2 Photo 15 / Second Floor / NW Bedroom.** Photo shows fireplace in NW Bedroom. Proposed scope include careful removal of c.2000 brick infill of fireplace. All historic tile and trim to remain. 2/3/23 / Crawford & Stearns, Architects

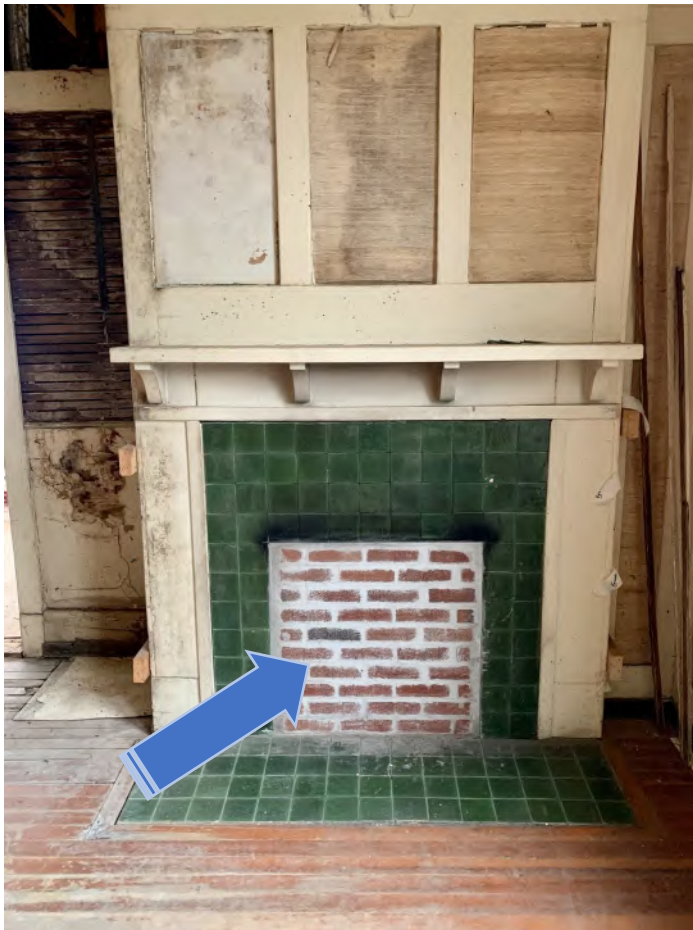
**GSH2 Photo 16  
Second Floor  
NW Bedroom**

Photo shows detail of fireplace in NW Bedroom. Proposed scope includes careful removal of c.2000 brick infill of fireplace. All historic tile and trim to remain.

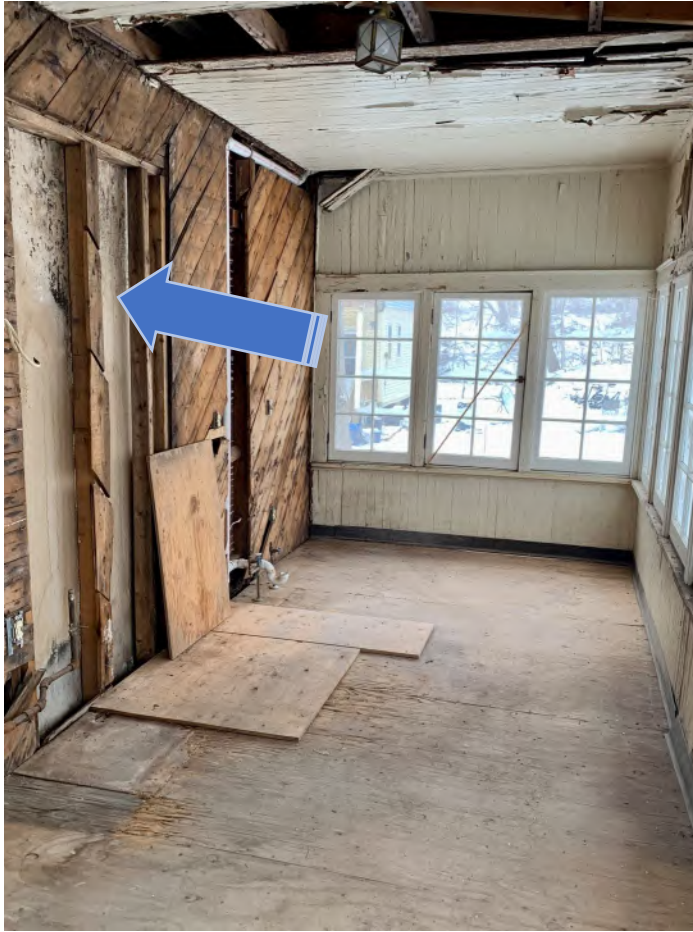
**GSH2 Photo 17**  
**Second Floor**  
**Sleeping Porch**

Photo shows view looking south in Sleeping Porch. Scope includes removal of drywall enclosure (at far left of photo) at former door location.

- e. **Sleeping Porch Door (former):** Proposed project includes careful removal of the 1985 infill of a former door from the SW Bedroom to the sleeping porch. (Photos 17-19)

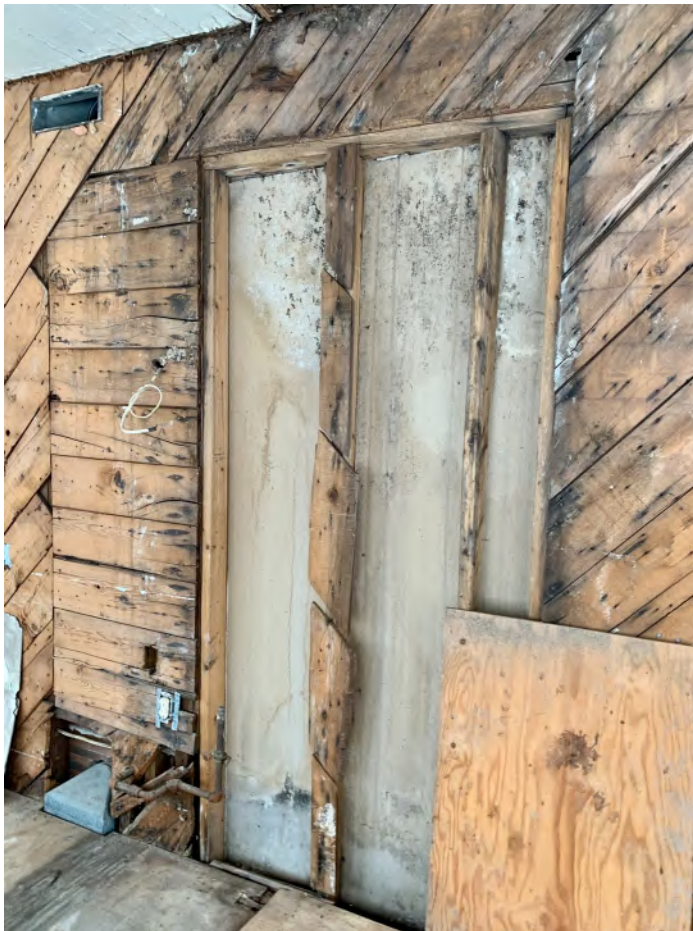
**GSH2 Photo 18**  
**Second Floor**  
**Sleeping Porch**

Project scope includes removal of drywall enclosure at former door location.

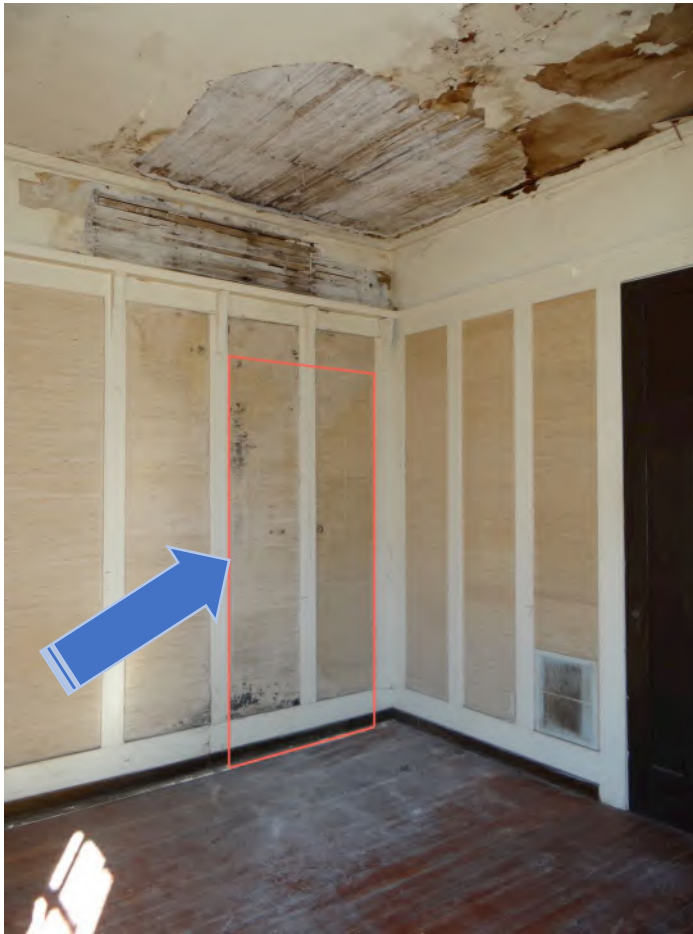
**GSH2 Photo 19**  
**Second Floor**  
**SW Bedroom**

Project scope includes removal of drywall enclosure at former door location, shown in red outline.

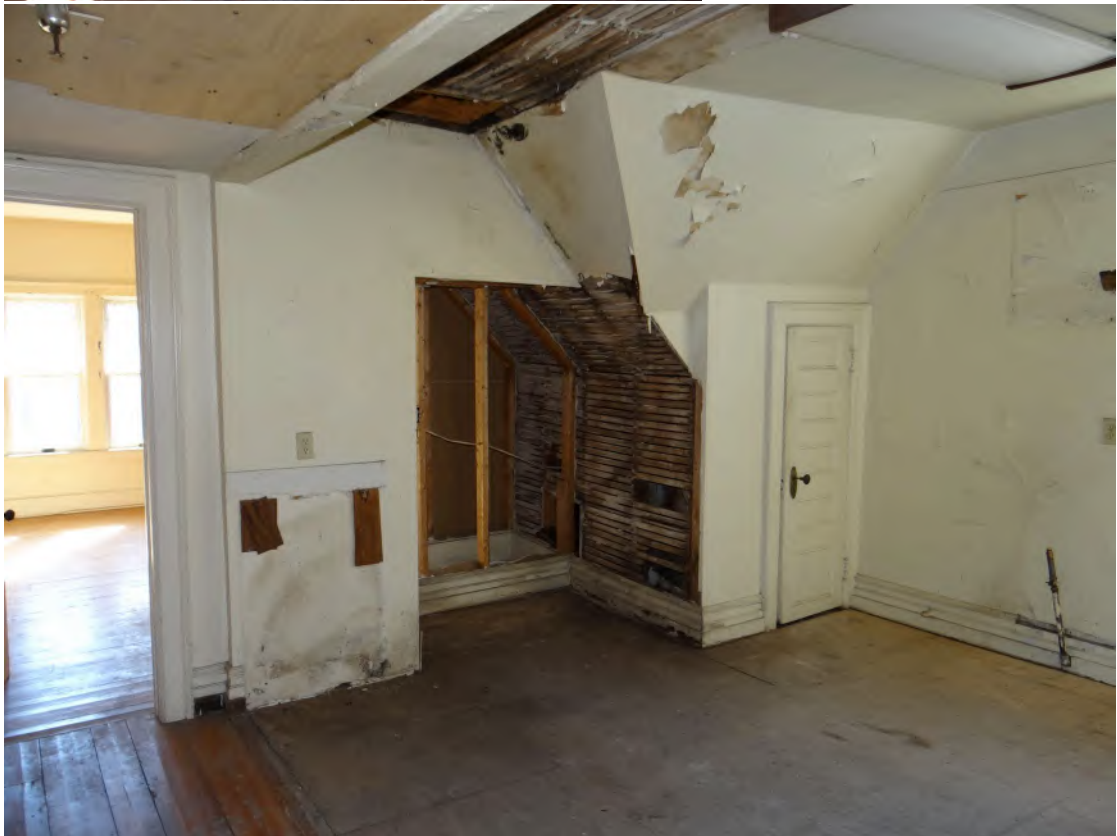
**GSH2 Photo 20 / Third Floor – Former Apartment Kitchen.** Proposed removals include 1985 plywood floor to allow for examination of historic flooring and framing conditions and removal of 1985 drywall to allow for examination of the roof framing conditions. 2/3/23 / Crawford & Stearns, Architects

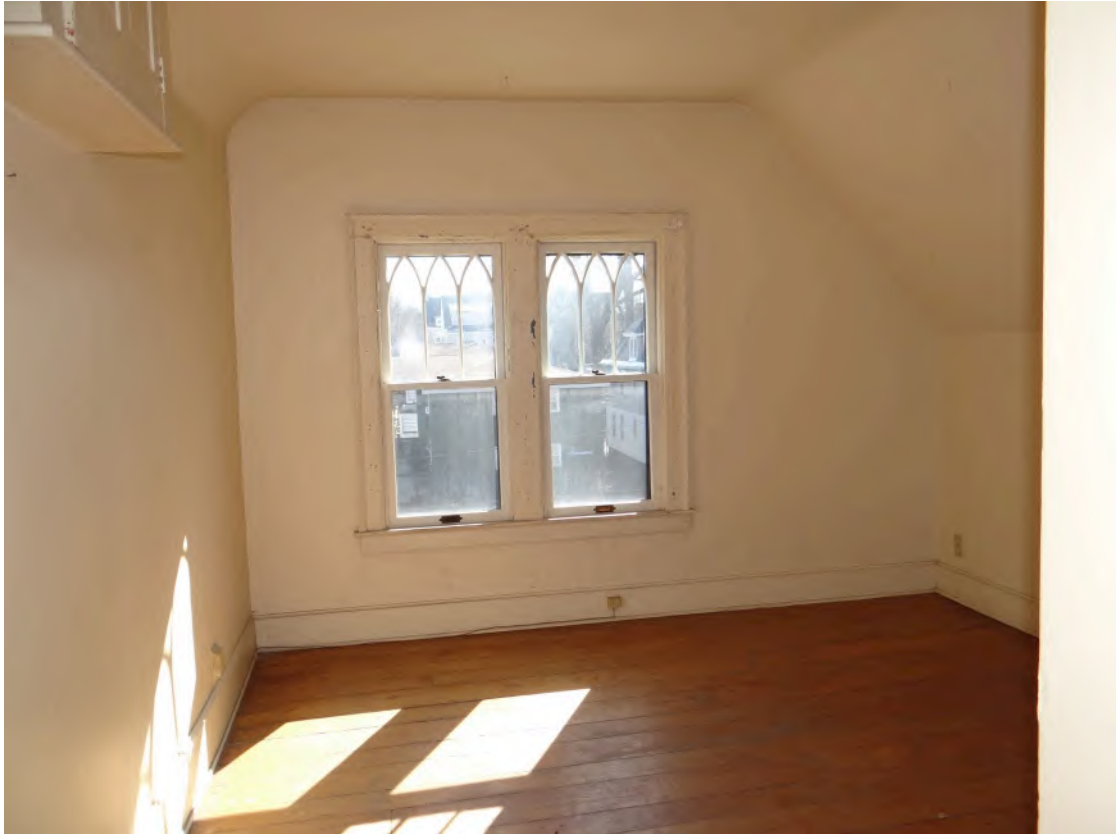
**GSH2 Photo 21 / Third Floor – SE Bedroom**

No removals proposed. 2/3/23, Crawford & Stearns, Architects.

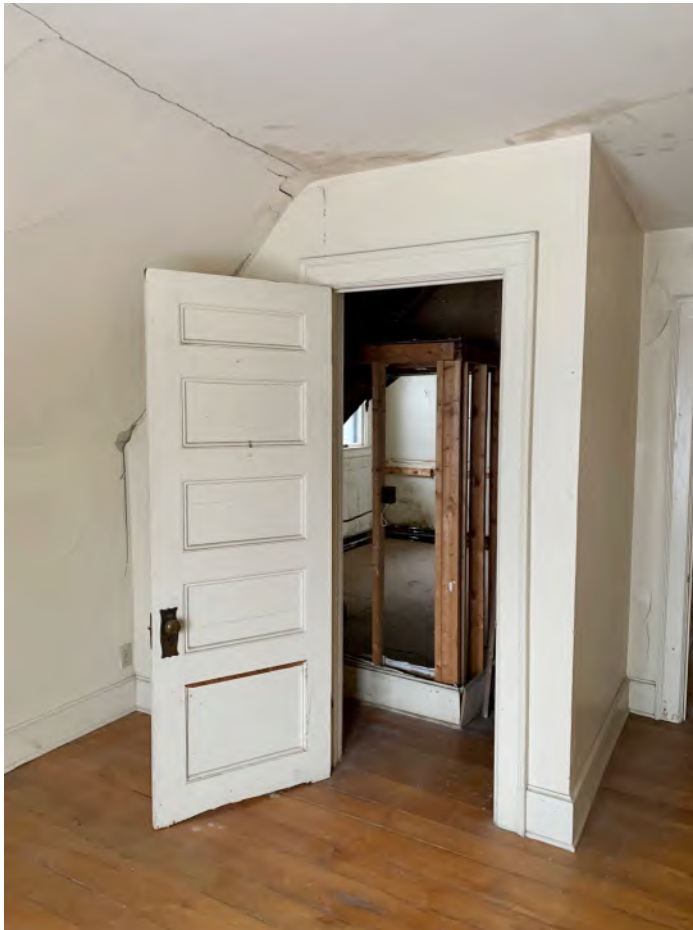
**GSH2 Photo 22  
Third Floor – SE Bedroom**

Proposed removal of the 1985 closet enclosure. Contractor to salvage the c.1900 trim, door, and baseboard.

This closet enclosure was constructed during the 1985 renovations (based on evidence of modern 2 x 4 framing and drywall). The door and trim were relocated from elsewhere on the Third Floor at that time. Door was cut down in 1985.

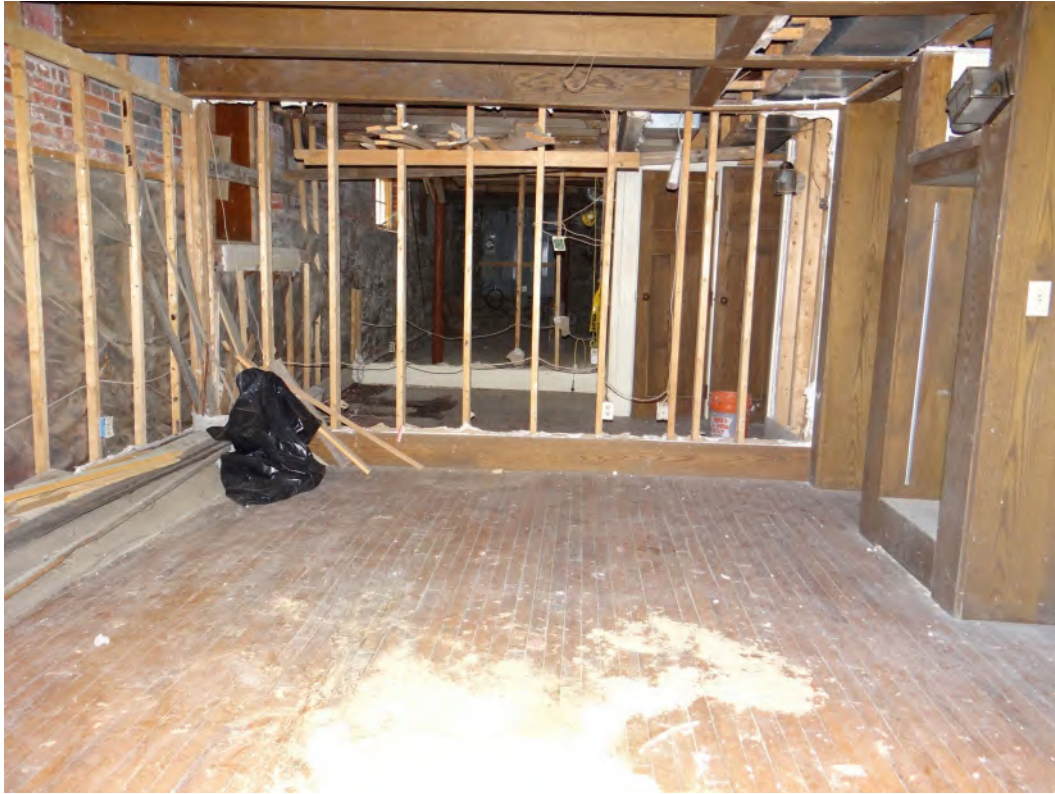
**GSH2 Photo 23 - Basement Apartment**

All finishes shown in the above photo date to the 1985 renovation of the Basement Apartment. Proposed removals include 1985 flooring, plywood, plastic underlayment, deteriorated drywall, false beams, and trim. 2/3/23, Crawford & Stearns, Architects.

- f. **Third Floor:** Proposed project includes removal of a limited amount of drywall, a section of 1985 wall framing, and a small area of plywood flooring at Third Floor. Early door and trim to be salvaged, tagged, and labeled. Refer to floor plans. Once drywall is removed we will be able to scope the roof framing. (Photos 20 and 22)
- g. **Basement Apartment:** Proposed project includes removal of various 1985 apartment finishes in the rear portion of the Basement including drywall, flooring, plywood underlayment, trim, false beams, and limited amounts of 1985 framing. Once these items are removed we will be able to appropriately scope this area for the future renovation project. (Photos 23 and 25)

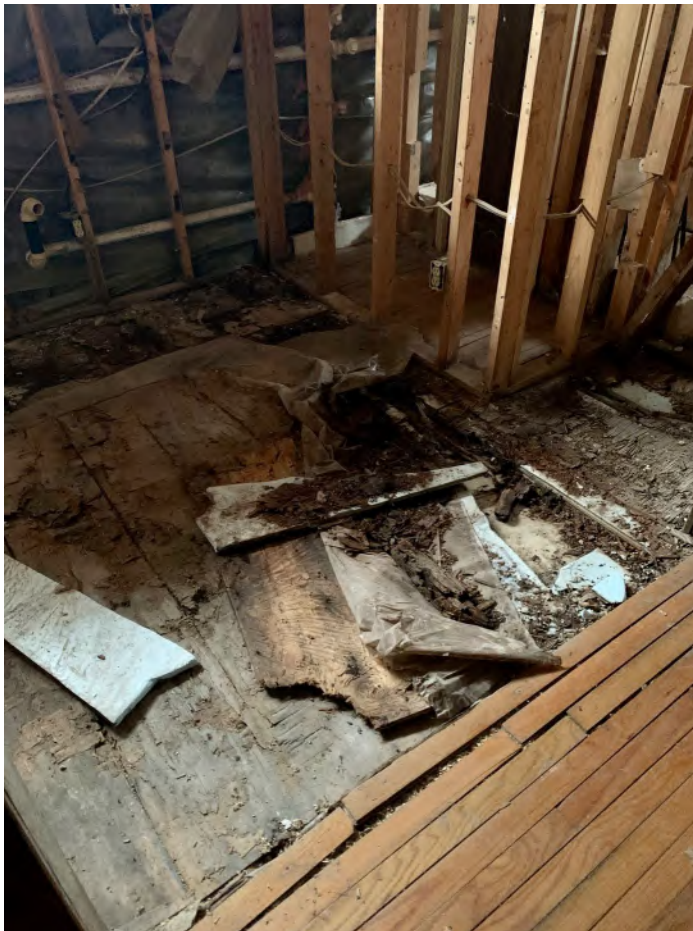
**GSH2 Photo 24  
- Basement Apartment**

All finishes shown in the photo date to the 1985 renovation of the Basement Apartment. Proposed removals include 1985 flooring, plywood, and plastic underlayment.

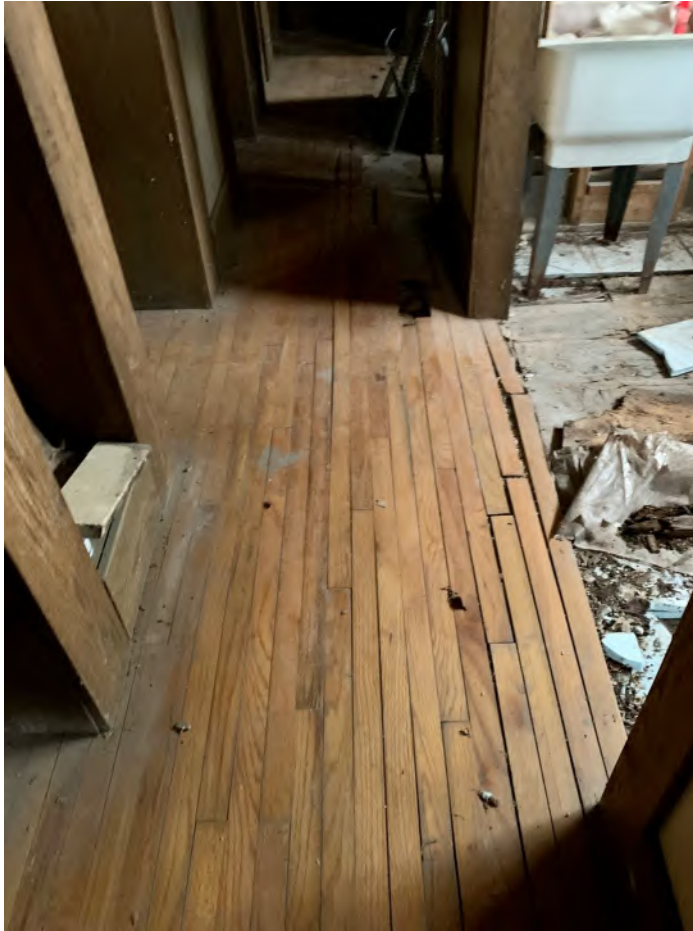
**GSH2 Photo 25**  
**- Basement Apartment**

All finishes shown in the above photo date to the 1985 renovation of the Basement Apartment. Proposed removals include 1985 flooring, plywood, plastic underlayment, deteriorated drywall, and 1985 period trim.
