SKANEATELES LAKE AND WATERSHED 2021 ANNUAL REPORT VOLUME XLVII

CITY OF SYRACUSE
DEPARTMENT OF WATER
WATER QUALITY MANAGEMENT

SKANEATELES LAKE AND WATERSHED
2021 ANNUAL REPORT

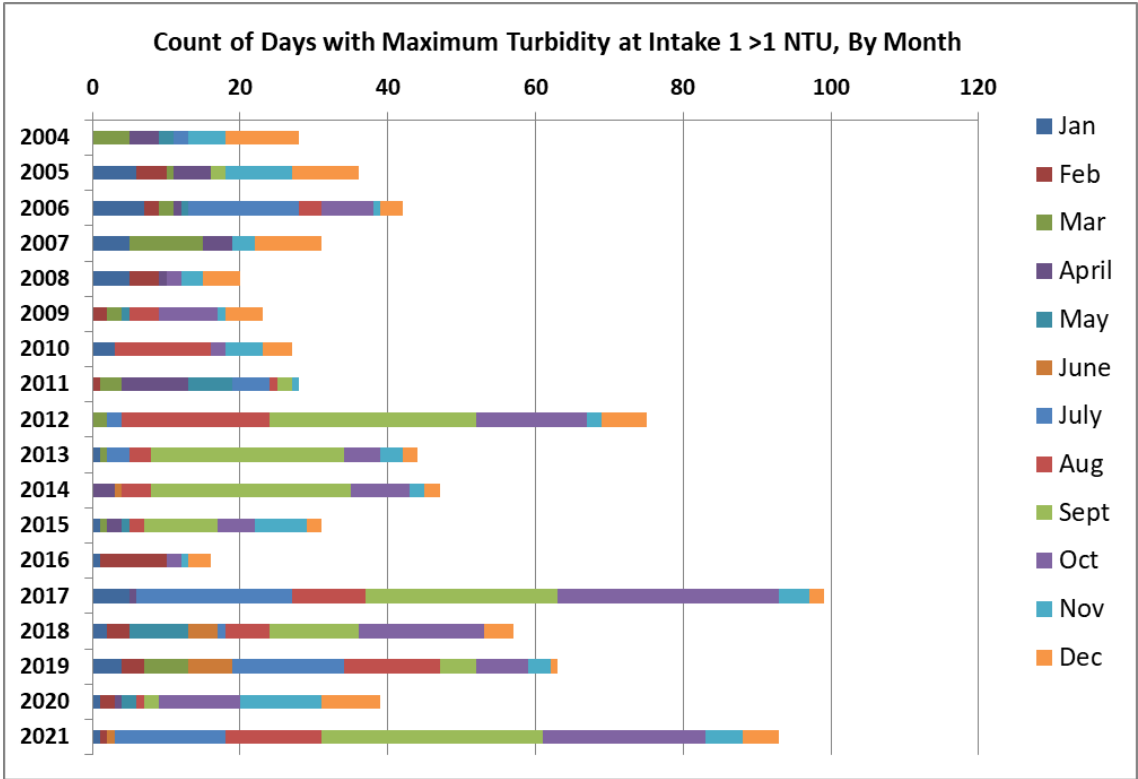
Figure 4 Monthly Counts of Turbidity >1 NTU at Intake 1, 2004-2021

Both Table No. 9 and Figure 4 display the variance in the number of days with maximum turbidity greater than 1 NTU at Intake #1 from 2004 to 2021.

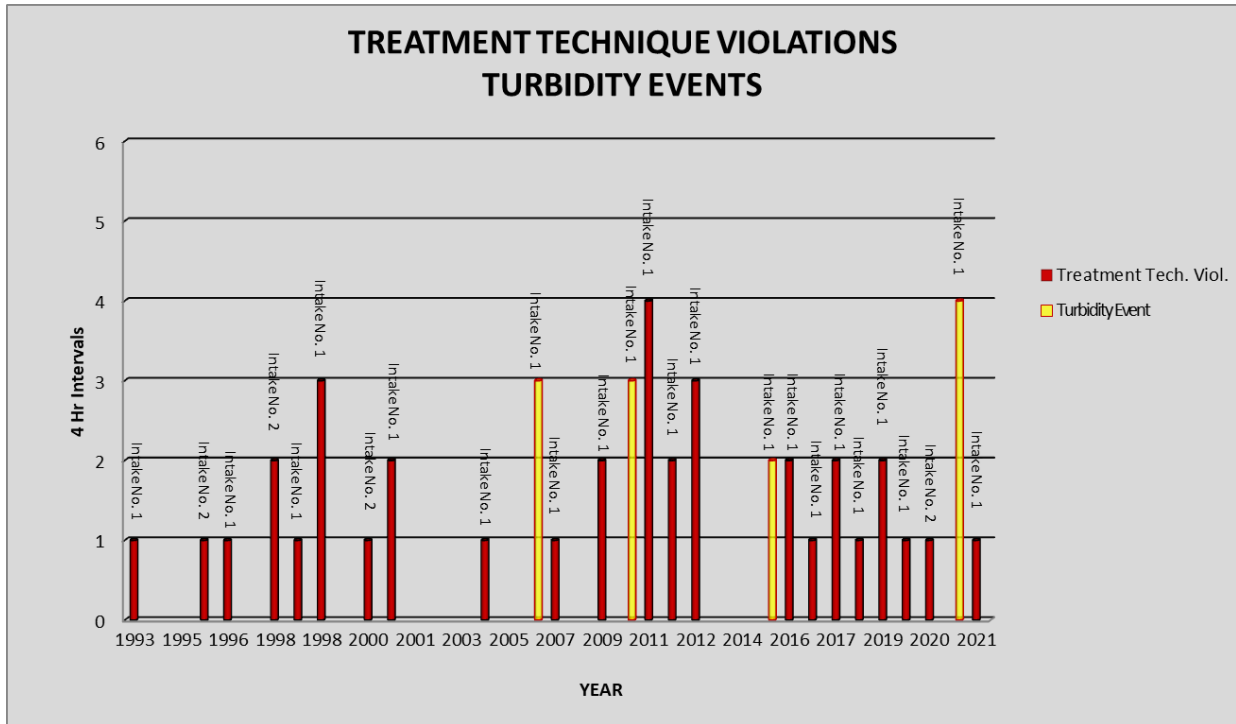
Figure 5 1993-2021 Treatment Technique Violations vs Turbidity Events

Refer to Figure 5 for TTV and Turbidity Events recorded since 1993. The Graph also displays the frequency that 5.0 NTU was exceeded (on a four hour interval) during the TTV or Turbidity Event. Note that in 2015, a Turbidity Event consisted of only two 5.0 NTU exceedances at four hour intervals, comparable to numerous TTV's illustrated in the graph. However, because the intervals were at 8:00 pm and 12:00 am, the conditions set forth by NYSDOH defining a Turbidity Event (a series of consecutive days during which at least one turbidity measurement each day exceeded 5 NTU) was attained.

One TTV was recorded in 2021. The violation occurred on November 12, on Intake #1. Sustained southerly winds resulted in an elevated turbidity recording of 10.73 NTU at 12:00 am. Intake #2 was completely closed by 11:20 pm on November 11 and re-opened on November 14. There were no Turbidity Events in 2021.

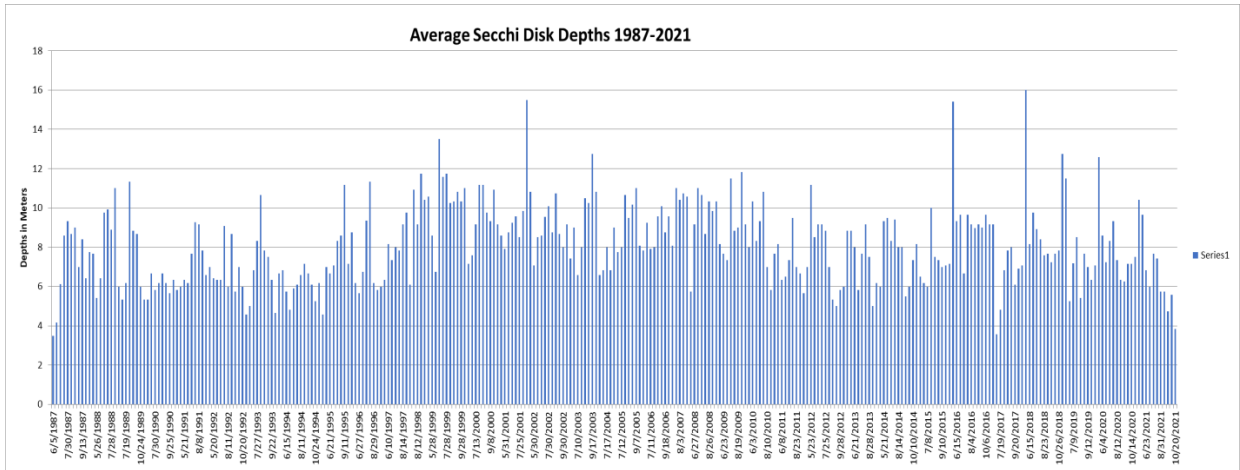
Figure 6 Average Secchi Disk Depths 1987-2021

It is noted that the Secchi disk readings effected during the station sampling can be somewhat skewed. Since stations I and VIII are shallow, the readings are consistently at the bottom, which is usually about six meters (as a result, samples are collected at about 15 feet). It is not unusual for the readings at the other Stations to vary considerably throughout the spring, summer and fall seasons, ranging from four to 16 meters (Figure 6). Figures 7 and 8 illustrate Secchi disk depth variations between early summer and fall. References to Secchi disk readings in the narrative below are adjusted, i.e., only Stations II – VII were used to determine averages.

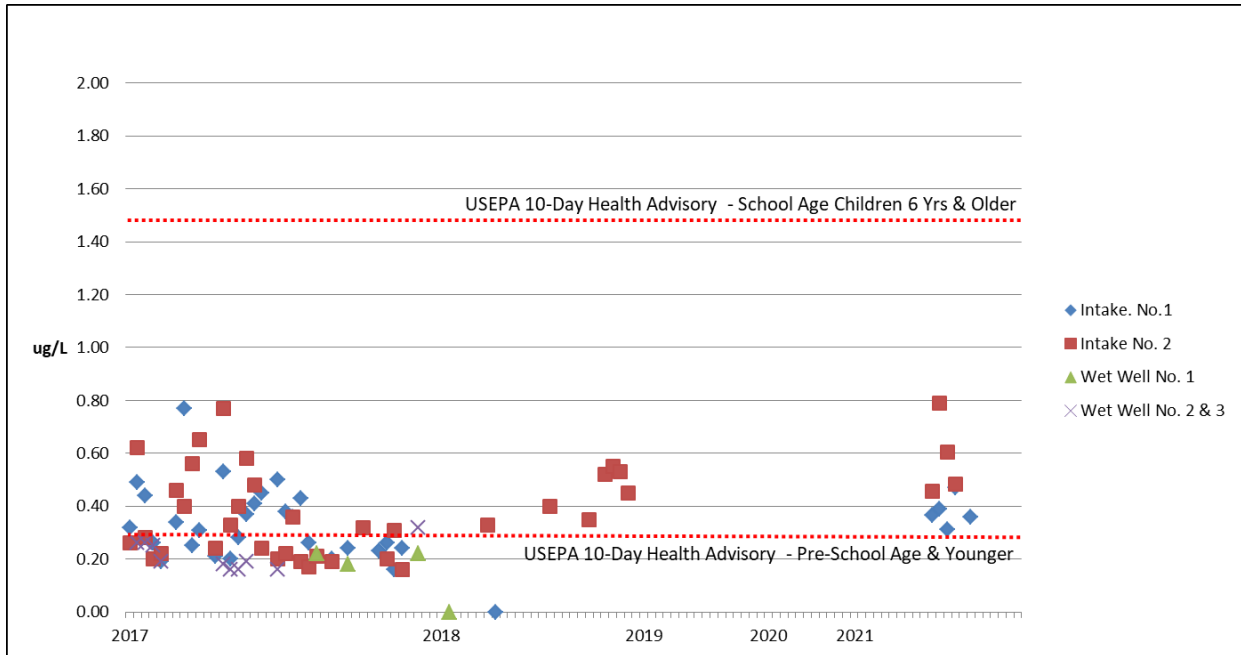
Figure 9 Skaneateles Lake Microcystin Levels 2017-2021

Throughout periods of microcystin detections in raw water intakes (2017, 2018 & 2021), the City has demonstrated that by boosting chlorine levels at the water intake cribs and wet wells and maintaining an elevated chlorine concentration in finished water, microcystin detection within the water distribution system could be avoided. Figure No. 9 shows the number of microcystin detections for both raw and treated water samples and the range of detections for the previous four years. Note that microcystin was not detected in 2019 or 2020.

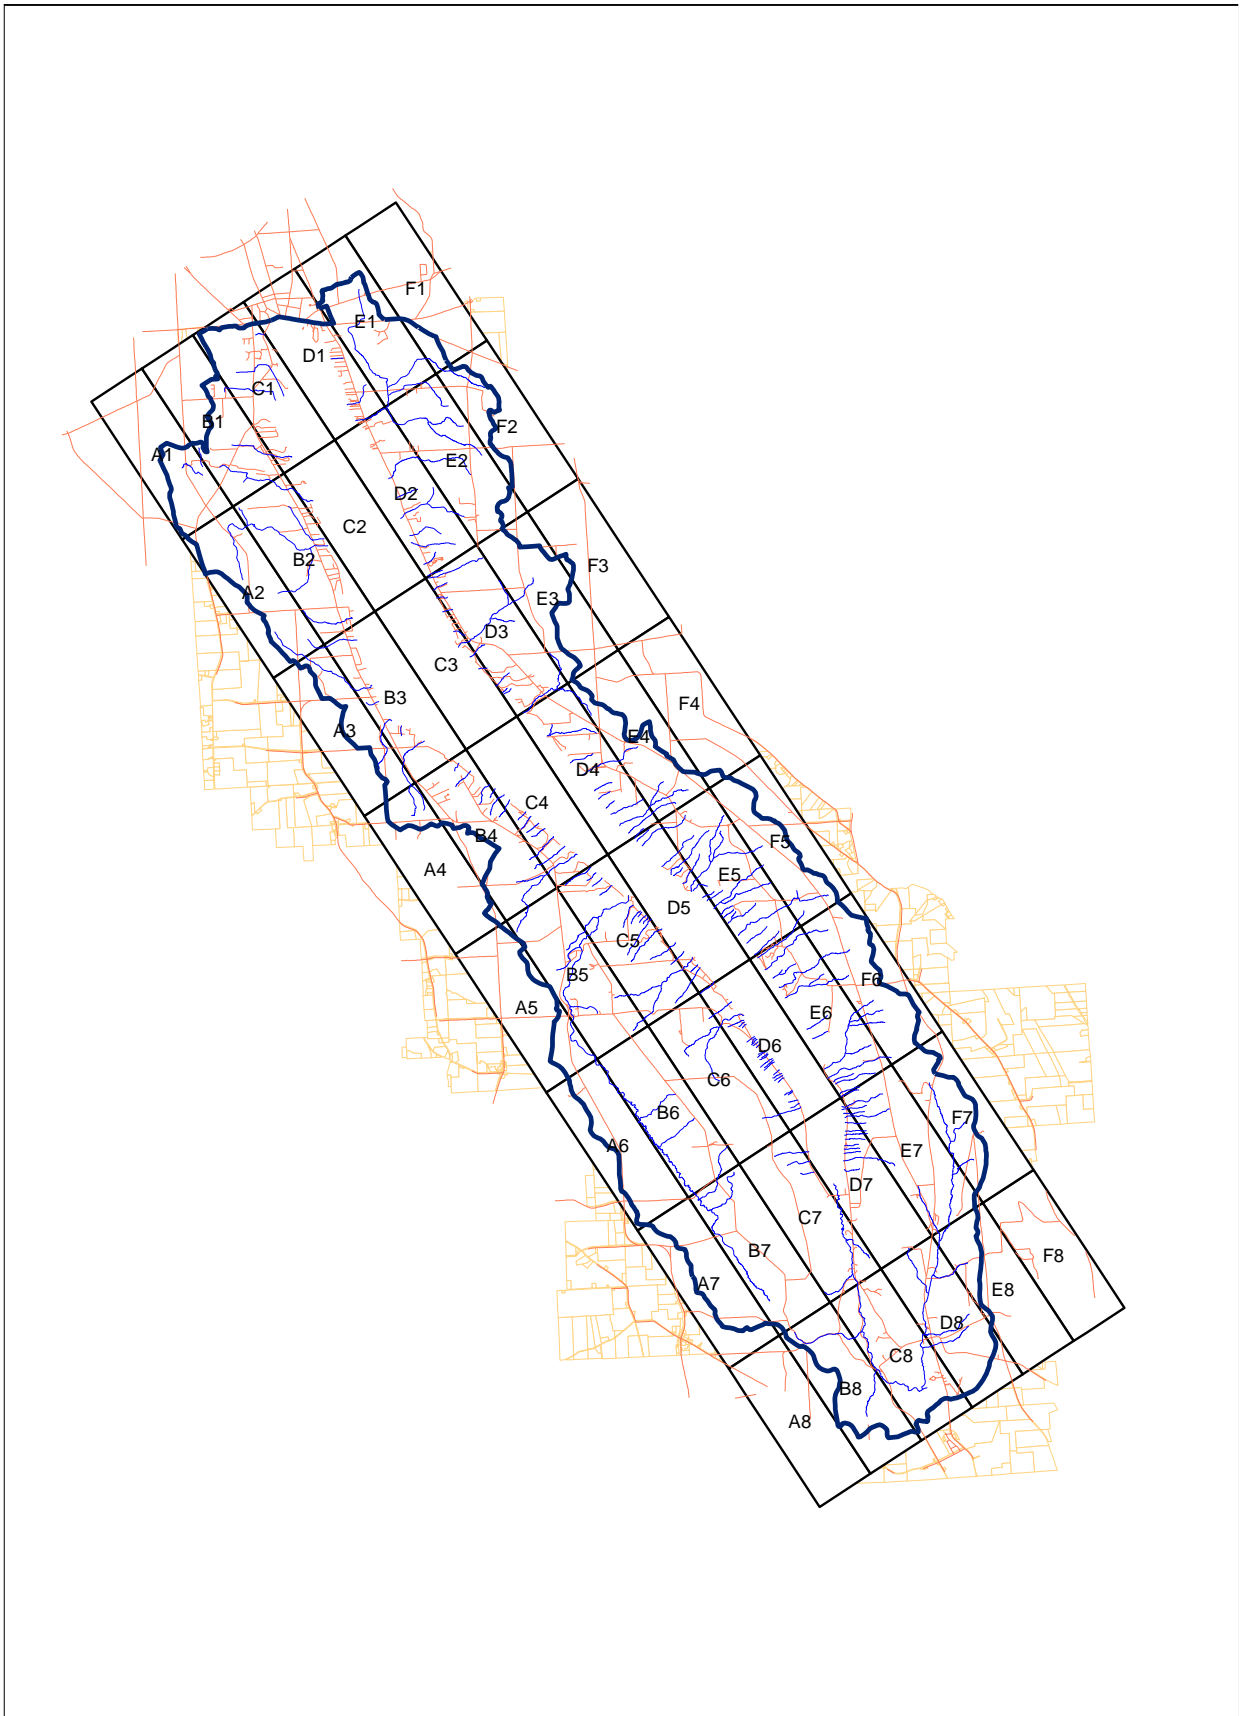
Figure 10 Skaneateles Lake Watershed Inspection Zones

In order to address this increased seasonal activity, Inspectors conduct intensive morning investigations of lakeshore properties. This includes walking properties, looking under structures, inspecting for OWTS failures, and investigating construction activities of any kind. When required, a boat detail is implemented for those areas that are difficult to access by truck or foot. In an effort to more effectively survey the entire land area within the watershed annually, watershed zones were digitally overlaid and labeled on a GIS map in 2012 (Figure 10). The zones appear on the Skaneateles Lake Watershed Map as 48 rectangular grids, each representing approximately 870 acres of land. Inspectors are assigned to individual zones based on the time of year. Zones comprising of lakefront seasonal cottages are inspected during the summer months and remote areas located off seasonal roads are typically inspected in the spring and fall.

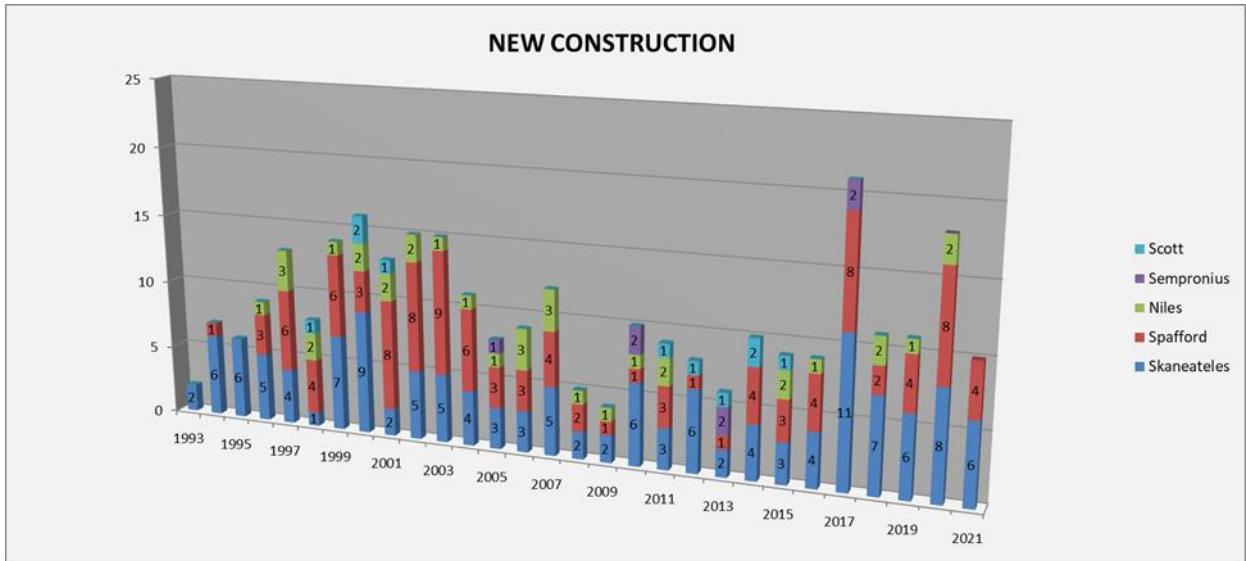
Figure 11 New Construction Activity within the Skaneateles Lake Watershed 1993-2021

The Watershed Protection Program reviewed a total 80 Building and Zoning Permit Applications in 2021. As discussed above, 10 were new construction. Twenty six applications were additions or renovations to existing dwellings and the remaining 44 applications included shoreline structures, accessory structures, landscape features or proposed subdivisions and lot line relocations. Figures 11 through 14 illustrate new construction and renovation proposals reviewed by the City of Syracuse and monitored throughout project duration in the Skaneateles Lake Watershed since 1993.

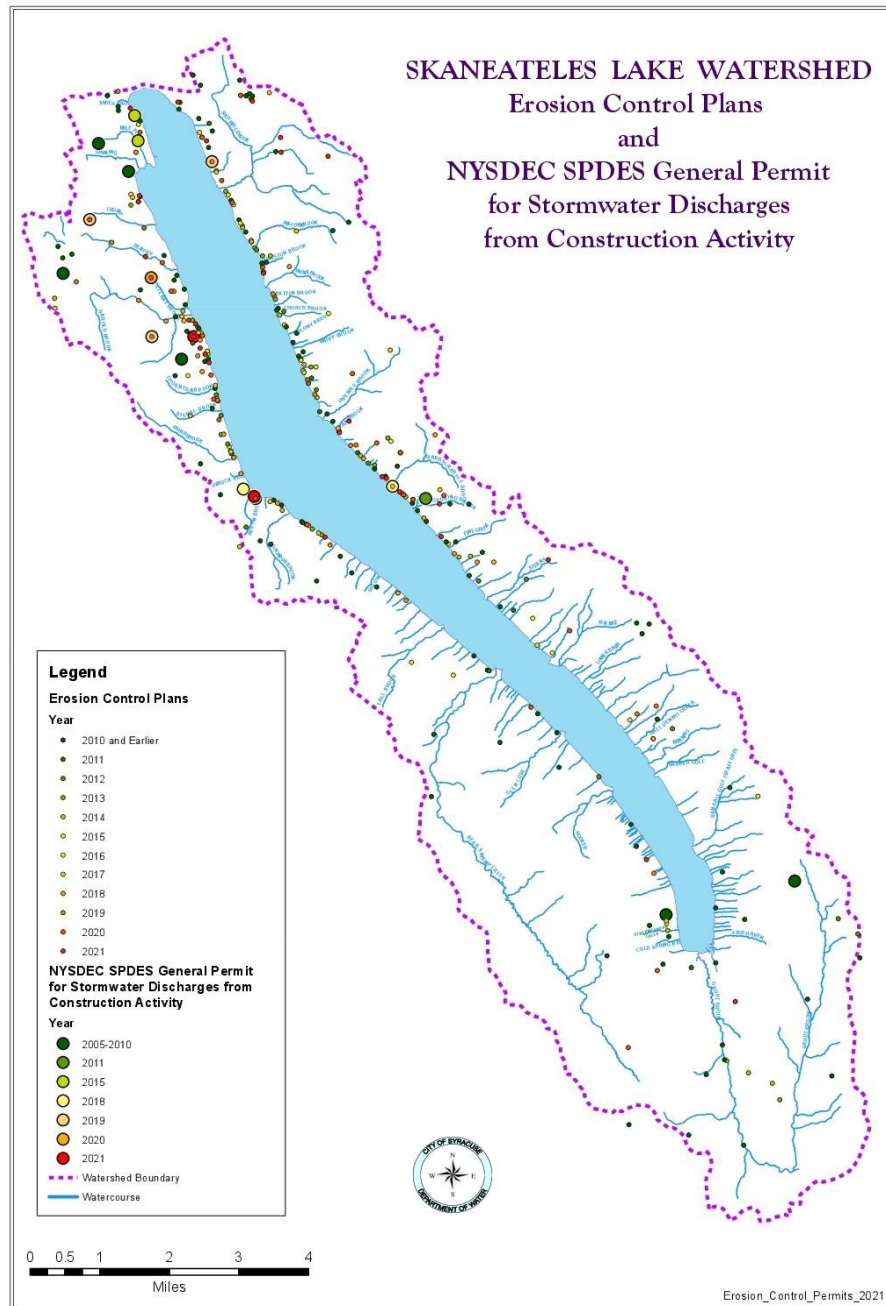
Figure 15 Erosion Control Plans/NYSDEC SPDES Permits

As of 2004, the Skaneateles Watershed Rules and Regulations require property owners proposing to disturb 5,000 square feet or greater of land in defined environmentally sensitive areas to submit a Sediment and Erosion Control Plan (SECP) to the City of Syracuse for review. In 2021, 29 SECPs were reviewed. A NYSDEC SPDES General Permit for Storm water Discharges (GP-0-15-002) is required in New York State for all construction activity over one acre. Three permits were issued for construction activity in the Watershed in 2021 under GP-0-15-002. Figure 15 illustrates SECP's reviewed and SPDES General Permits issued within the Skaneateles Lake Watershed since 2004.

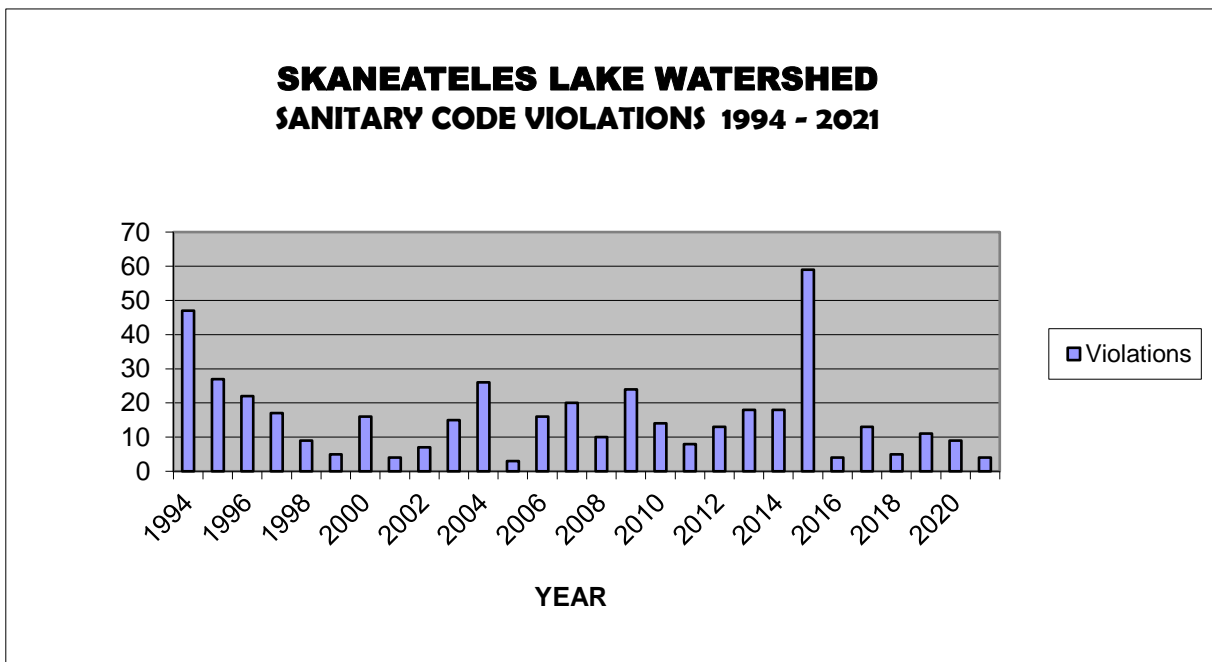
Figure 16 Skaneateles Lake Watershed Sanitary Code Violations 1994-2021

The enforcement of Sanitary Code violations is the responsibility of the respective county health departments. Alleged violators are issued a Violation Notice from the City of Syracuse and given five working days to reply and declare their intent to affect the necessary repairs. If there is no response, or if the property owner refuses to abate the problem, the violation is forwarded to the respective county health department for enforcement. Sanitary Code violations identified by Watershed Inspectors since 1994 are shown in Figure 16.

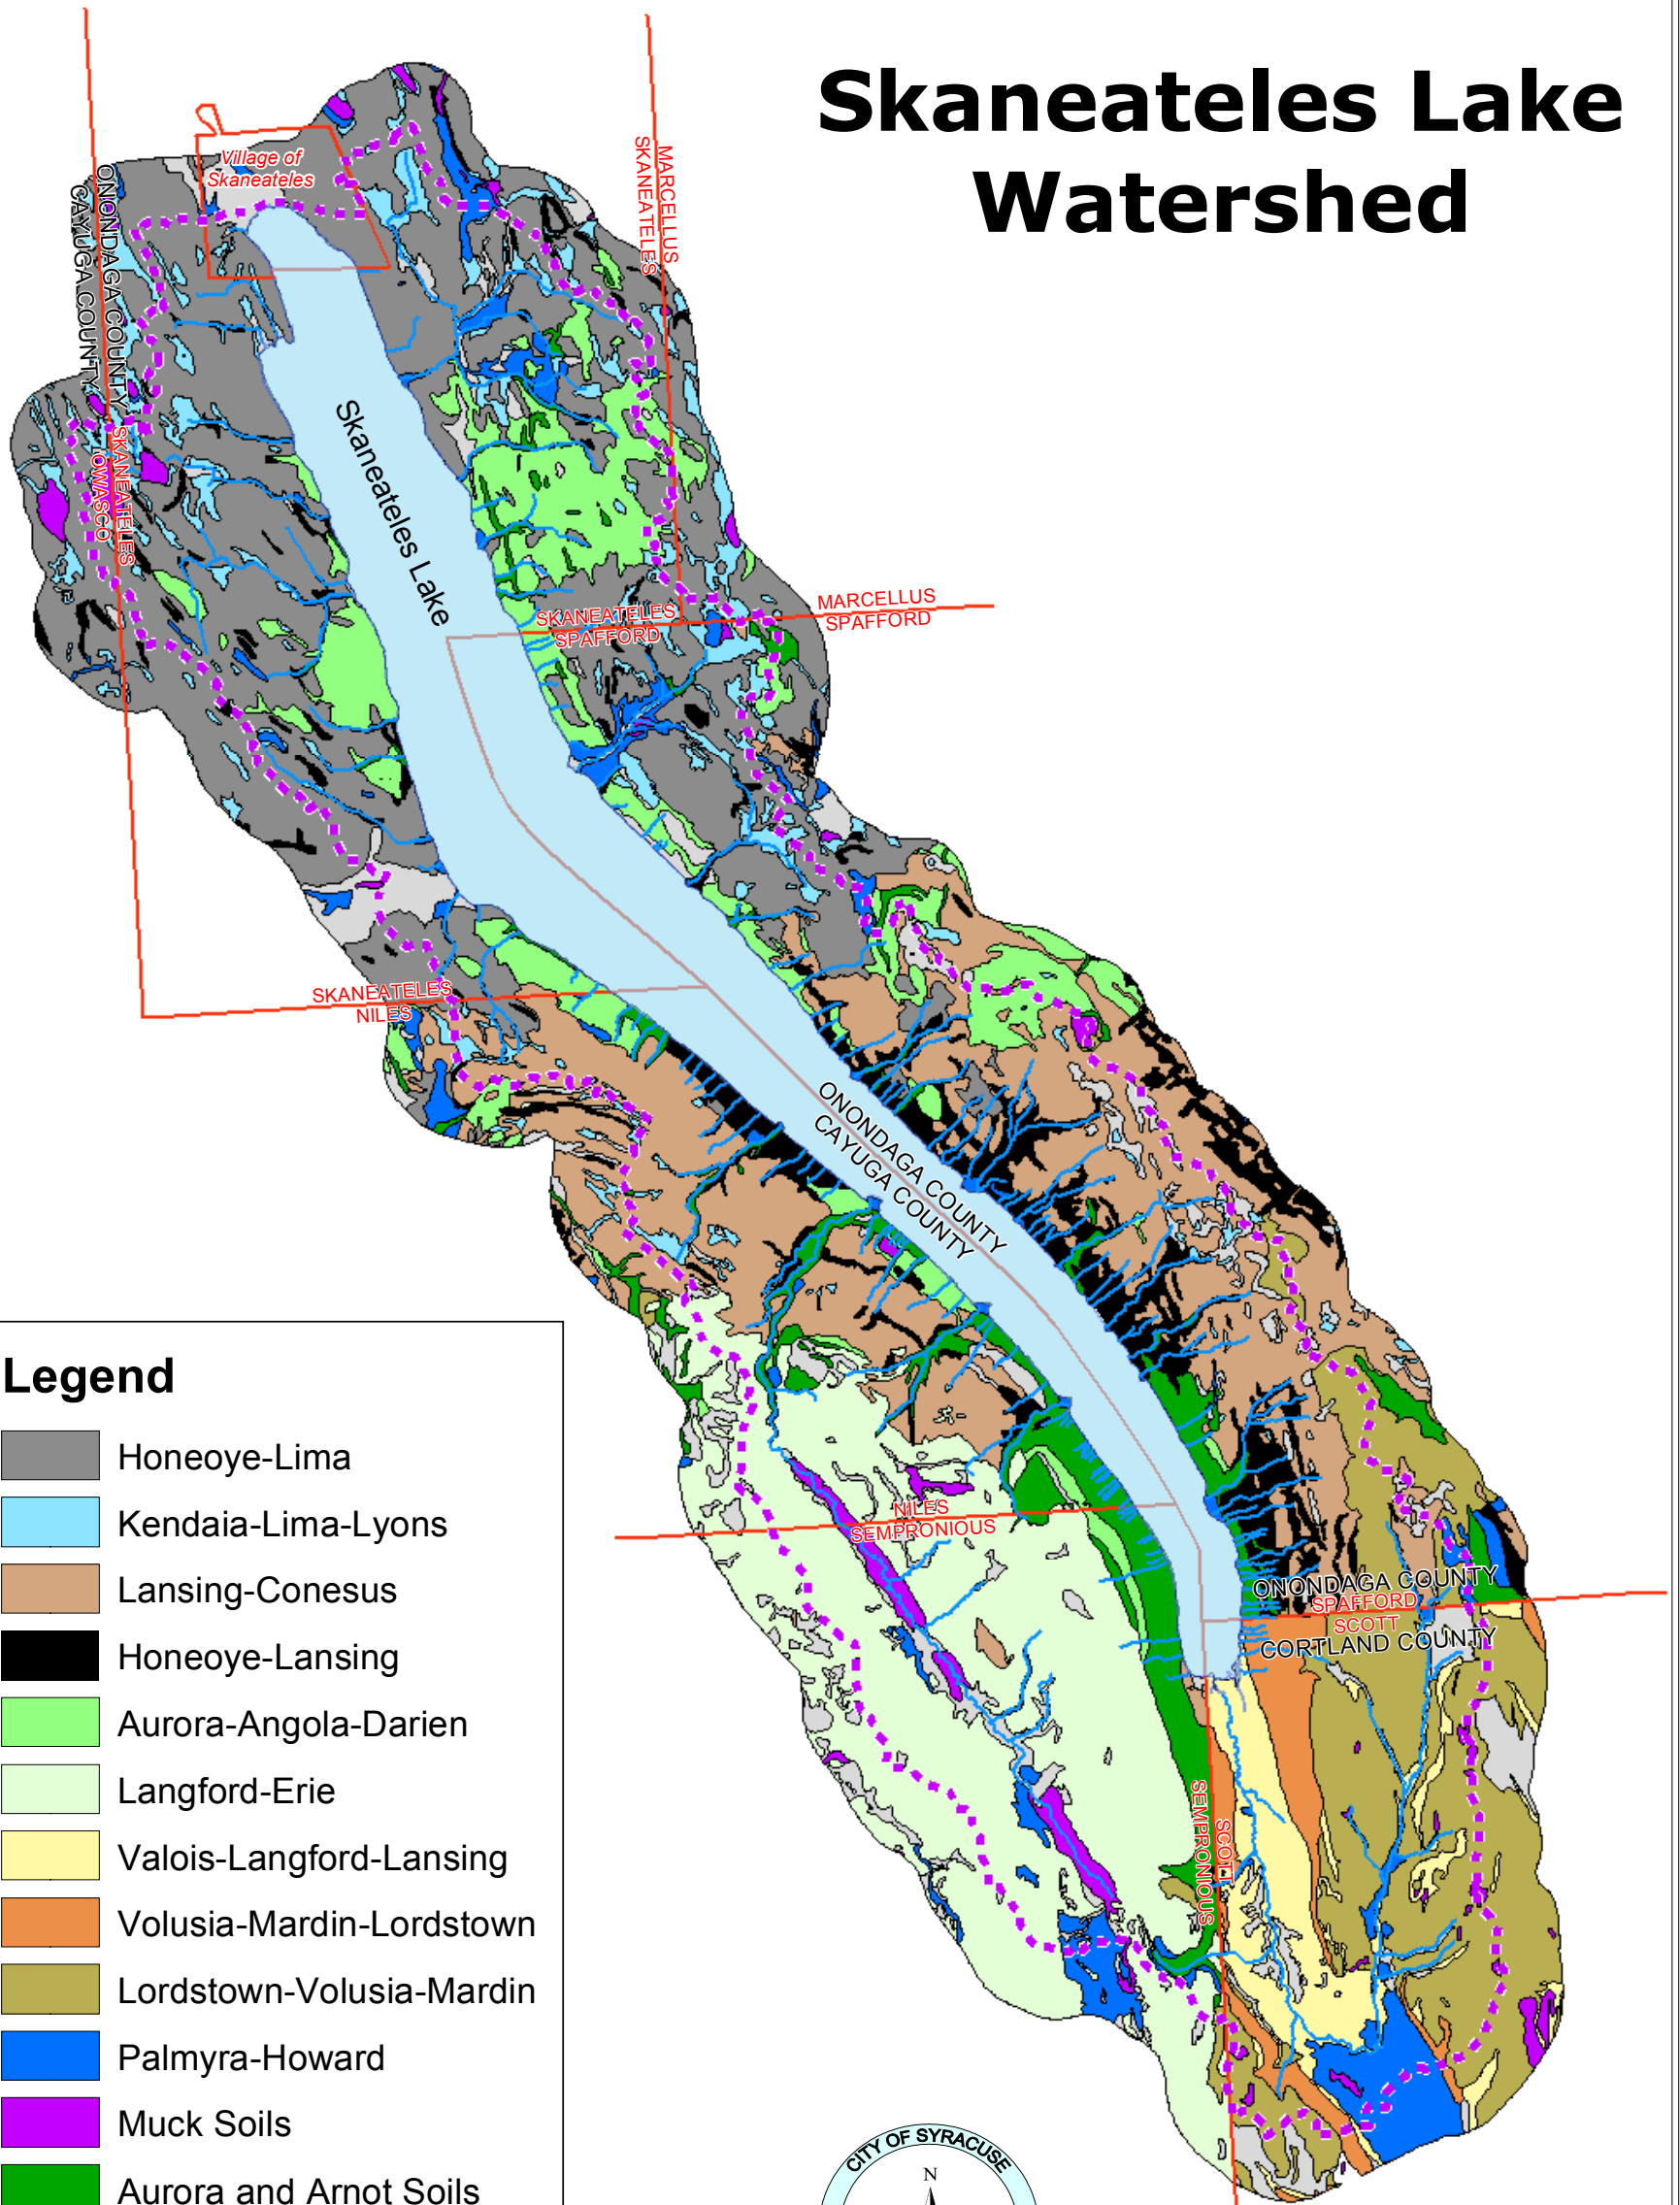
Exhibit B: Soil Associations Map

- Honeoye-Lima
- Kendaia-Lima-Lyons
- Lansing-Conesus
- Honeoye-Lansing
- Aurora-Angola-Darien
- Langford-Erie
- Valois-Langford-Lansing
- Volusia-Mardin-Lordstown
- Lordstown-Volusia-Mardin
- Palmyra-Howard
- Muck Soils
- Aurora and Arnot Soils
- Minor Soil Associations
- Streams in the Watershed
- Watershed Boundary
- Municipal Boundaries

There are several soil associations within the watershed (Exhibit B and Table No. 2). The associations discussed below account for 80% of the watershed area and are considered representative of the character of the watershed. The remainder (20%) will not be discussed. It is noted that the associations generated by the GIS compare well, though not exactly, with the U.S. Department of Agriculture Soil Surveys prepared for each county. It would appear that this is due to the inherent discrepancies often found between maps and mapping systems.

The major soil associations found in the northern two-thirds of the watershed are: Honeoye-Lima, Lansing-Conesus, Honeoye-Lansing, and Aurora-Angola-Darien. These associations are generally characterized as deep, medium textured silt loams and gravelly silt loams. Slopes range from 2-8%, except the Honeoye-Lansing Association that has slopes of 15-25%. They are moderately well, to well drained. Permeability is slow to moderate, and seasonal ground water is generally 15" to <36".
