**SYRACUSE
LANDMARK
PRESERVATION
BOARD**

Certificate of Appropriateness Application

Case Number: CA-23-06

WINDOW SURVEY FORM

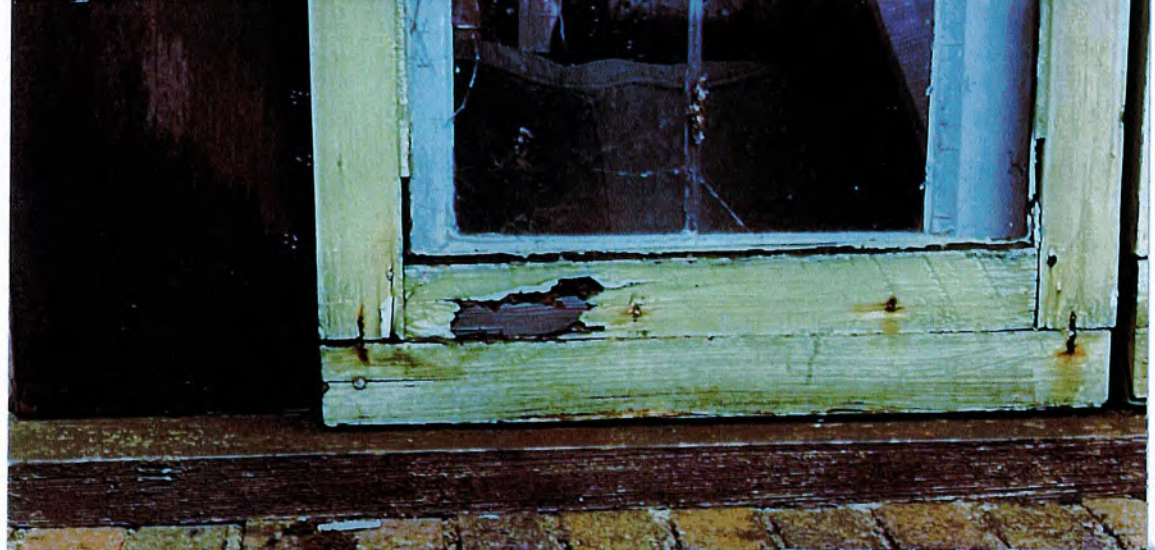
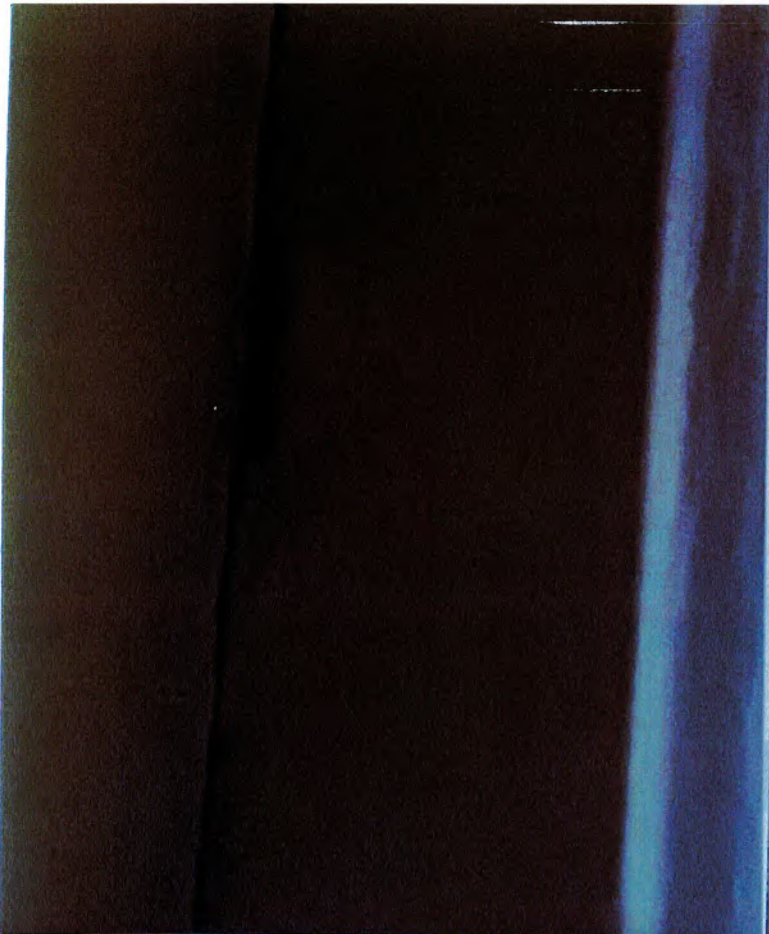
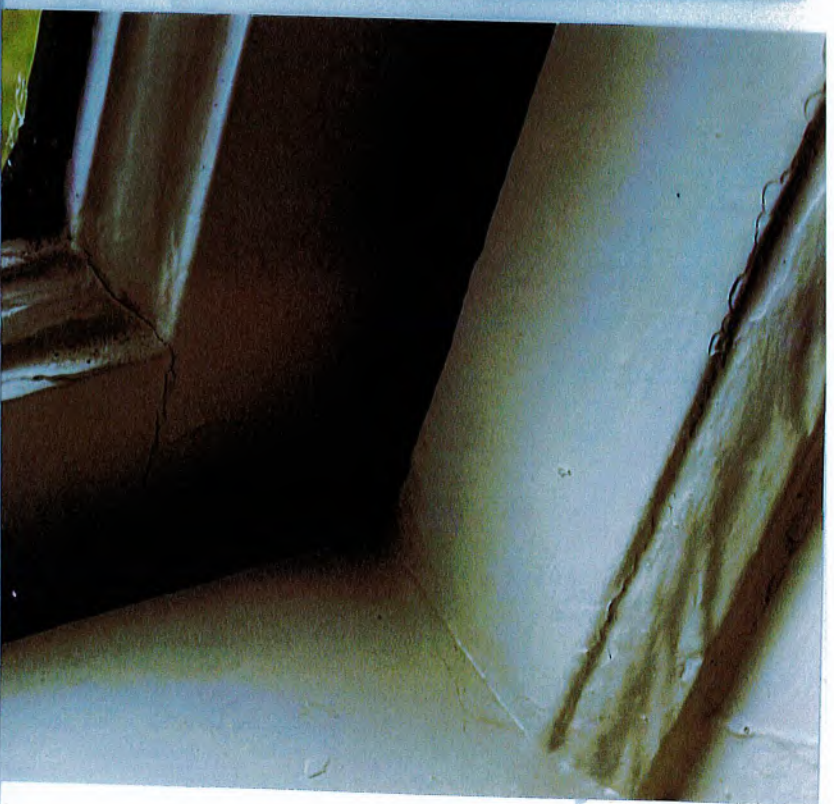
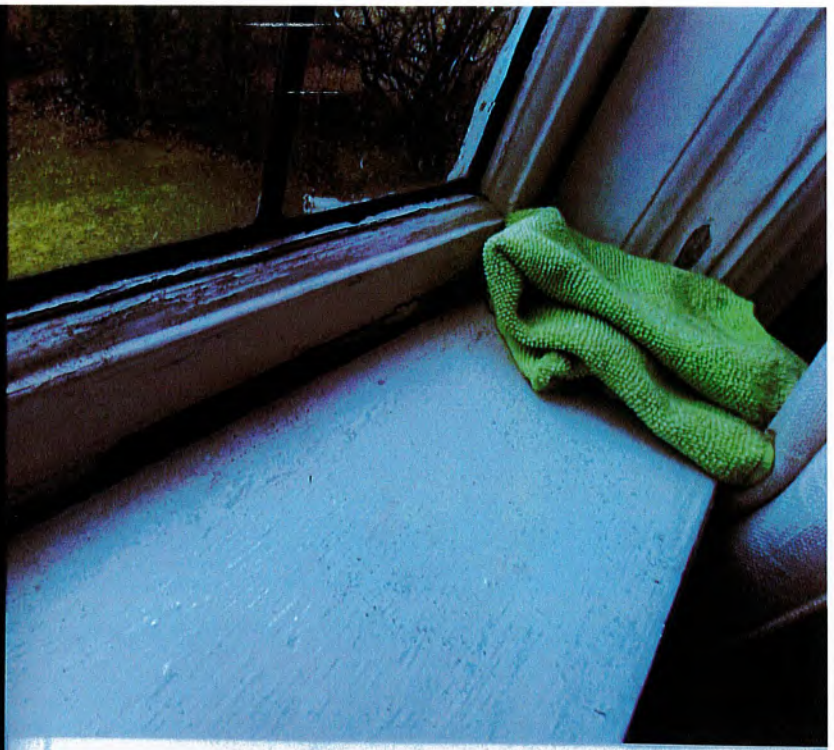
At the front of the starting on the top left we have a double casement that is in the Master Bedroom. Inside and outside the unit is rotten. The storms leak at the top, the water used to sit on the sill, not runs into the wall as the sills have failed. When the window comes from the right direction rain comes in the top of the unit and runs down the interior sash. The unit doesn't close completely or correctly leading to large amounts of condensation in the master bedroom. The family is chasing mold and mildew in this room constantly even running a dehumidifier.

The lower walk out bay has failed. The units are sinking into the rotten sills. The sills allow water in behind the brick. The units needed to be repaired and have maintenance done years ago. It hasn't happened. These units are almost unsalvageable. We will recreate the look and feel of this all while making the unit structurally sound again.

The triple unit of diamonds are interesting as they are fixed units and mostly protected. The storms and the sills show soft spots. The plan is to remove the storms, repair the sills and install the new fixed units from the outside. We are going to do all this while attempting to not touch the inner diamond sashes. This will help the house keep its character and elegance. IF the diamonds have to be removed to repair we have another plan to keep them intact and put them back in their rightful spot.

Lastly the three casements in the stucco by the porch. All three of these units are not closing due to water damaged sills. The leaks do not currently appear to be allowing water behind the stucco, but it is causing swelling of the sills and the sashes. The sashes are warping from not closing properly and are creating large drafts in addition to condensation concerns.

The plan that we have is the same for all the windows. We are going to remove the storms that remain. We will then remove the sashes of the old windows. The frames will be repaired and straightened. We will remove and replace any rotten or missing wood. We will moisture protect the entire opening. We will then be sliding new Pella Impervia windows back into the existing trim. The advantage for the Stazzone-McGee's with Impervia is it is a complete fiberglass unit. This is going to make it extremely strong to help hold the openings true and square going forward. The other advantages are that it can deal with the high moisture content that they have been experiencing since day. It is also designed to look like painted wood from the exterior, giving it more of that historic feel. For the neighborhood the advantages of Impervia are not only that textured painted look. The visible glass on the units will be on average ¼" narrower in width than the existing, but 3/8" taller visible glass on height, allowing the perspective to stay the same. Also the units are very slim which allows them to be installed in the place of the current sashes and not protrude further out of the house than the previous storm windows did. This is the closest match for historic applications as they could find after meeting with many different suppliers. All of this will be done with minimal disruption to the exterior of the home and also in a manner consistent with the EPA's lead safe practices to keep the family and the community safe.

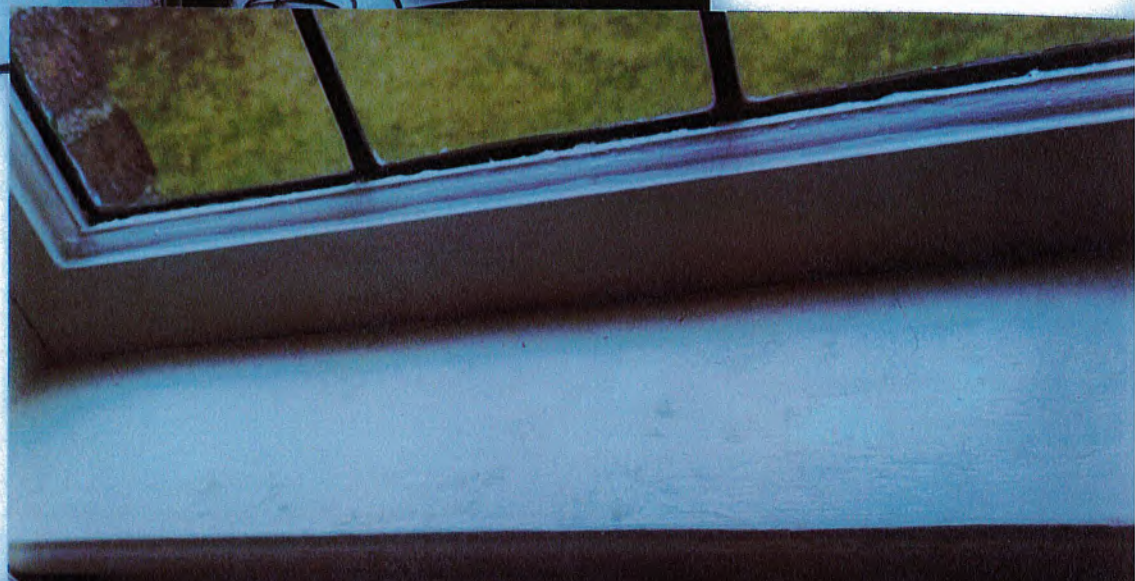
The upper left hand corner is a double casement that goes into their youngest son's room. This room has 2 large radiators in it but is still the coldest room in the home. This is due to all 5 casements in the room not closing. There are gaps of 1 ¼" on some sashes. The gaps have caused warping of the sashes so on days that they can manage to get the windows to close there is still a draft. The temperature changes at the windows are causing frost on the room side in addition to the condensation. The family has put towels on most of the interior stools to try to keep the water from going too far, but that led to mildew on the towels and some cases mold under the towels on the stools and window stops.

On the first floor the three wide casement is an enclosed porch that has become part of the living space over the years. The windows leak when it rains. And the units don't shut even when pushing from the exterior. This appears to be swelling in the frame and sash from the high moisture.

The final unit on the left side is a double unit in the living room. This unit was damaged from the same water that caused the ceiling to collapse in that room. There is evidence of water getting in wall as the oak flooring is showing internal rot at the base of the wall directly below this unit. This window suffers like the others from condensation and in extreme weather days large frost build up. The sash is soft enough that the window locks have pulled out and the units cannot be secure.

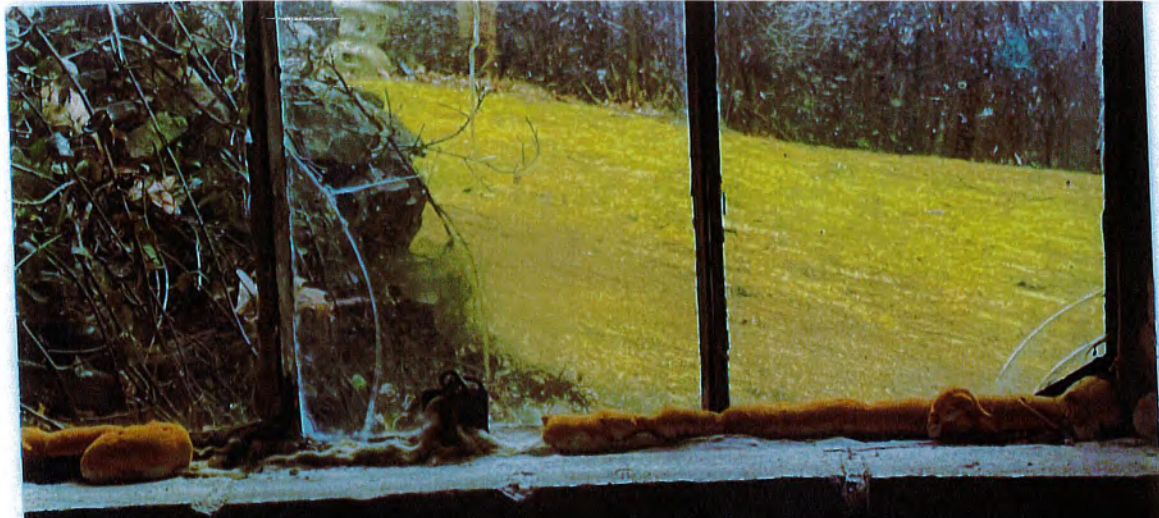
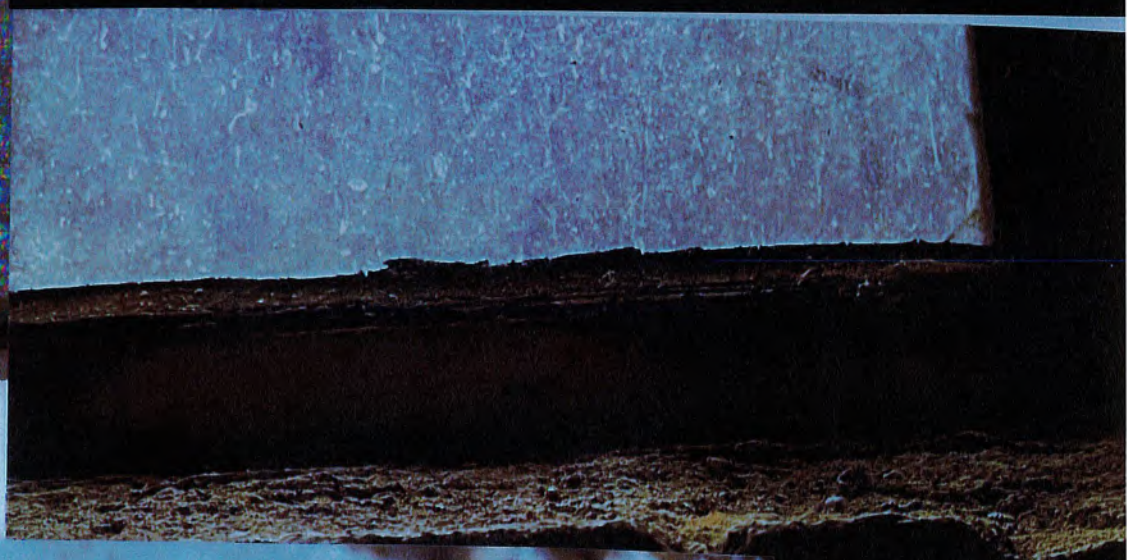
Basement/Garage

The basement is a little different. There are windows on all sides of the home. The landscaping prevented the pictures from showing most of them.
