Certificate of Appropriateness Application

EXISTING CONDITIONS	PROPOSED PHASE 2 WORK
<p><u>First Floor Restoration:</u> The First Floor retains a substantial amount of the Stickley design as illustrated in the 1902 Craftsman Magazine. The building was modified several times between 1940s-1980s creating five apartments with five bathrooms, five kitchens, and additional bedrooms. Significant features of the 1902 design including trim, finishes, high wainscot paneling, beams, and columns all remain. Some original chestnut paneling was replaced c.1985 with inappropriate knotty pine. Some original doors remain and others were replicated in the 1980s. Woodwork is deteriorated/ damaged/worn due to water and structural issues. As of 2023 the 1902 chestnut woodwork is exhibiting new mold growth due to developing moisture issues and the lack of heating/cooling and humidity control.</p>	<p>Fully restore Stickley’s 1902 historic features and finishes in the very significant primary First Floor historic rooms including Living Room, Entry Hall, Stair Hall, Dining Room, and Inglenook. Restore all finishes including plaster (walls and ceiling), flooring, and trim per the Secretary of the Interior

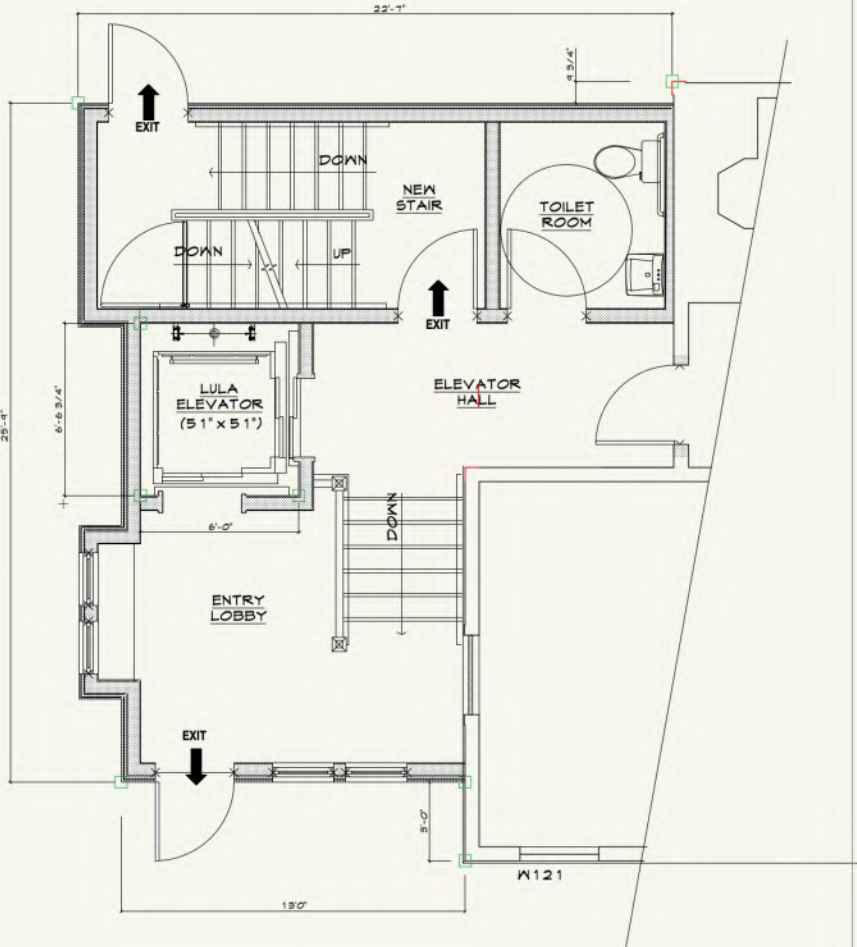
PHASE 2 ADDITION:
FIRST FLOOR PLAN
 2
 AXXX 3/8" = 1'-0"
 NORTH

Proposed Addition

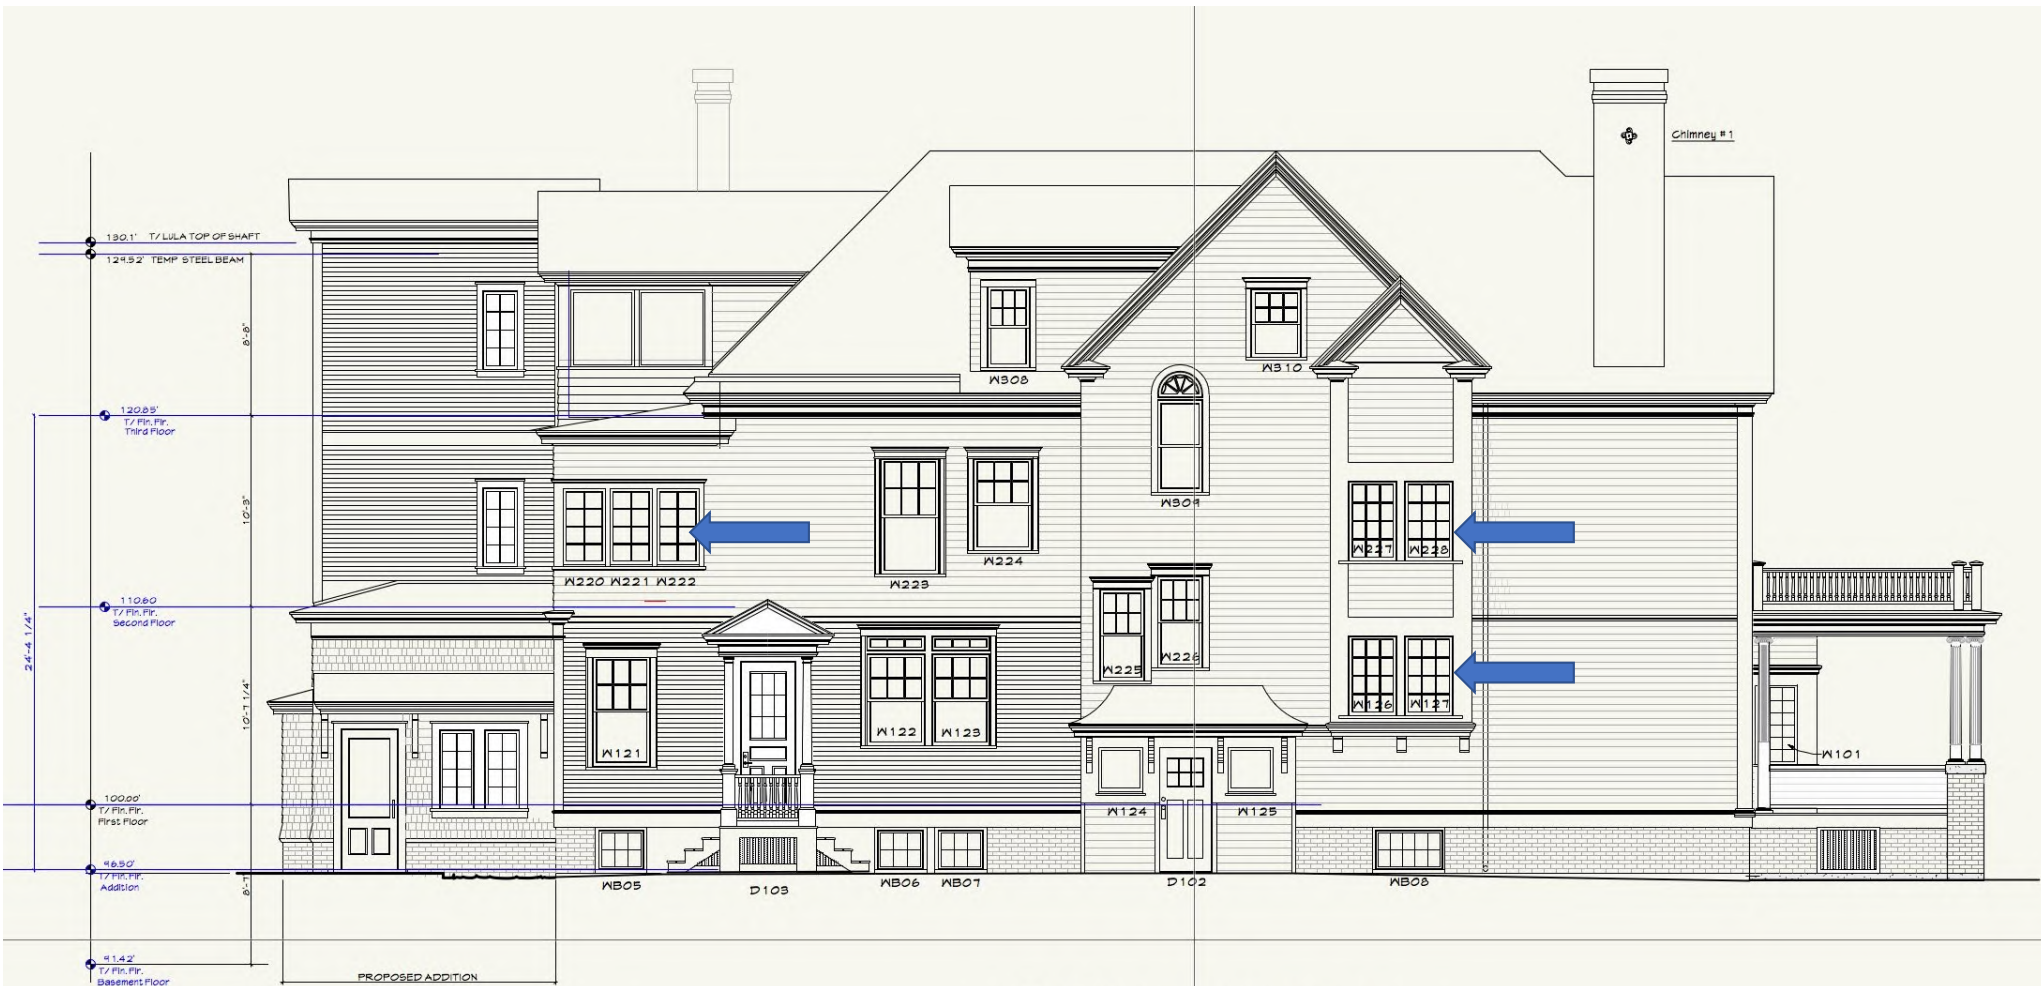
1 SOUTH ELEVATION
 A602 1/4" = 1'-0"

Proposed Addition

2. The four window sash at the South Elevation at W126-W127 and W227-W228 are mid-1990s replacement units in original frames. Originally these would have been wood sash with leaded divided lites to match the windows at the Living and Dining Rooms. We proposed to install new fixed in place custom replacement American Chestnut sash with leaded divided lites to match the Living Room. Exteriors would have wood storm sash to match the Living Room Windows.

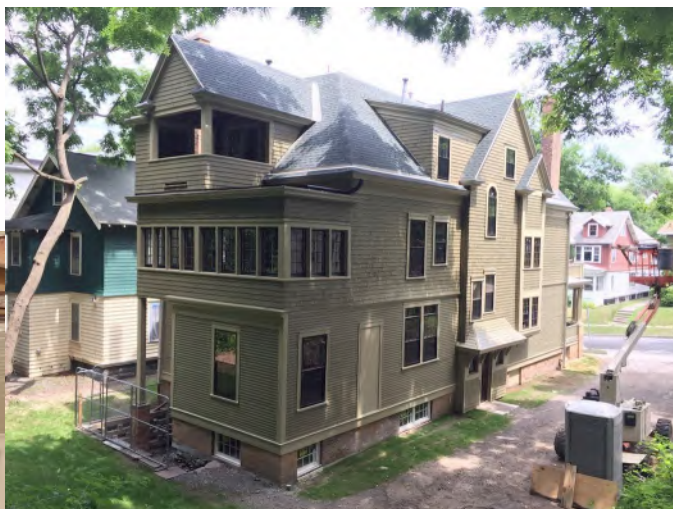
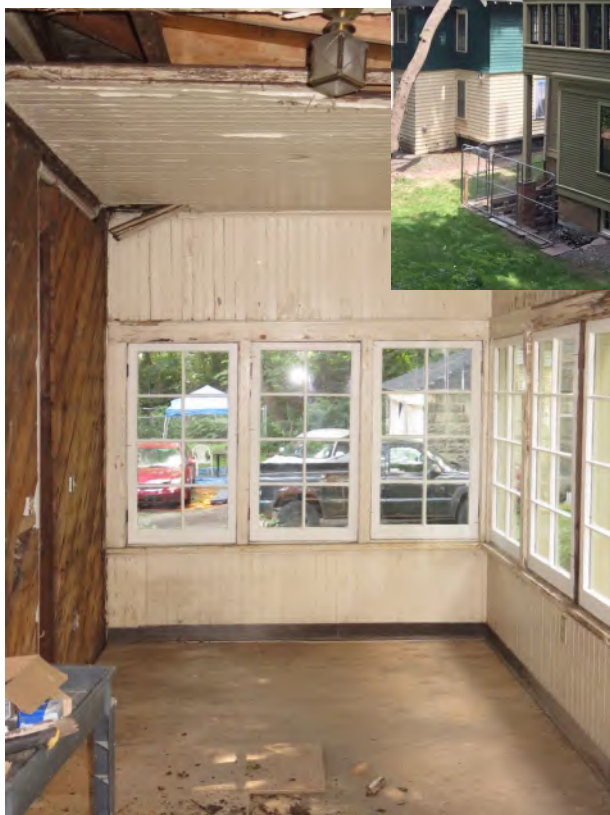
MARVIN®

Marvin Signature™ Ultimate Casement Push Out Narrow Frame window opens quickly and easily with push out operation as an alternative to traditional crank operation.

Features of the Ultimate Casement Push Out Narrow Frame Window

- Available in heights up to 8 feet or widths up to 3.5 feet
- Contemporary-style window with sleek design and square profiles
- Narrow jamb for replacement applications that minimizes tear-down of existing frame and walls
- Unique wash mode allows access to both sides of glass from indoors
- Retractable screen option is nearly invisible when the screen is not in use

1. The existing 8-lite casement windows in the former Second Floor sleeping porch at the rear of the house are not original to the 1900-1902 house, are lightweight, and are not weatherproof for a finished interior. These windows most likely date to late 1910's or early 1920's and after the Stickley ownership period of significance (1902-1911). New painted Marvin wood casement windows (8 total at W215-W222) are proposed with matching wood 8-lite muntin pattern. The NYS OPRHP's preliminary determination is that the proposed casement replacements would have no adverse effect on the property. A representative example of an existing casement sash with be tagged and stored in the Attic.
