SYRACUSE LANDMARK PRESERVATION BOARD

Certificate of Appropriateness Application

Case Number: CA-18-04

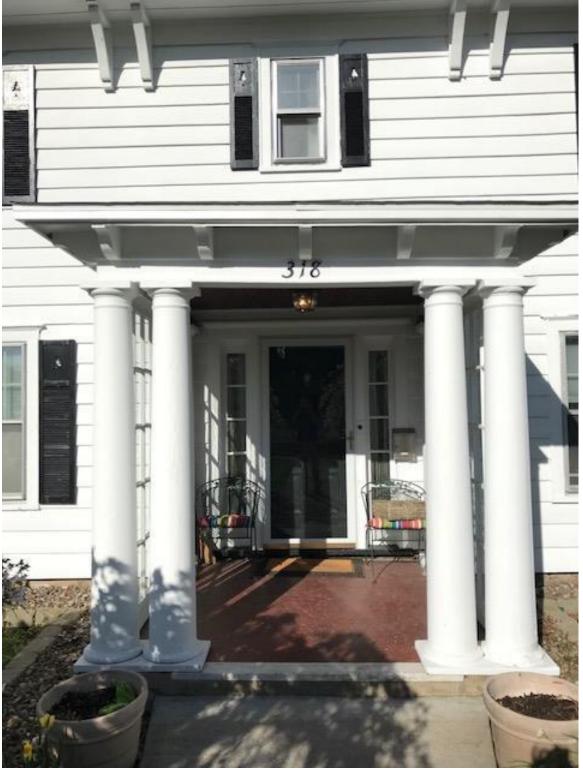
318 Berkeley Drive. Photo of porch showing how it has dropped on the right side. Compare the line of the siding to the line of the porch roof.

A white K-style gutter will be installed around three sides of porch roof with downspout on the right side against the main house, allowing the column on far right to dry out so it cam be repaired. Eventually we will level the concrete slab, and remove the gutter.

K-style gutter to be installed will match existing gutters on the main roof of house.

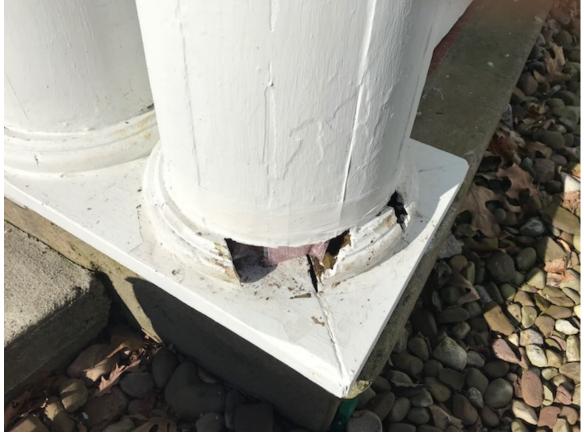
Close up of rotting column base due to water flowing unevenly off of porch roof. This will ultimately be restored with ABATRON wood epoxy, but it has to completely try out first.

- 2-1 Please describe the nature of the work for which the Certificate of Appropriateness is being sought: Porch in Front has dropped on North Side Causing water damage to column base (See phote) Short-term: Install K-style gutter on Front pokch, so Column candry out and be repaired Long-term: Level concrete slap of Front Porch see attached for additional details
